## CRINGILA PUBLIC SCHOOL NEAR-SURFACE TEMPERATURE MONITORING INVESTIGATION

Summary Report  
15/06/2020 – 26/06/2020

Cringila Public School

Document Quality Management Details							
<b>Job Reference:</b>	J153825-03						
<b>Report Name:</b>	TI-26 Near-Surface Temperature Monitoring						
<b>Site Details:</b>	Cringila Public School – 35 Sheffield Street, Cringila NSW 2502 Northwest Hotspot						
<b>Client Name:</b>	NSW Department of Education						
<b>Client Number:</b>	C107471						
<b>Signatures:</b>

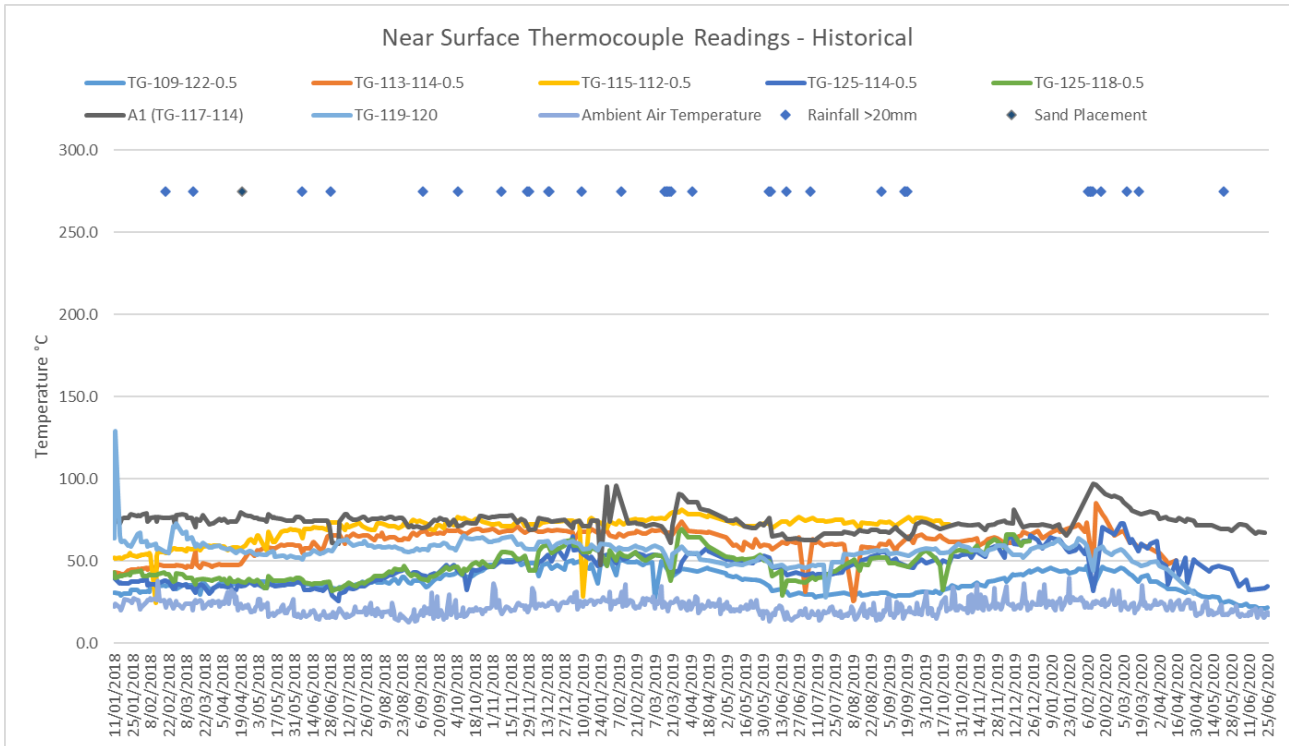
### 3.1. Near-Surface Temperature Graph – Selected Points (Historical)

Near surface temperature measurements for key thermocouple locations, progressive from Thursday 11<sup>th</sup> January 2018 to present.

The near-surface temperature appears to fluctuate seasonally across the surface of the northwest hotspot grid monitoring area.

Fluctuations in near-surface temperature are also evident following significant rain events (i.e. over 20mm rain).

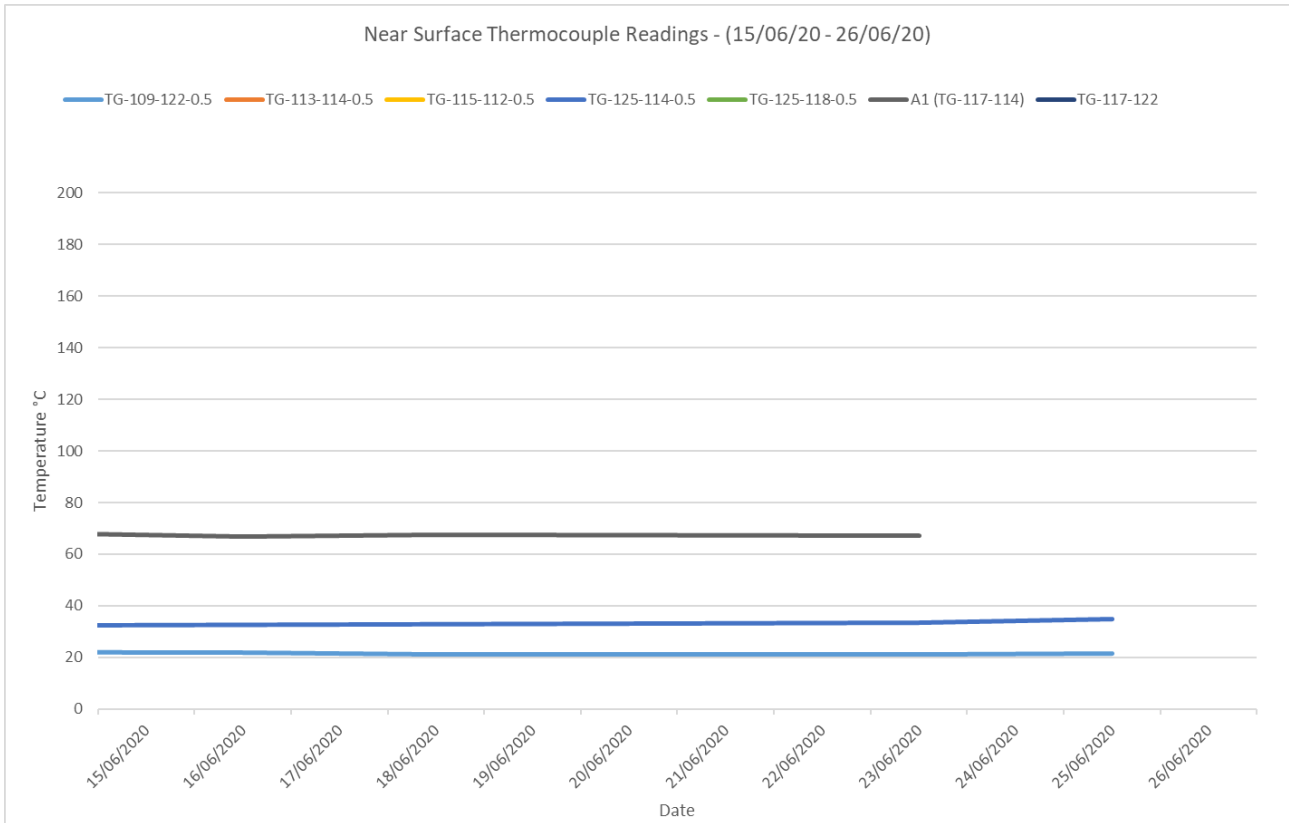
### 3.2. Near-Surface Temperature Graph – Selected Points (Fortnightly)

Near-surface temperature measurements for key thermocouple locations, over the monitoring period – between 15<sup>th</sup> June 2020 and 26<sup>th</sup> June 2020 in the northwest Hotspot, situated on the Cringila Public School grounds.

Please note – data from certain points was not available within this date range due to technical constraints.

Variations in the near-surface temperature at selected points across the northwest hotspot over the period of monitoring appear to coincide with the high rainfall events during the period.

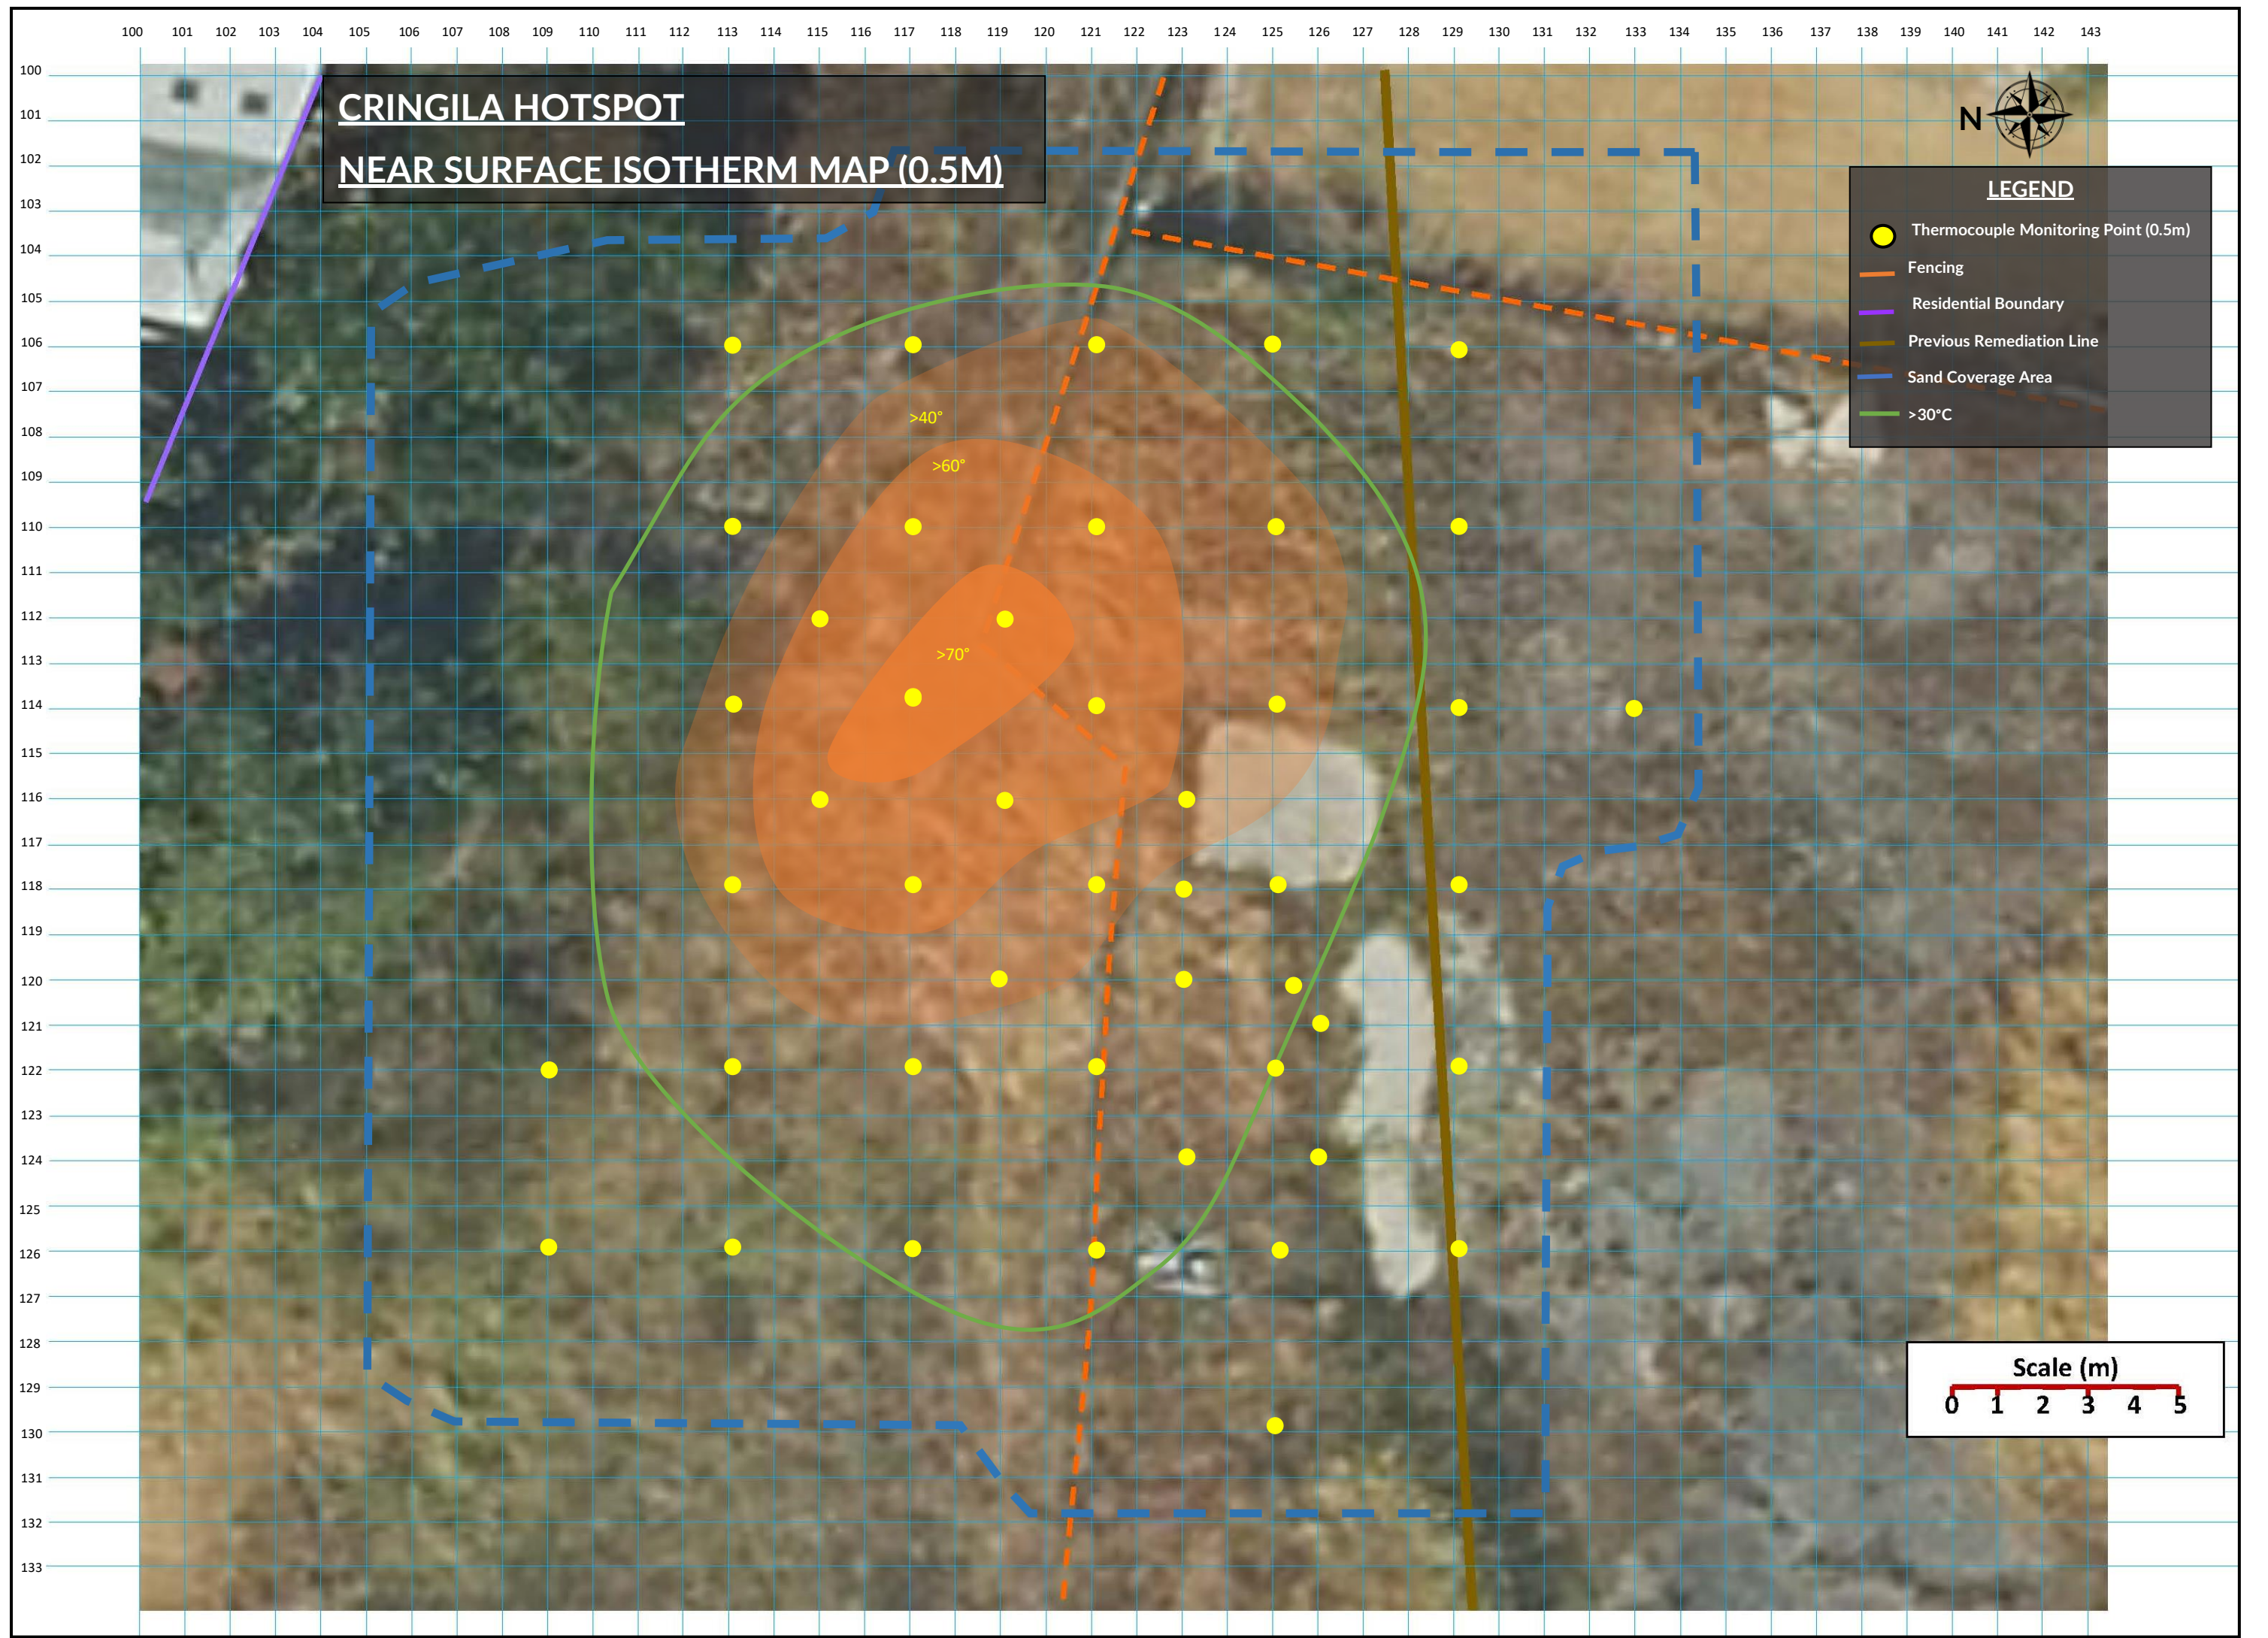
### Appendix B: Near-Surface Temperature Isotherm Map (0.5m)

The isotherm map shows the general zone of influence for temperatures between 30°C and 70°C at 0.5m, coloured orange. The isotherm map suggests that the hotspot may extend deeper than 0.5m and that the increased temperature in these areas is a result of heat venting to the surface.

It is noted that temperature at the near-surface may be variable across the hotspot due to inconsistencies in the consolidation and compaction of subsurface materials.

# CRINGILA HOTSPOT NEAR SURFACE ISOTHERM MAP (0.5M)

It is recommended that weekly site inspections and recording are continued to monitor the near-surface temperatures surrounding the subsurface hotspot identified at the site.
