CRINGILA PUBLIC SCHOOL
MONTHLY SUBSURFACE GAS
MONITORING REPORT
– SEPTEMBER 2019

J153825-03

NSW Department
of Education
Cringila Public School

35 Sheffield Street,
Cringila NSW 2502

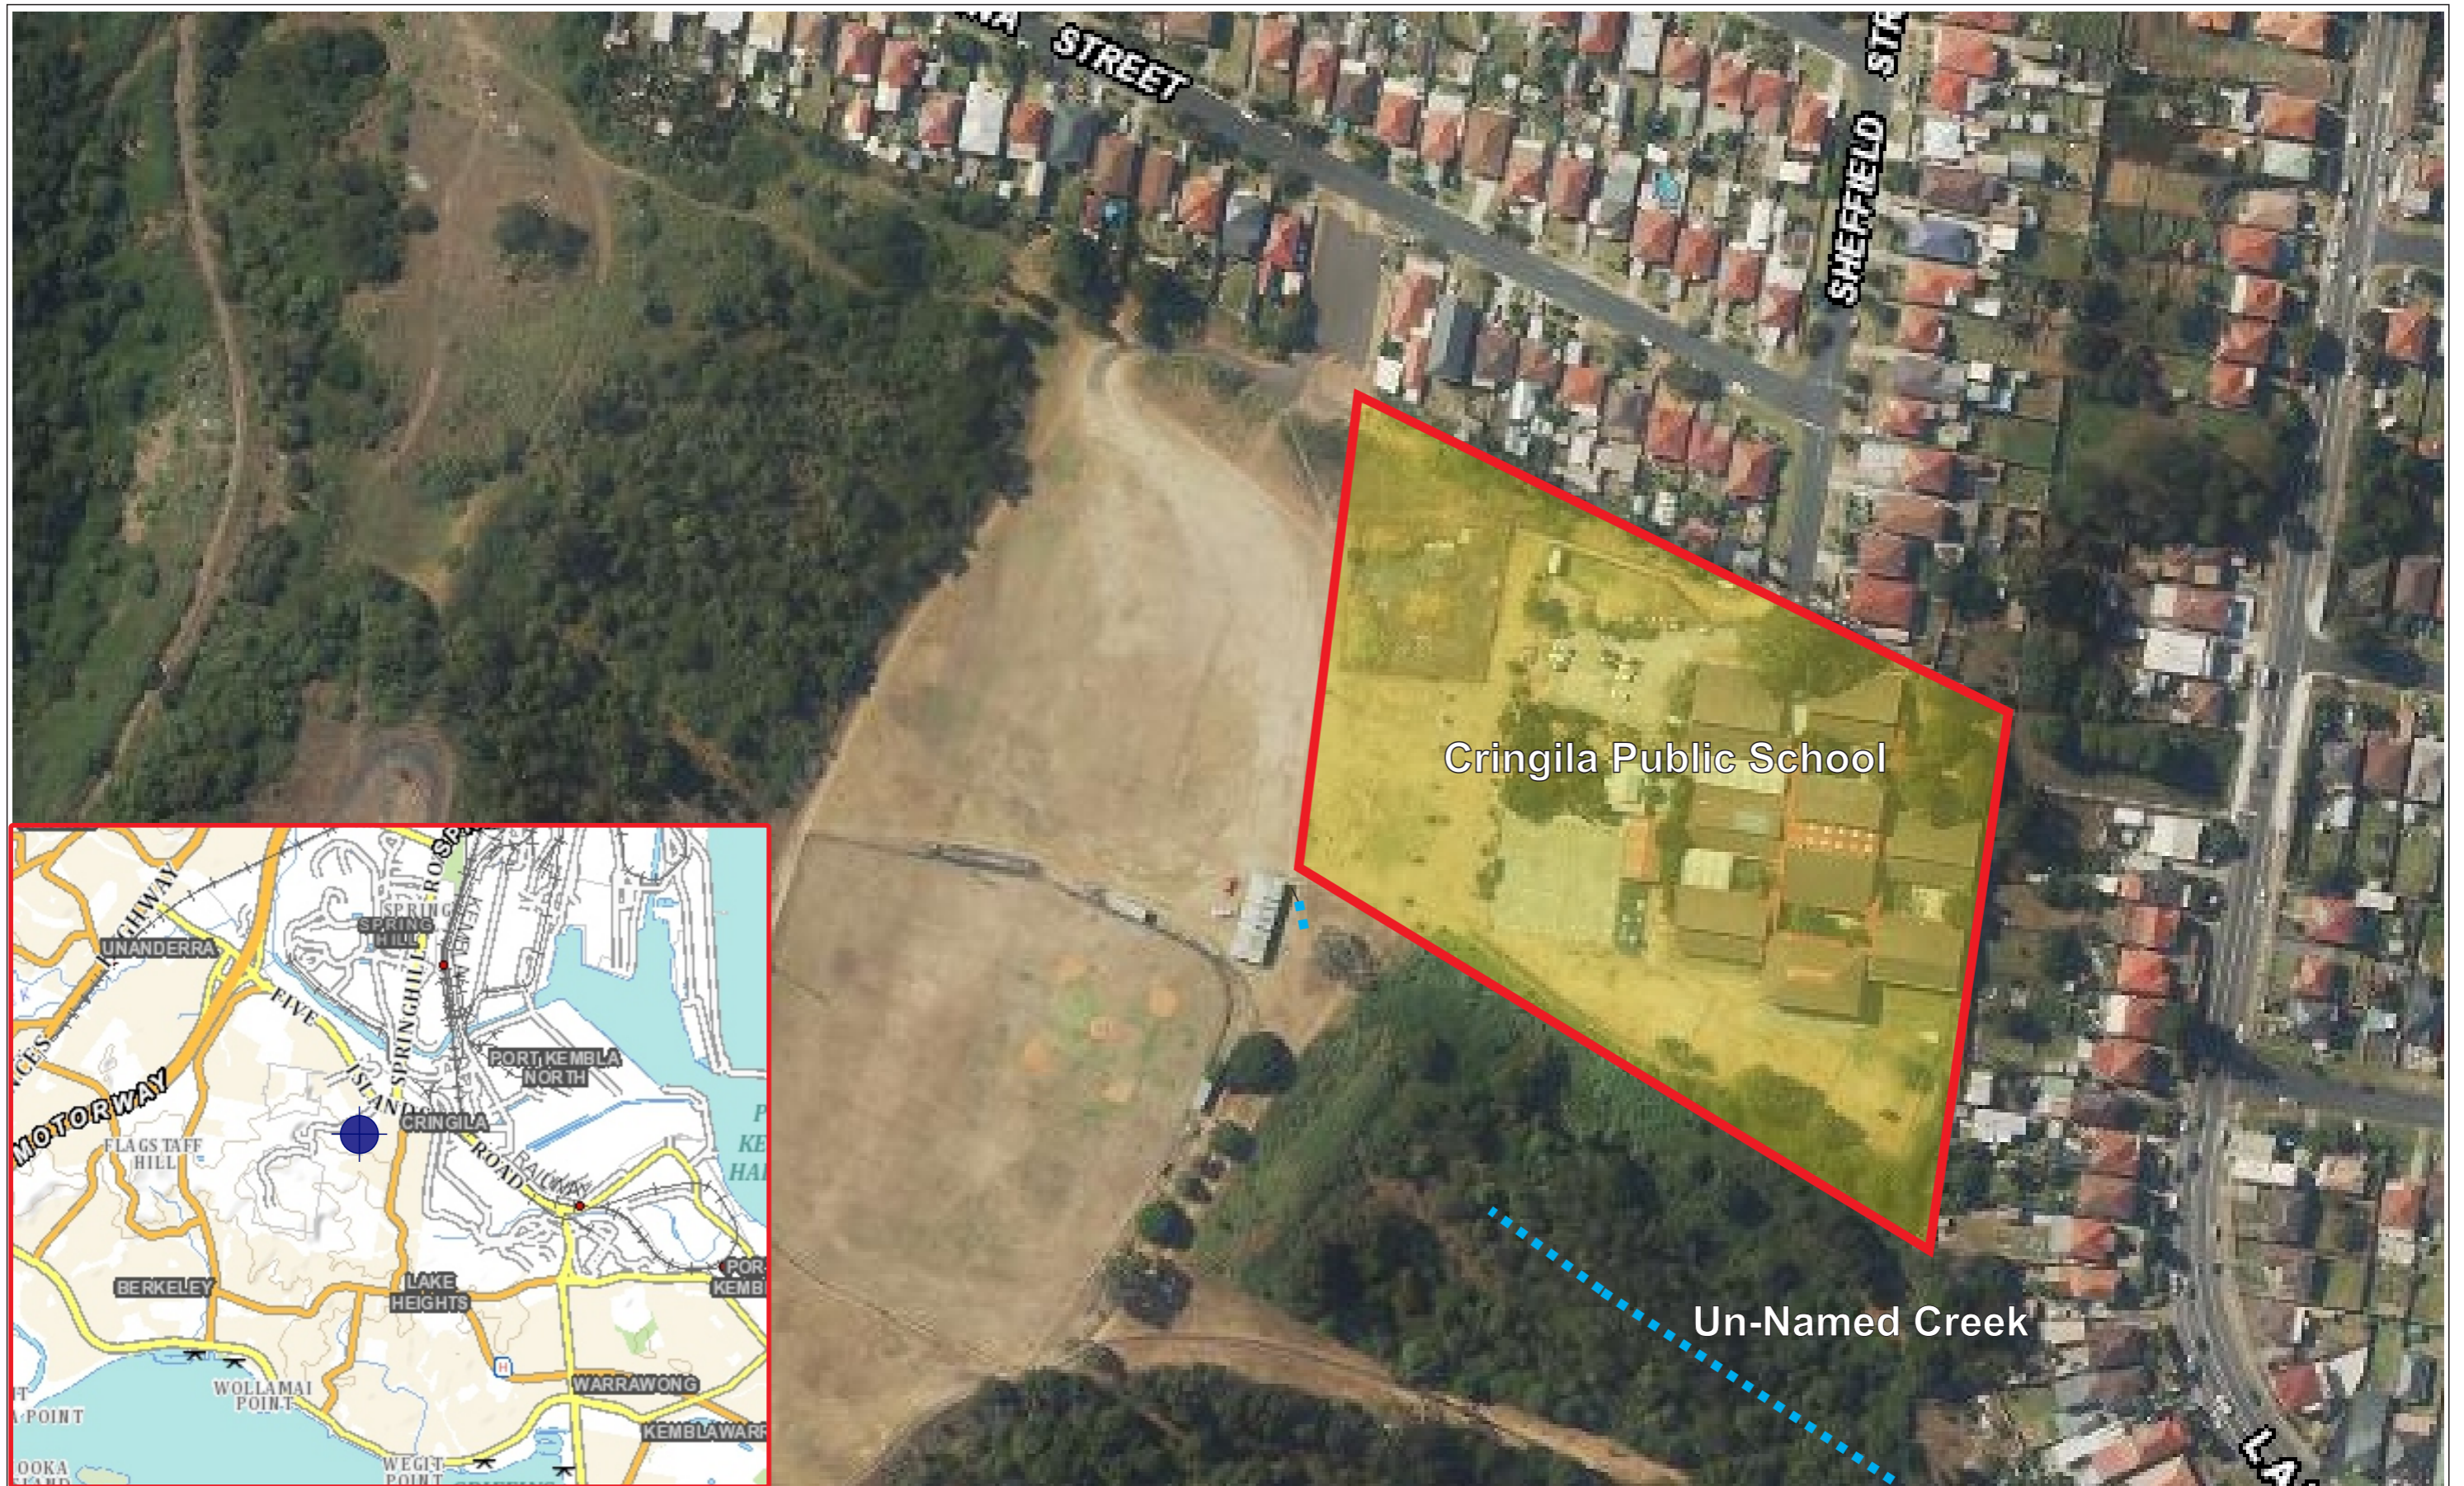
Client Name:		Department of Education		
Client Number:		C107471	Project Number: J155958	
Project Description: Monthly Monitoring Report- Cringila Public School				
Address:		Cringila Public School		
Prepared:	AMW	Reviewed:	MB	Date: 19/06/2018
Figure 1		Site Location and Regional Context

This report summarises the findings of the September 2019 monthly round of subsurface gas monitoring carried out at Cringila Public School, located at 35 Sheffield Street, Cringila NSW (refer **Figure 1** in **Appendix A** for site layout).

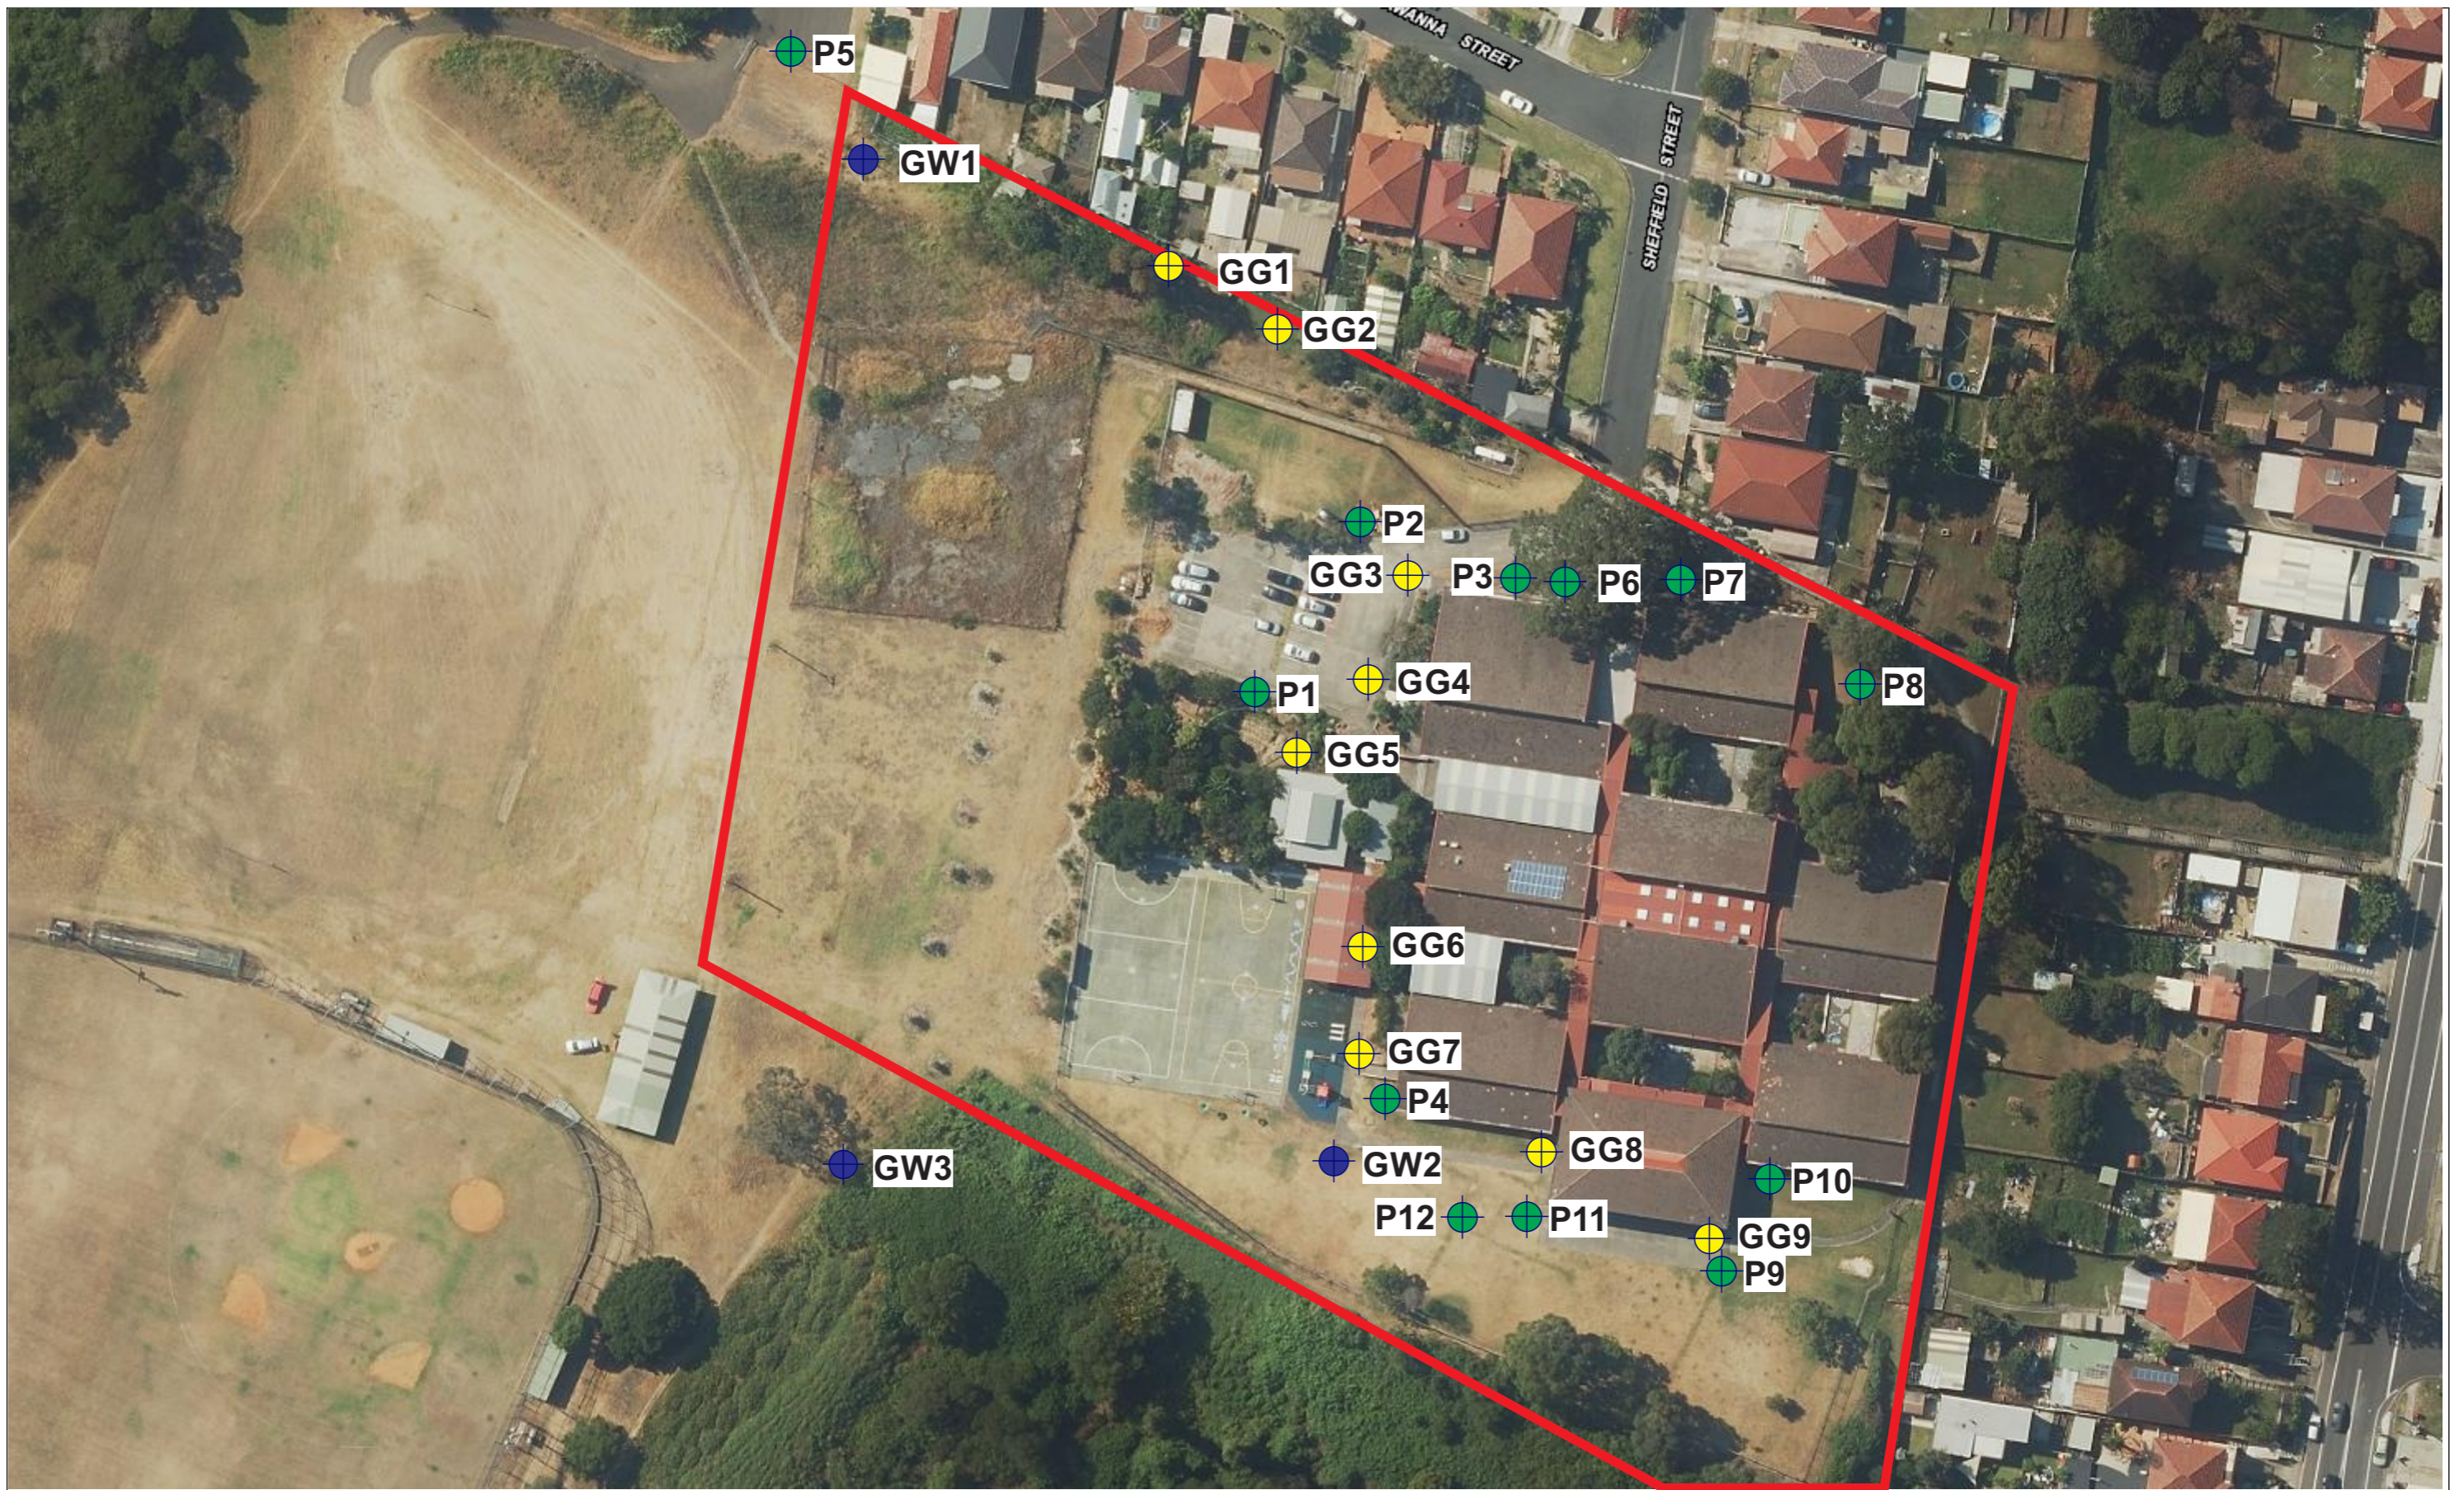
The monitoring ports of the GA5000 were fitted to the X-cap of each of the 9 (GG1 to GG9) subsurface monitoring wells. Subsurface gas and flow rate were recorded as well as concentrations of the following Hazardous Gases (refer to **Figure 2** of **Appendix A** for monitoring locations);

Service pits were assessed by inserting the GA5000 nozzle into the pits with the sampling tube inserted at least 30 cm below the cover grate for a minimum of 30 seconds. The locations of service pits monitored (P1 to P12) are presented in **Figure 2** of **Appendix A**.
