CRINGILA PUBLIC SCHOOL
AIR MONITORING RISK ASSESSMENT

Summary Report
27/07/2020 – 07/08/2020

Cringila Public School

Cringila Public School – Northwest Hotspot

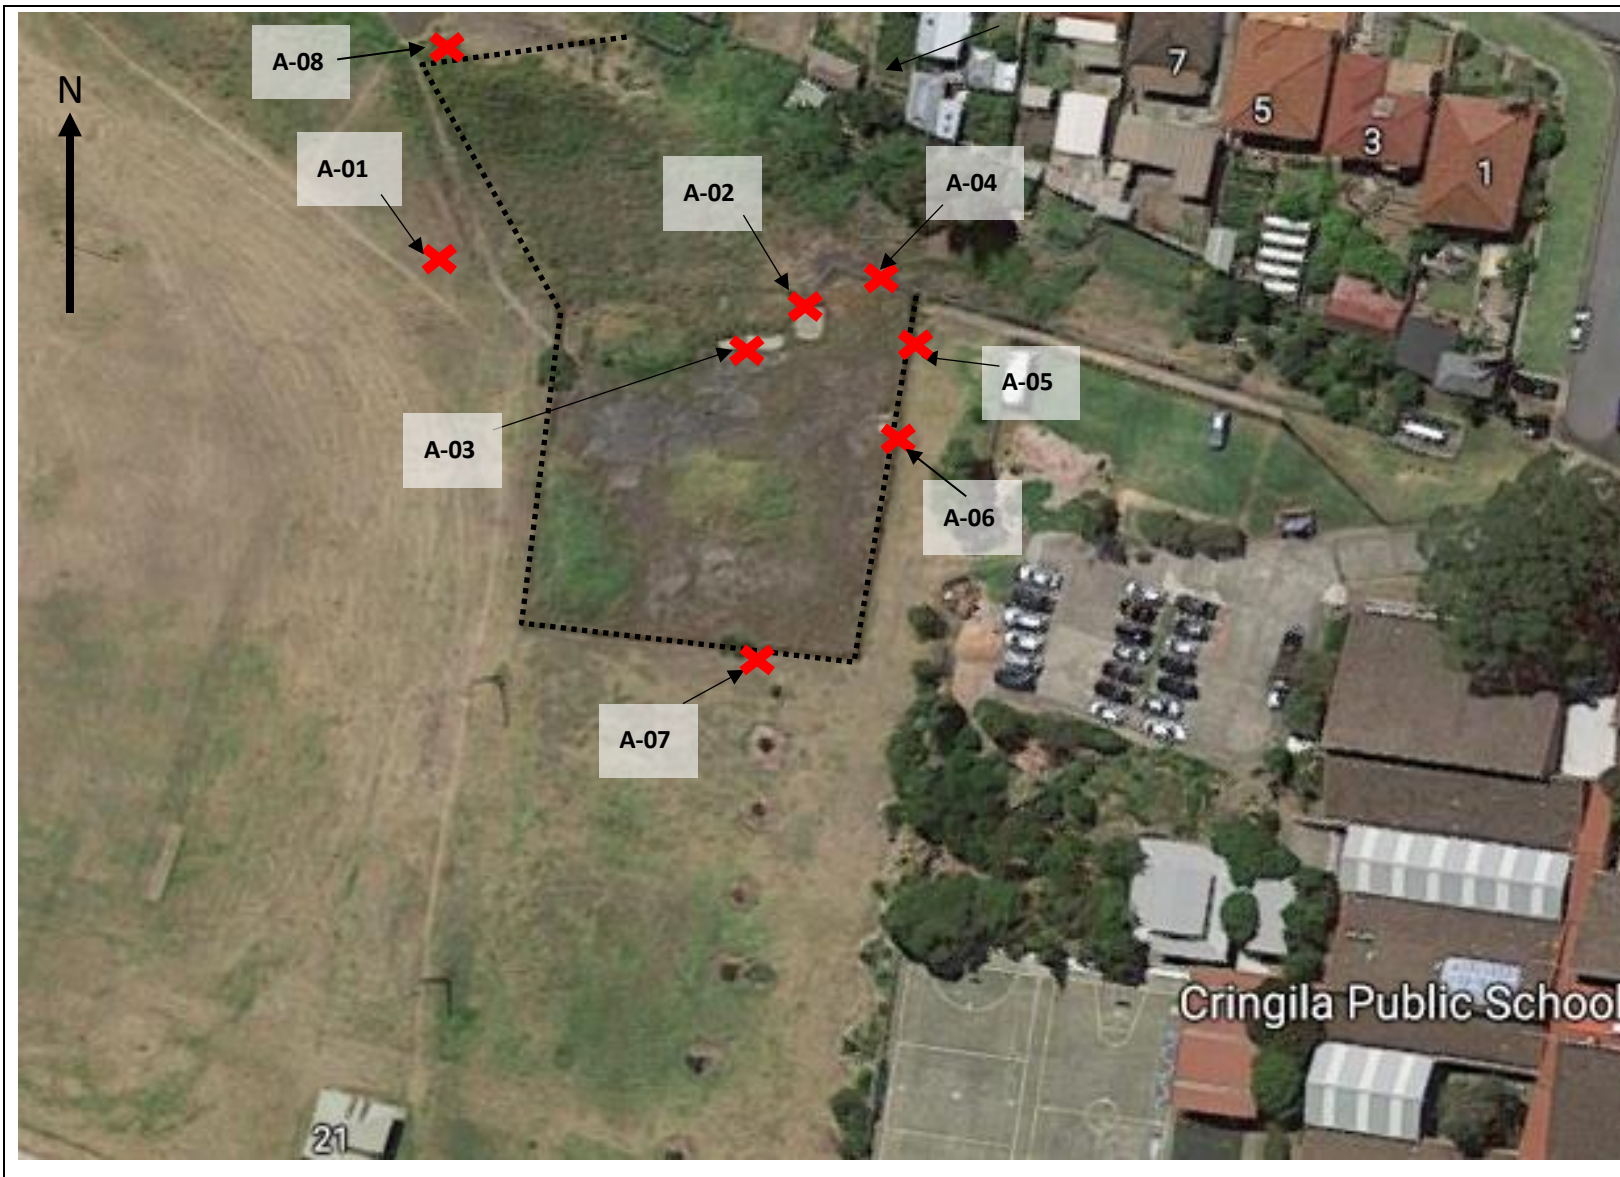
Appendix A: Site Map and Sampling Locations

- A-01 General Background
- A-02 NW Hotspot – Concrete Cap Surface
- A-03 NW Hotspot – Small Mound
- A-04 NW Hotspot – NE fence line
- A-05 Exclusion Area Fence Line East of Hotspot (Approx. 10m)
- A-06 Exclusion Area Fence Line Southeast of Hotspot (Approx. 15m)
- A-07 Exclusion Area Fence Line South of Hotspot (Approx. 30m)
- A-08 Exclusion Area Fence Line Northwest of Hotspot, adjacent 17 Lackawanna Street (Approx. 50m)

The atmospheric pollutant results for each monitoring event are summarised in the tables below, and monitoring locations can be viewed in **Appendix A**.
