CRINGILA PUBLIC SCHOOL  
INDOOR AIR QUALITY RISK ASSESSMENT

Summary Report  
05/10/2020 – 16/10/2020

NSW Department  
of Education

Cringila Public School

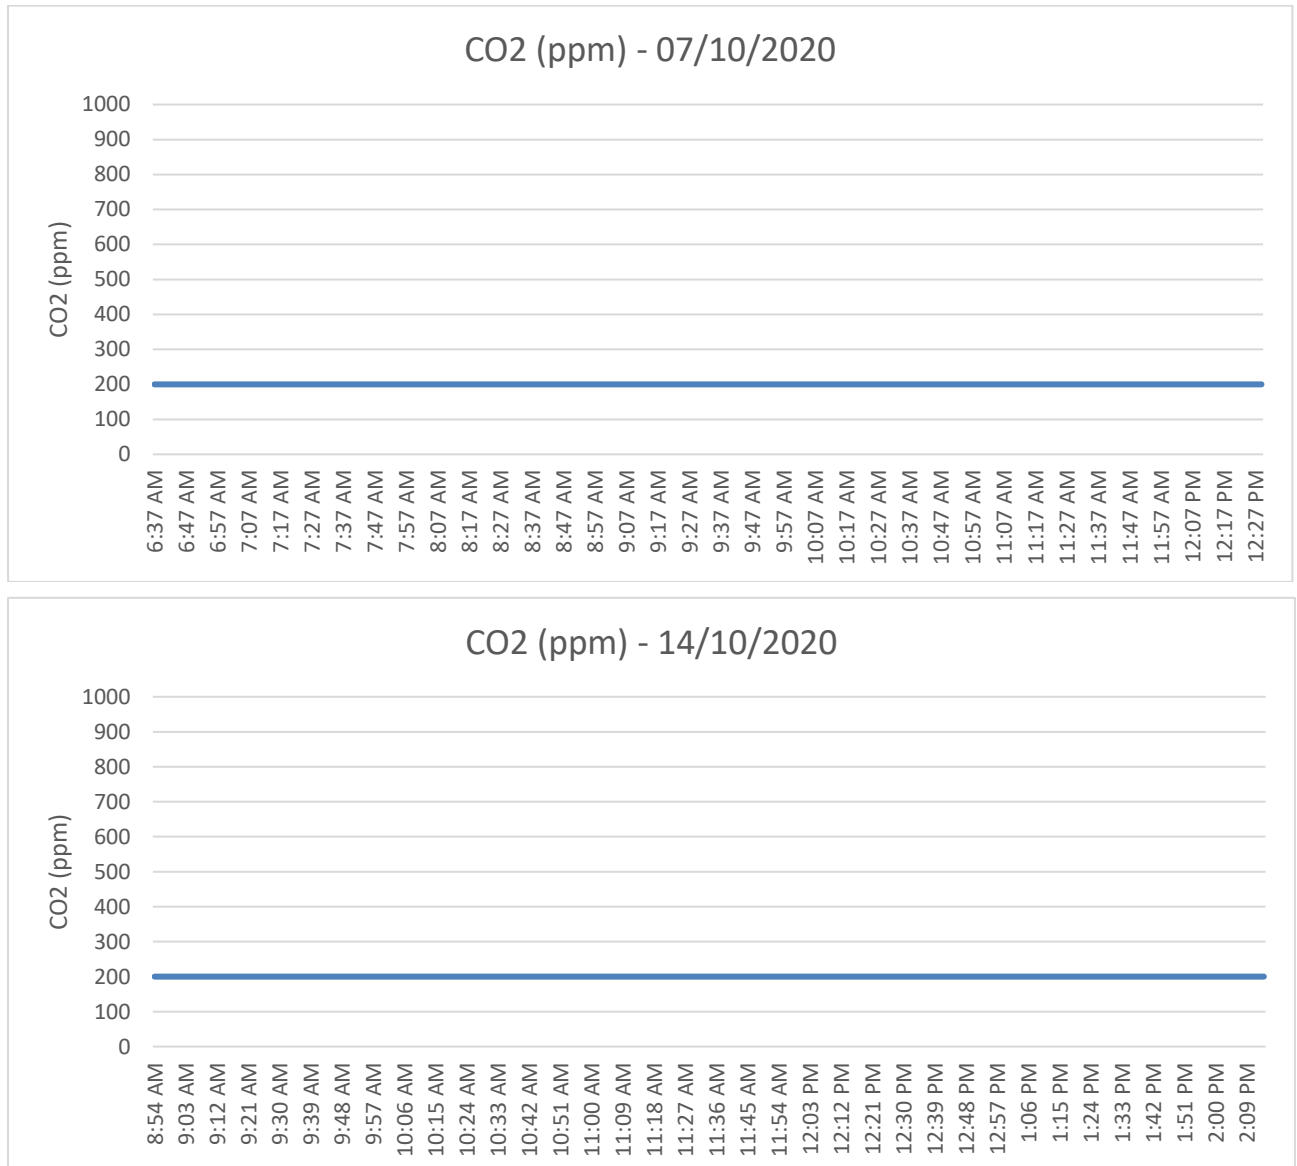
Figure 1: Carbon Dioxide (CO<sub>2</sub>) monitoring results

The Carbon Dioxide (CO<sub>2</sub>) concentration results for the monitoring conducted between 5<sup>th</sup> October 2020 and 16<sup>th</sup> October 2020 is summarised below in **Figure 1**. Monitoring locations are displayed in **Appendix A: Site Map and Sampling Locations**.

The monitoring results for CO<sub>2</sub> within the Reception Area (Room 6R0021) at Cringila Public School ranged between 200ppm and 700ppm during the period of monitoring. All results were below the ASHRAE guideline level of 1,000 ppm. It should be noted that the adopted ASHRAE Guideline of 1,000 ppm is set for comfort only. A time weighted average (TWA) of 5,000 ppm has been set by Safe Work Australia for health purposes.

This concludes the indoor air quality monitoring summary report for monitoring conducted between 5<sup>th</sup> October 2020 and 16<sup>th</sup> October 2020. It is recommended that weekly assessments are continued in order to gain firm and reliable data sets regarding the concentration of CO<sub>2</sub> and CO within indoor environments at the school whilst further investigation of the site is undertaken.

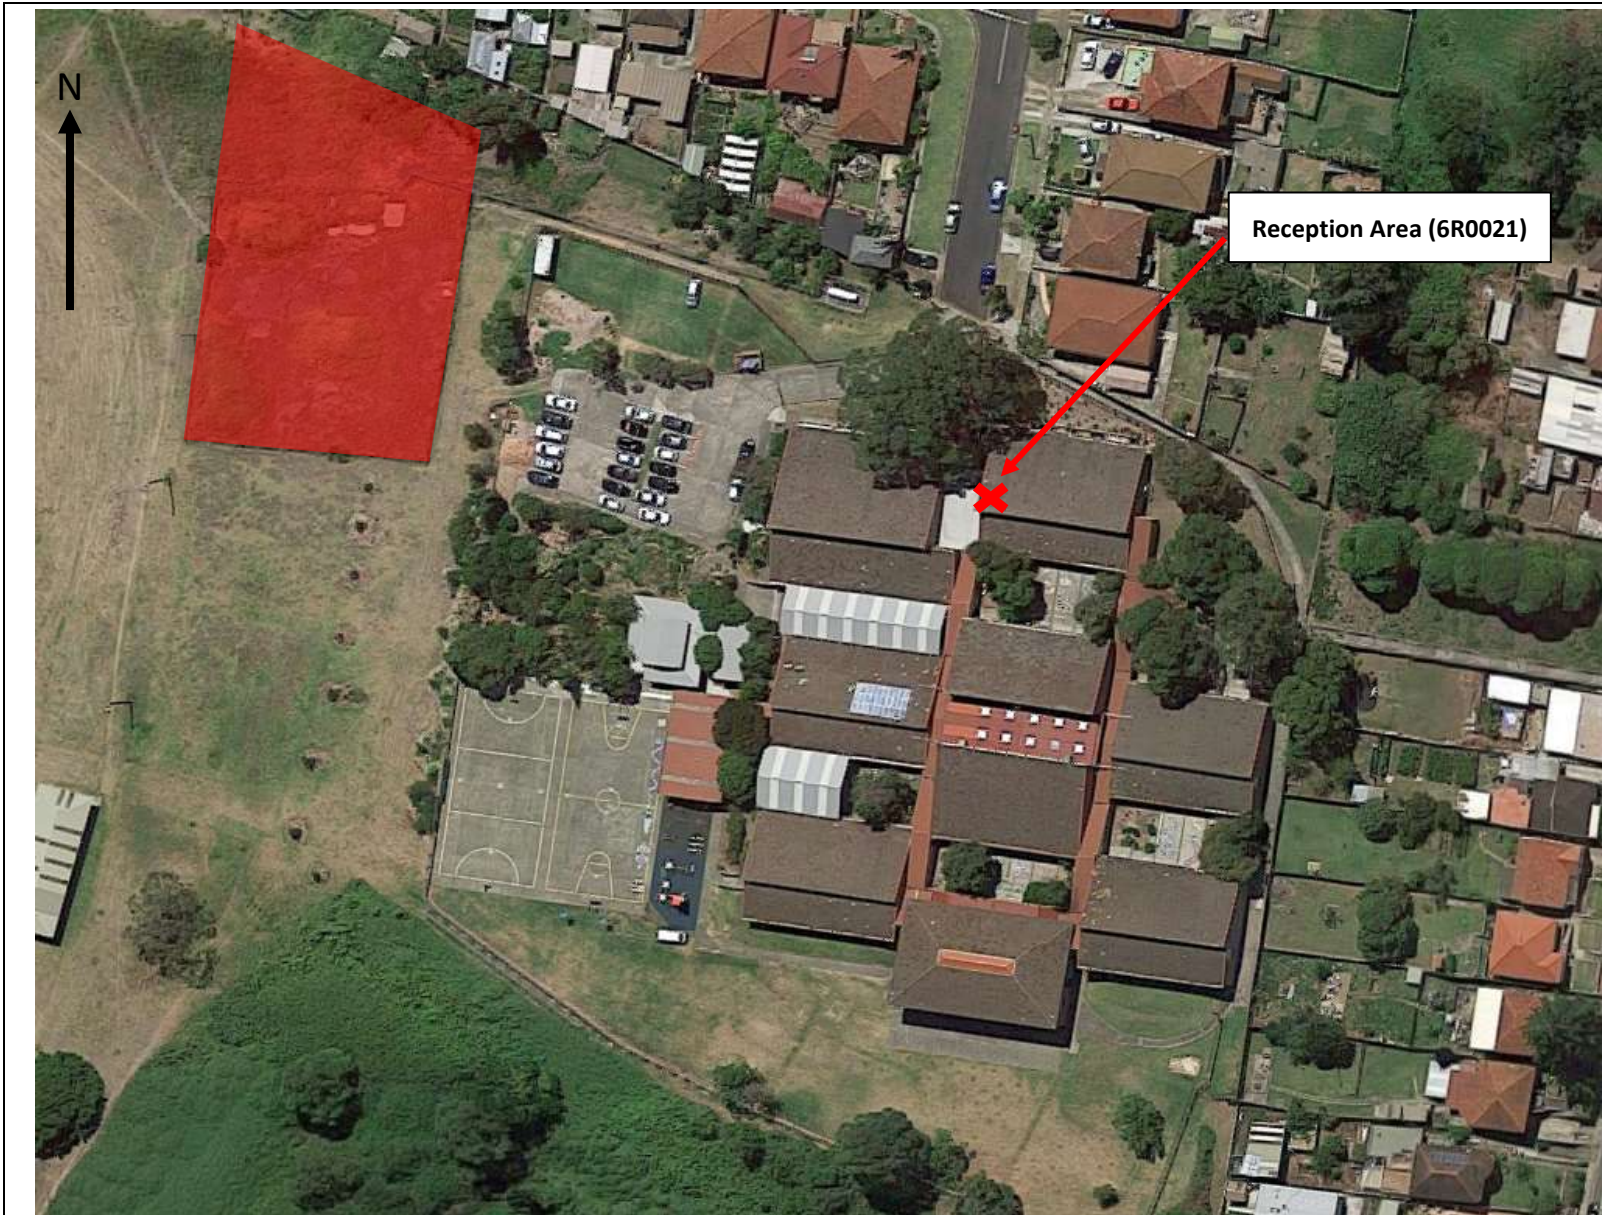
### **Appendix A: Site Map and Sampling Location**

- ✕ Air Quality Monitoring Location
- Northwest Hotspot Investigation Area

Site	Cringila Public School
Monitoring Location	Reception Area (6R0021)
Date	5 <sup>th</sup> October 2020 - 16 <sup>th</sup> October 2020
Job Number	J153825-04
Report	AMR-IAQ-08
Version	1.0
