CRINGILA PUBLIC SCHOOL  
NEAR-SURFACE TEMPERATURE  
MONITORING INVESTIGATION

Summary Report  
29/06/2020 – 10/07/2020

Cringila Public School

July 2020  
C107471: J153825-04: TO/RC

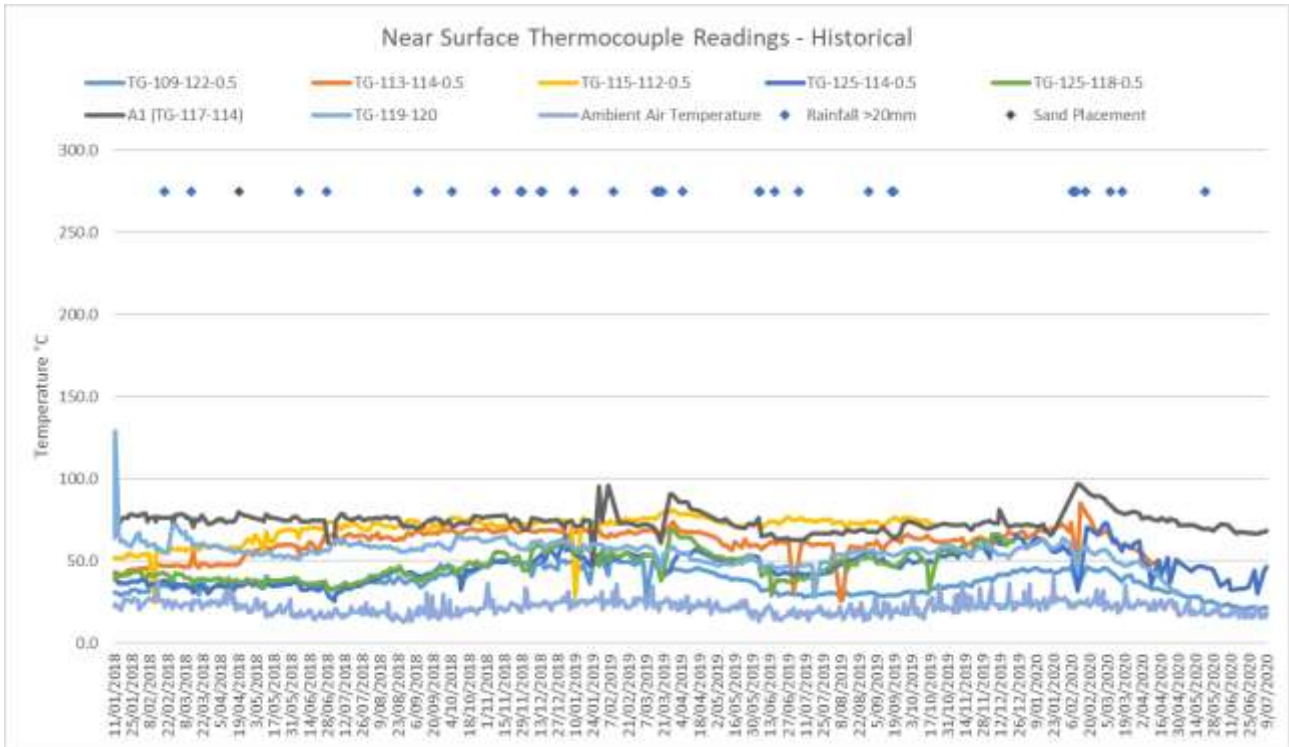
### 3.1. Near-Surface Temperature Graph – Selected Points (Historical)

Near surface temperature measurements for key thermocouple locations, progressive from Thursday 11<sup>th</sup> January 2018 to present.

The near-surface temperature appears to fluctuate seasonally across the surface of the northwest hotspot grid monitoring area.

Fluctuations in near-surface temperature are also evident following significant rain events (i.e. over 20mm rain).

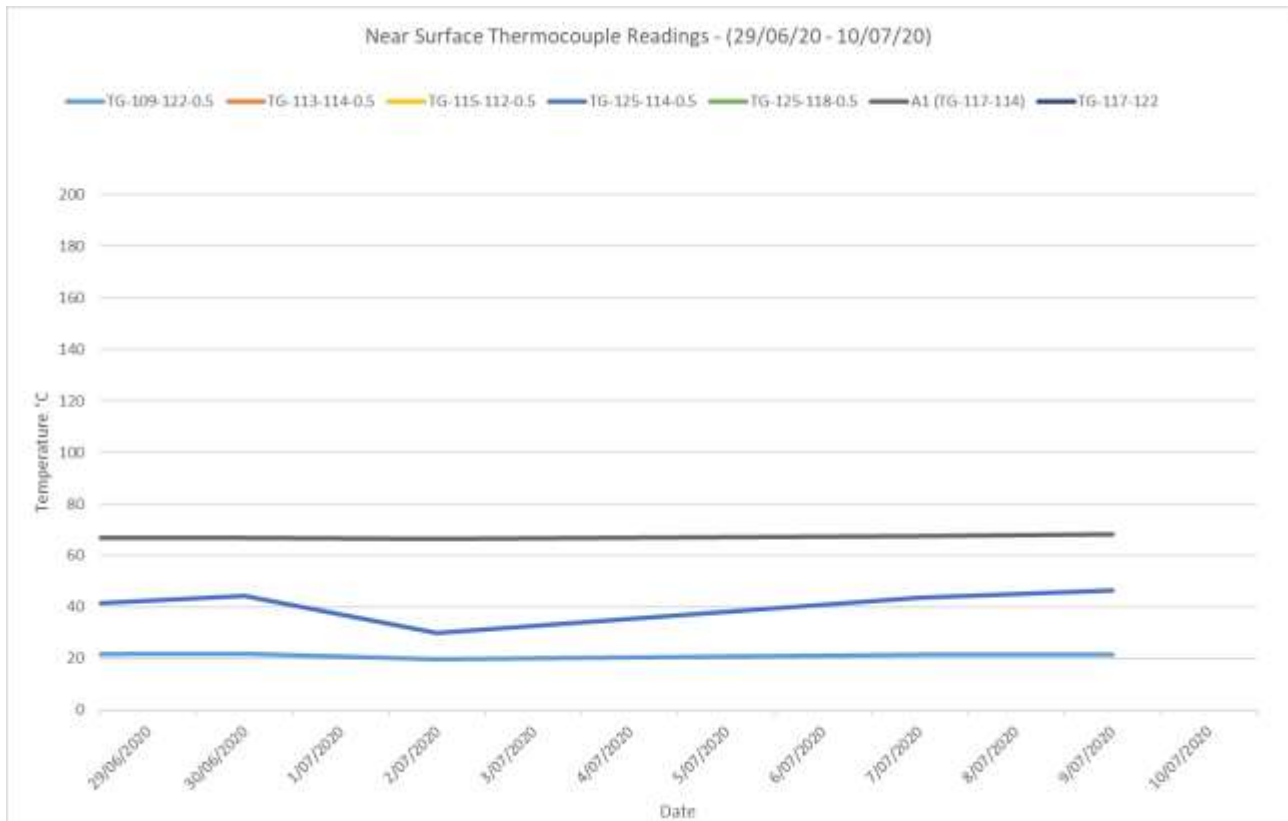
### 3.2. Near-Surface Temperature Graph – Selected Points (Fortnightly)

Near-surface temperature measurements for key thermocouple locations, over the monitoring period – between 29<sup>th</sup> June 2020 and 10<sup>th</sup> July 2020 in the northwest Hotspot, situated on the Cringila Public School grounds.

Please note – data from certain points was not available within this date range due to technical constraints.

Variations in the near-surface temperature at selected points across the northwest hotspot over the period of monitoring appear to coincide with the high rainfall events during the period.

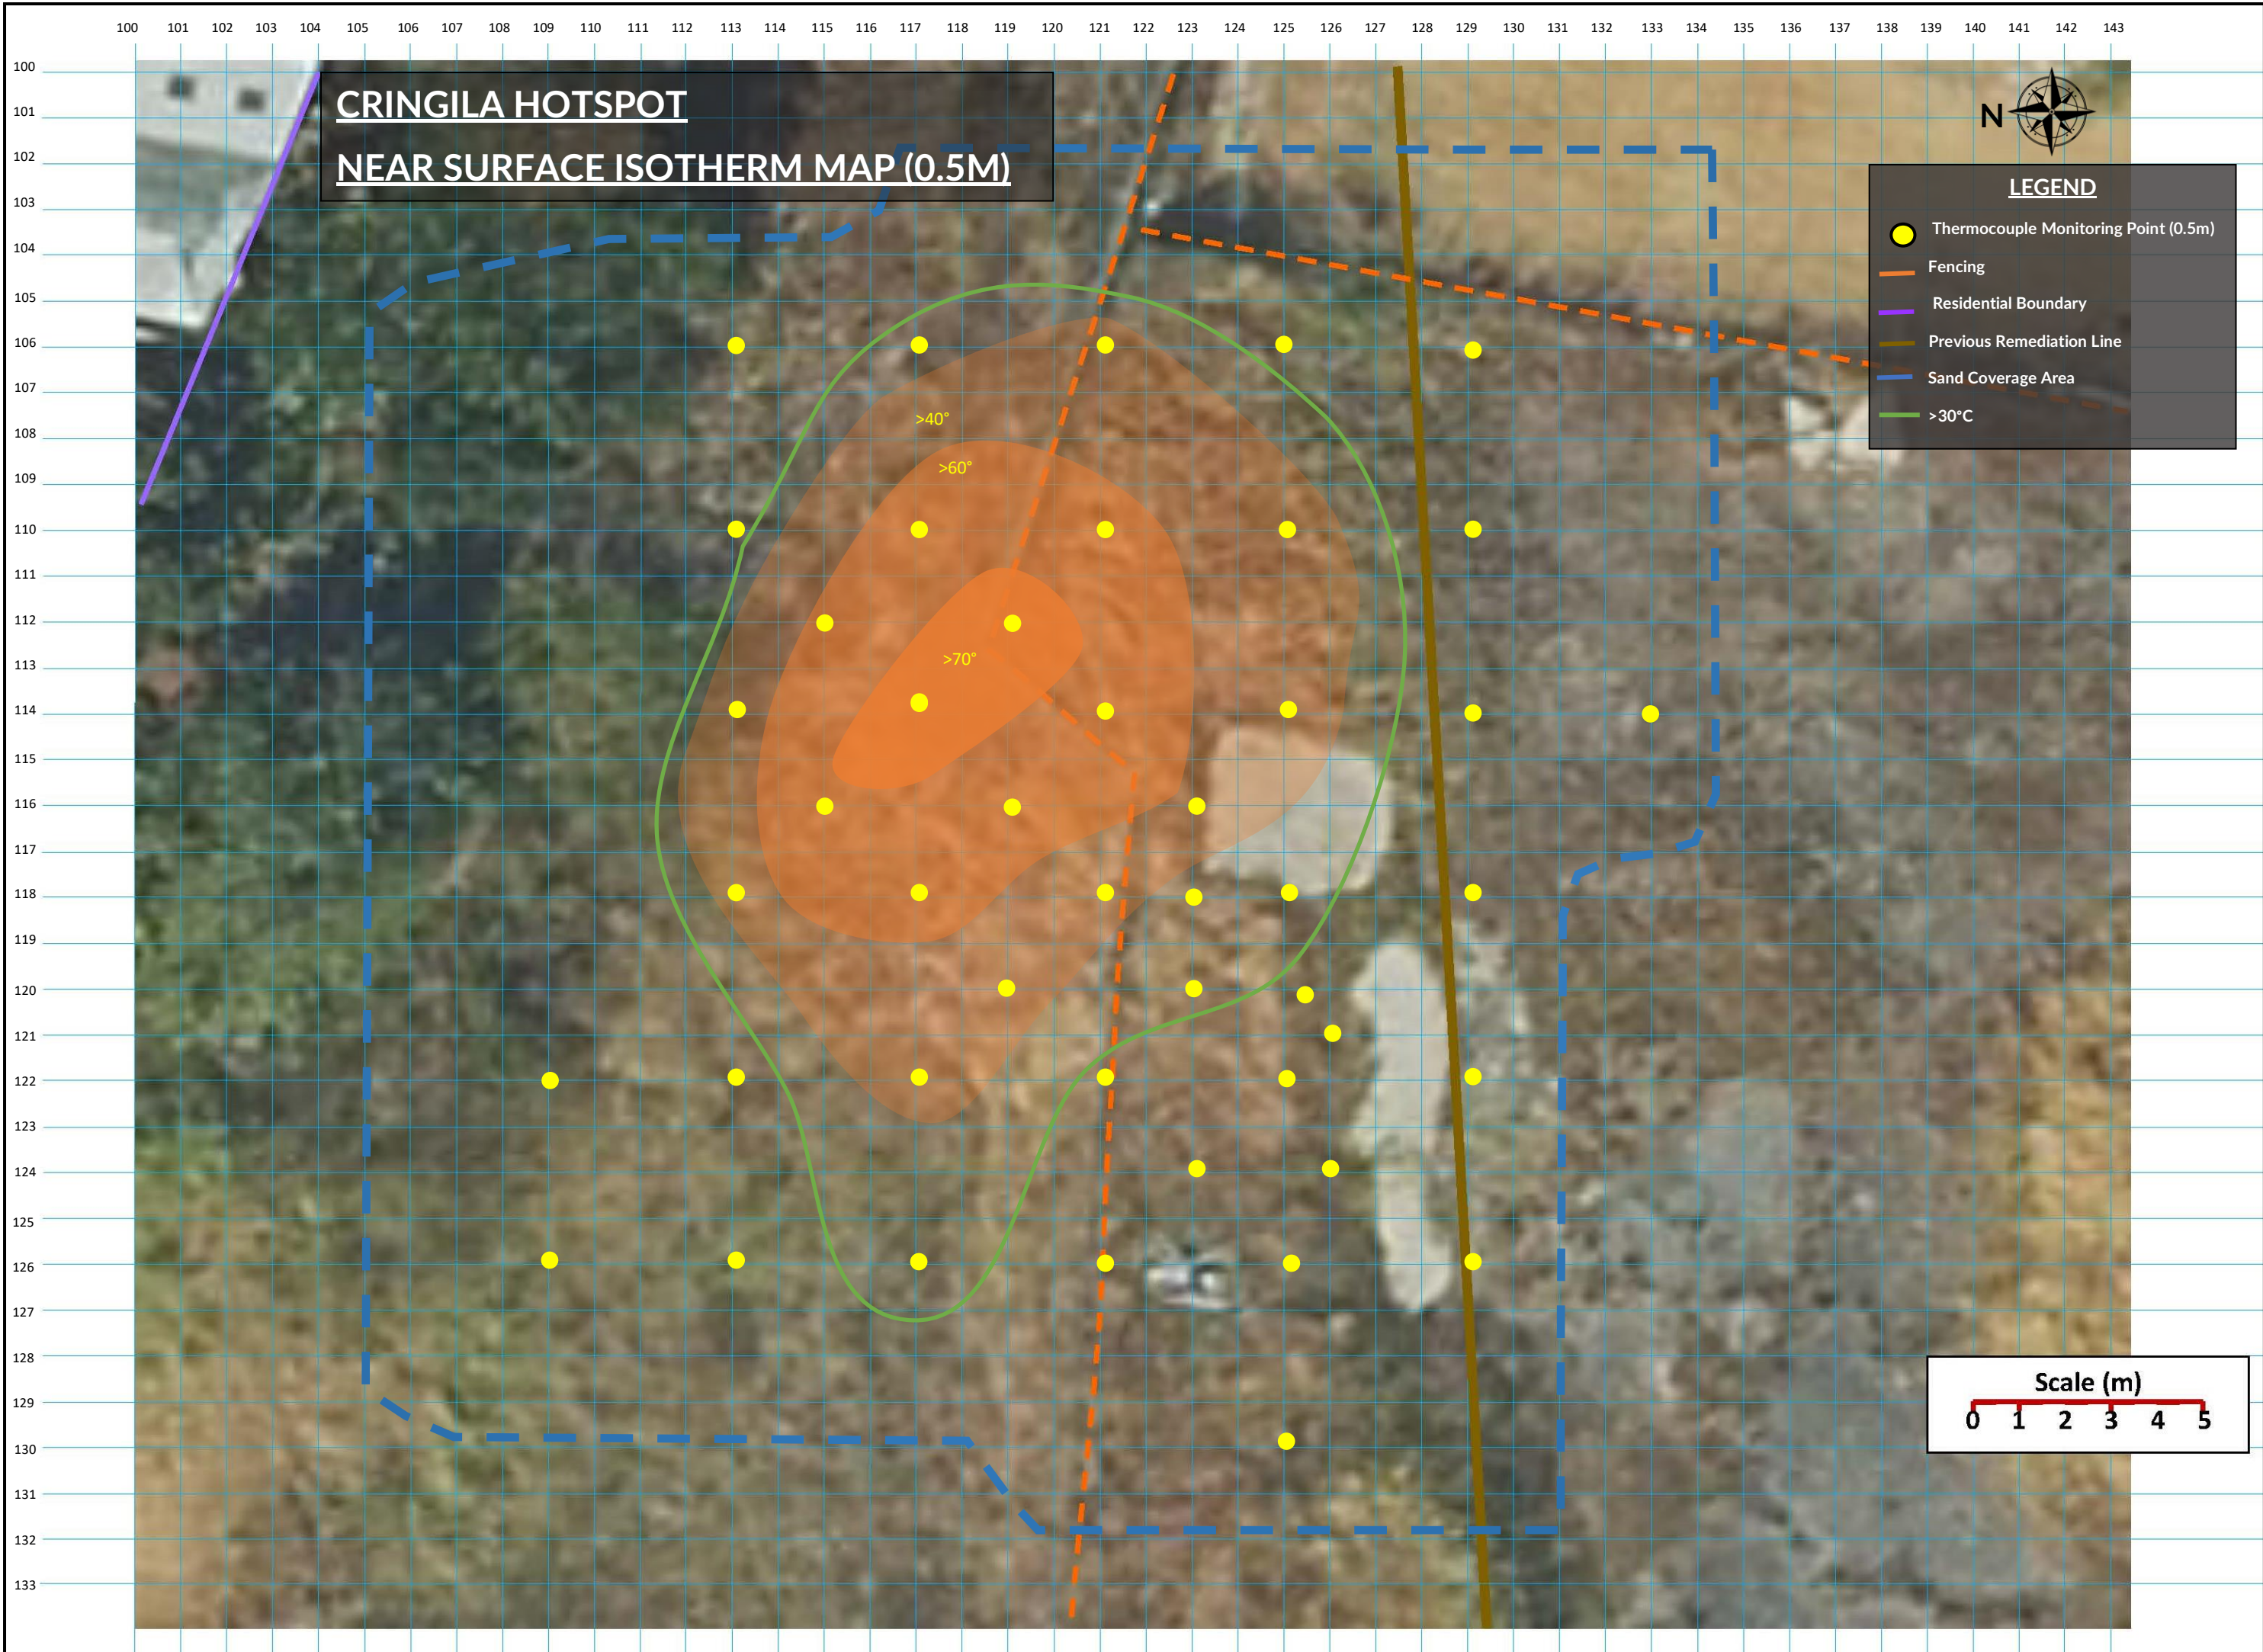
### **Appendix B: Near-Surface Temperature Isotherm Map (0.5m)**

The isotherm map shows the general zone of influence for temperatures between 30°C and 70°C at 0.5m, coloured orange. The isotherm map suggests that the hotspot may extend deeper than 0.5m and that the increased temperature in these areas is a result of heat venting to the surface.

It is noted that temperature at the near-surface may be variable across the hotspot due to inconsistencies in the consolidation and compaction of subsurface materials.

# CRINGILA HOTSPOT NEAR SURFACE ISOTHERM MAP (0.5M)

It is recommended that weekly site inspections and recording are continued to monitor the near-surface temperatures surrounding the subsurface hotspot identified at the site.
