CRINGILA PUBLIC SCHOOL NEAR-SURFACE TEMPERATURE MONITORING INVESTIGATION

Summary Report
13/07/2020 – 24/07/2020

Cringila Public School

August 2020
C107471: J153825-04: TO

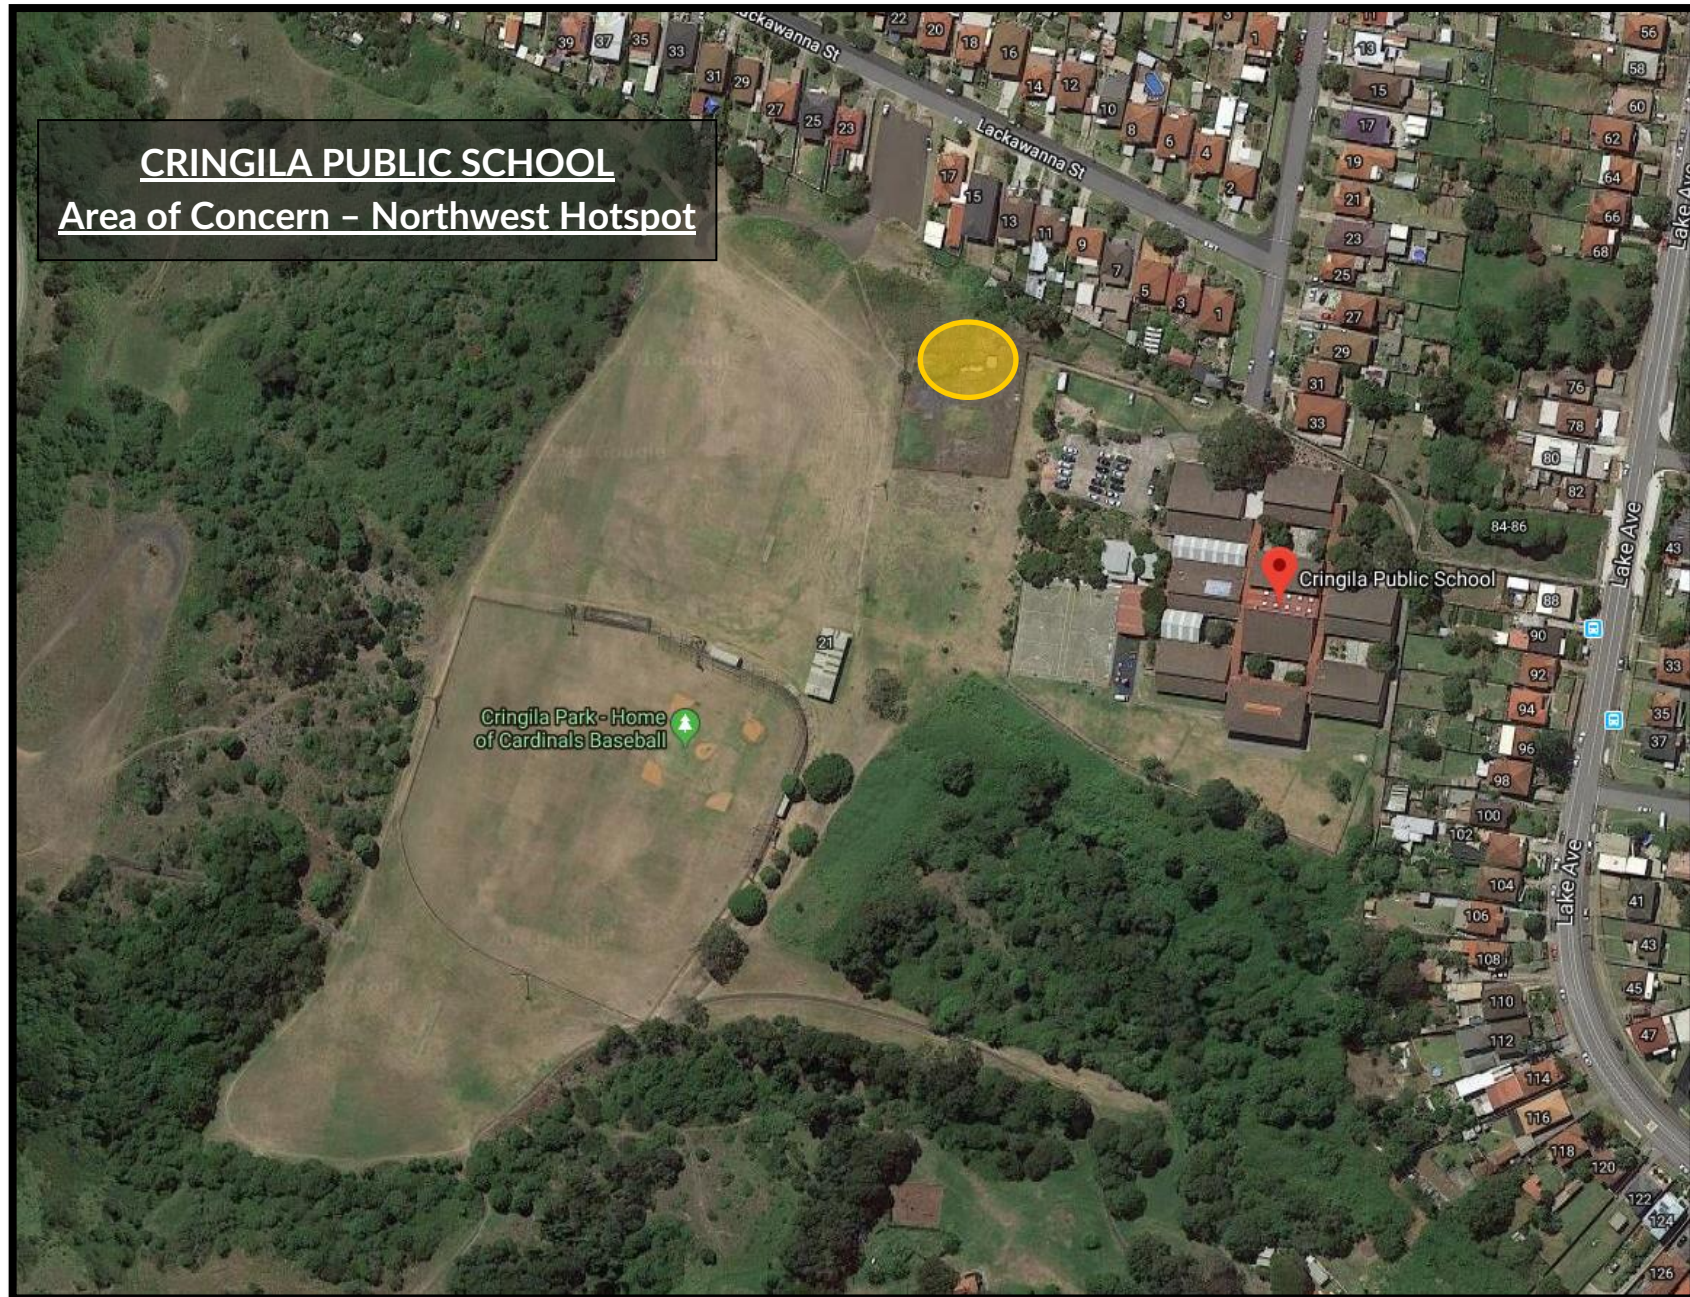
Appendix A: Area of Concern – Northwest Hotspot Map

CRINGILA PUBLIC SCHOOL
Area of Concern - Northwest Hotspot

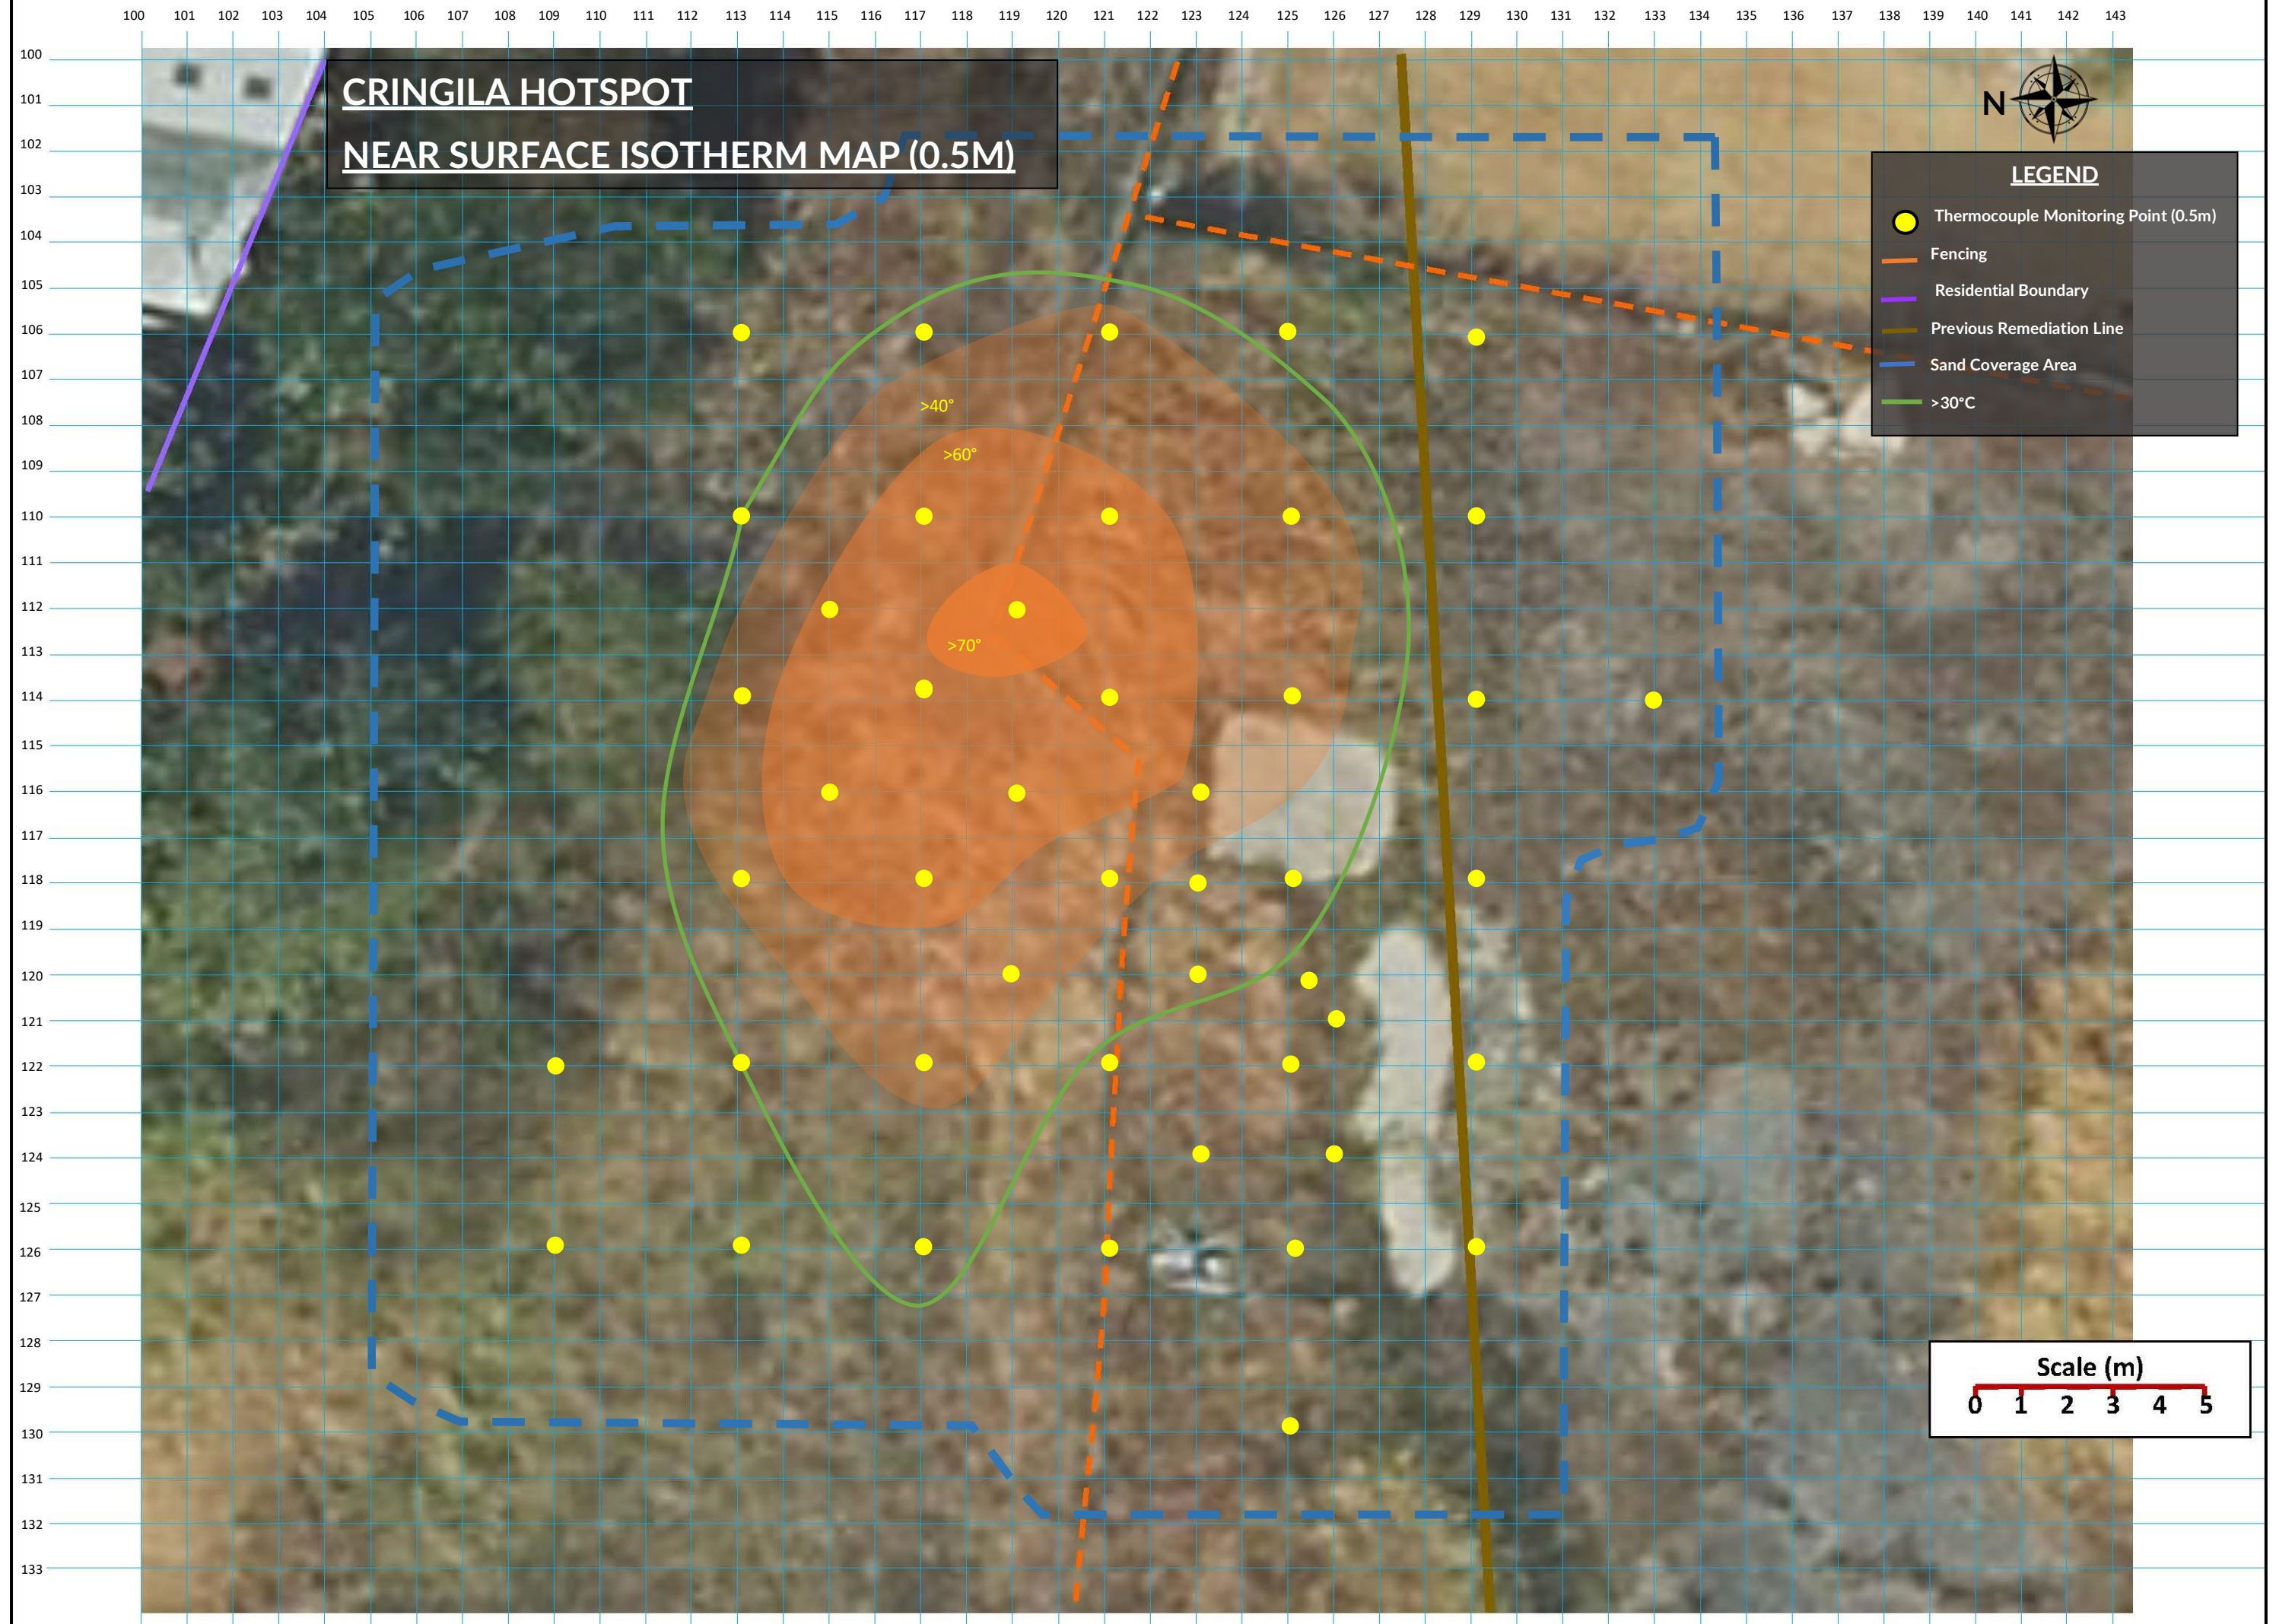
Appendix B: Near-Surface Temperature Isotherm Map (0.5m)

The isotherm map shows the general zone of influence for temperatures between 30°C and 70°C at 0.5m, coloured orange. The isotherm map suggests that the hotspot may extend deeper than 0.5m and that the increased temperature in these areas is a result of heat venting to the surface.

It is noted that temperature at the near-surface may be variable across the hotspot due to inconsistencies in the consolidation and compaction of subsurface materials.

CRINGILA HOTSPOT NEAR SURFACE ISOTHERM MAP (0.5M)

It is recommended that weekly site inspections and recording are continued to monitor the near-surface temperatures surrounding the subsurface hotspot identified at the site.
