CRINGILA PUBLIC SCHOOL NEAR-SURFACE TEMPERATURE MONITORING INVESTIGATION

Summary Report
27/07/2020 – 07/08/2020

Cringila Public School

August 2020
C107471: J153825-04: TO

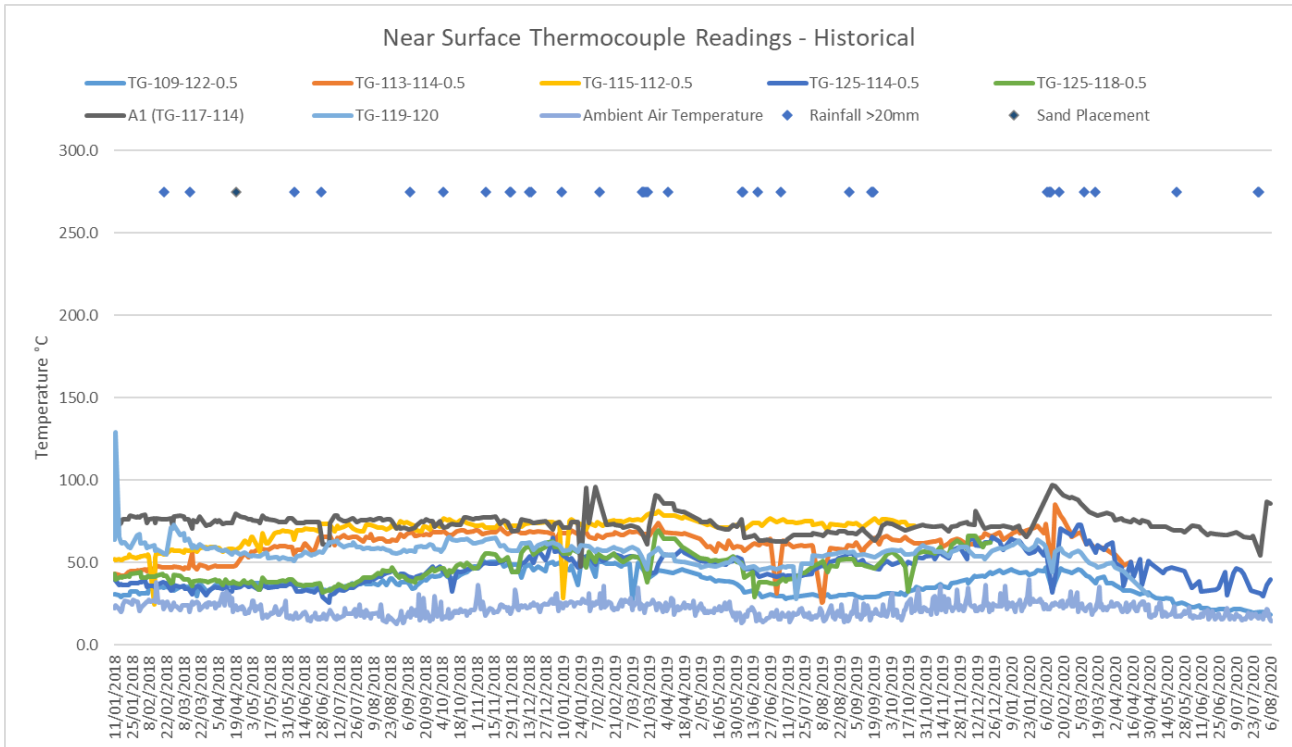
3.1. Near-Surface Temperature Graph – Selected Points (Historical)

Near surface temperature measurements for key thermocouple locations, progressive from Thursday 11th January 2018 to present.

The near-surface temperature appears to fluctuate seasonally across the surface of the northwest hotspot grid monitoring area.

Fluctuations in near-surface temperature are also evident following significant rain events (i.e. over 20mm rain).

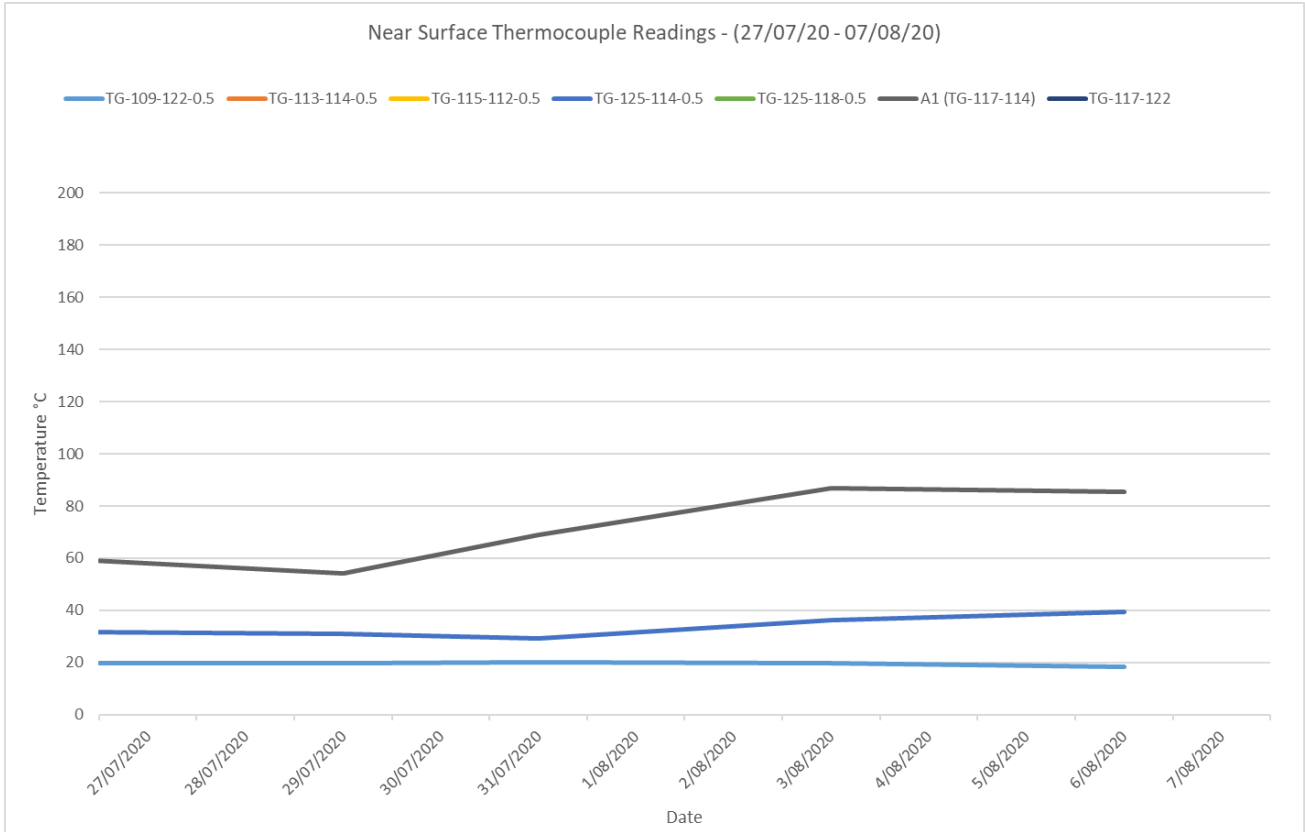
3.2. Near-Surface Temperature Graph – Selected Points (Fortnightly)

Near-surface temperature measurements for key thermocouple locations, over the monitoring period – between 27th July 2020 and 7th August 2020 in the northwest Hotspot, situated on the Cringila Public School grounds.

Please note – data from certain points was not available within this date range due to technical constraints.

Variations in the near-surface temperature at selected points across the northwest hotspot over the period of monitoring appear to coincide with the high rainfall events during the period.

Some variations in the near-surface temperature readings were identified during the period of monitoring. These variations appear to be influenced by the high rainfall recorded early within the monitoring period.

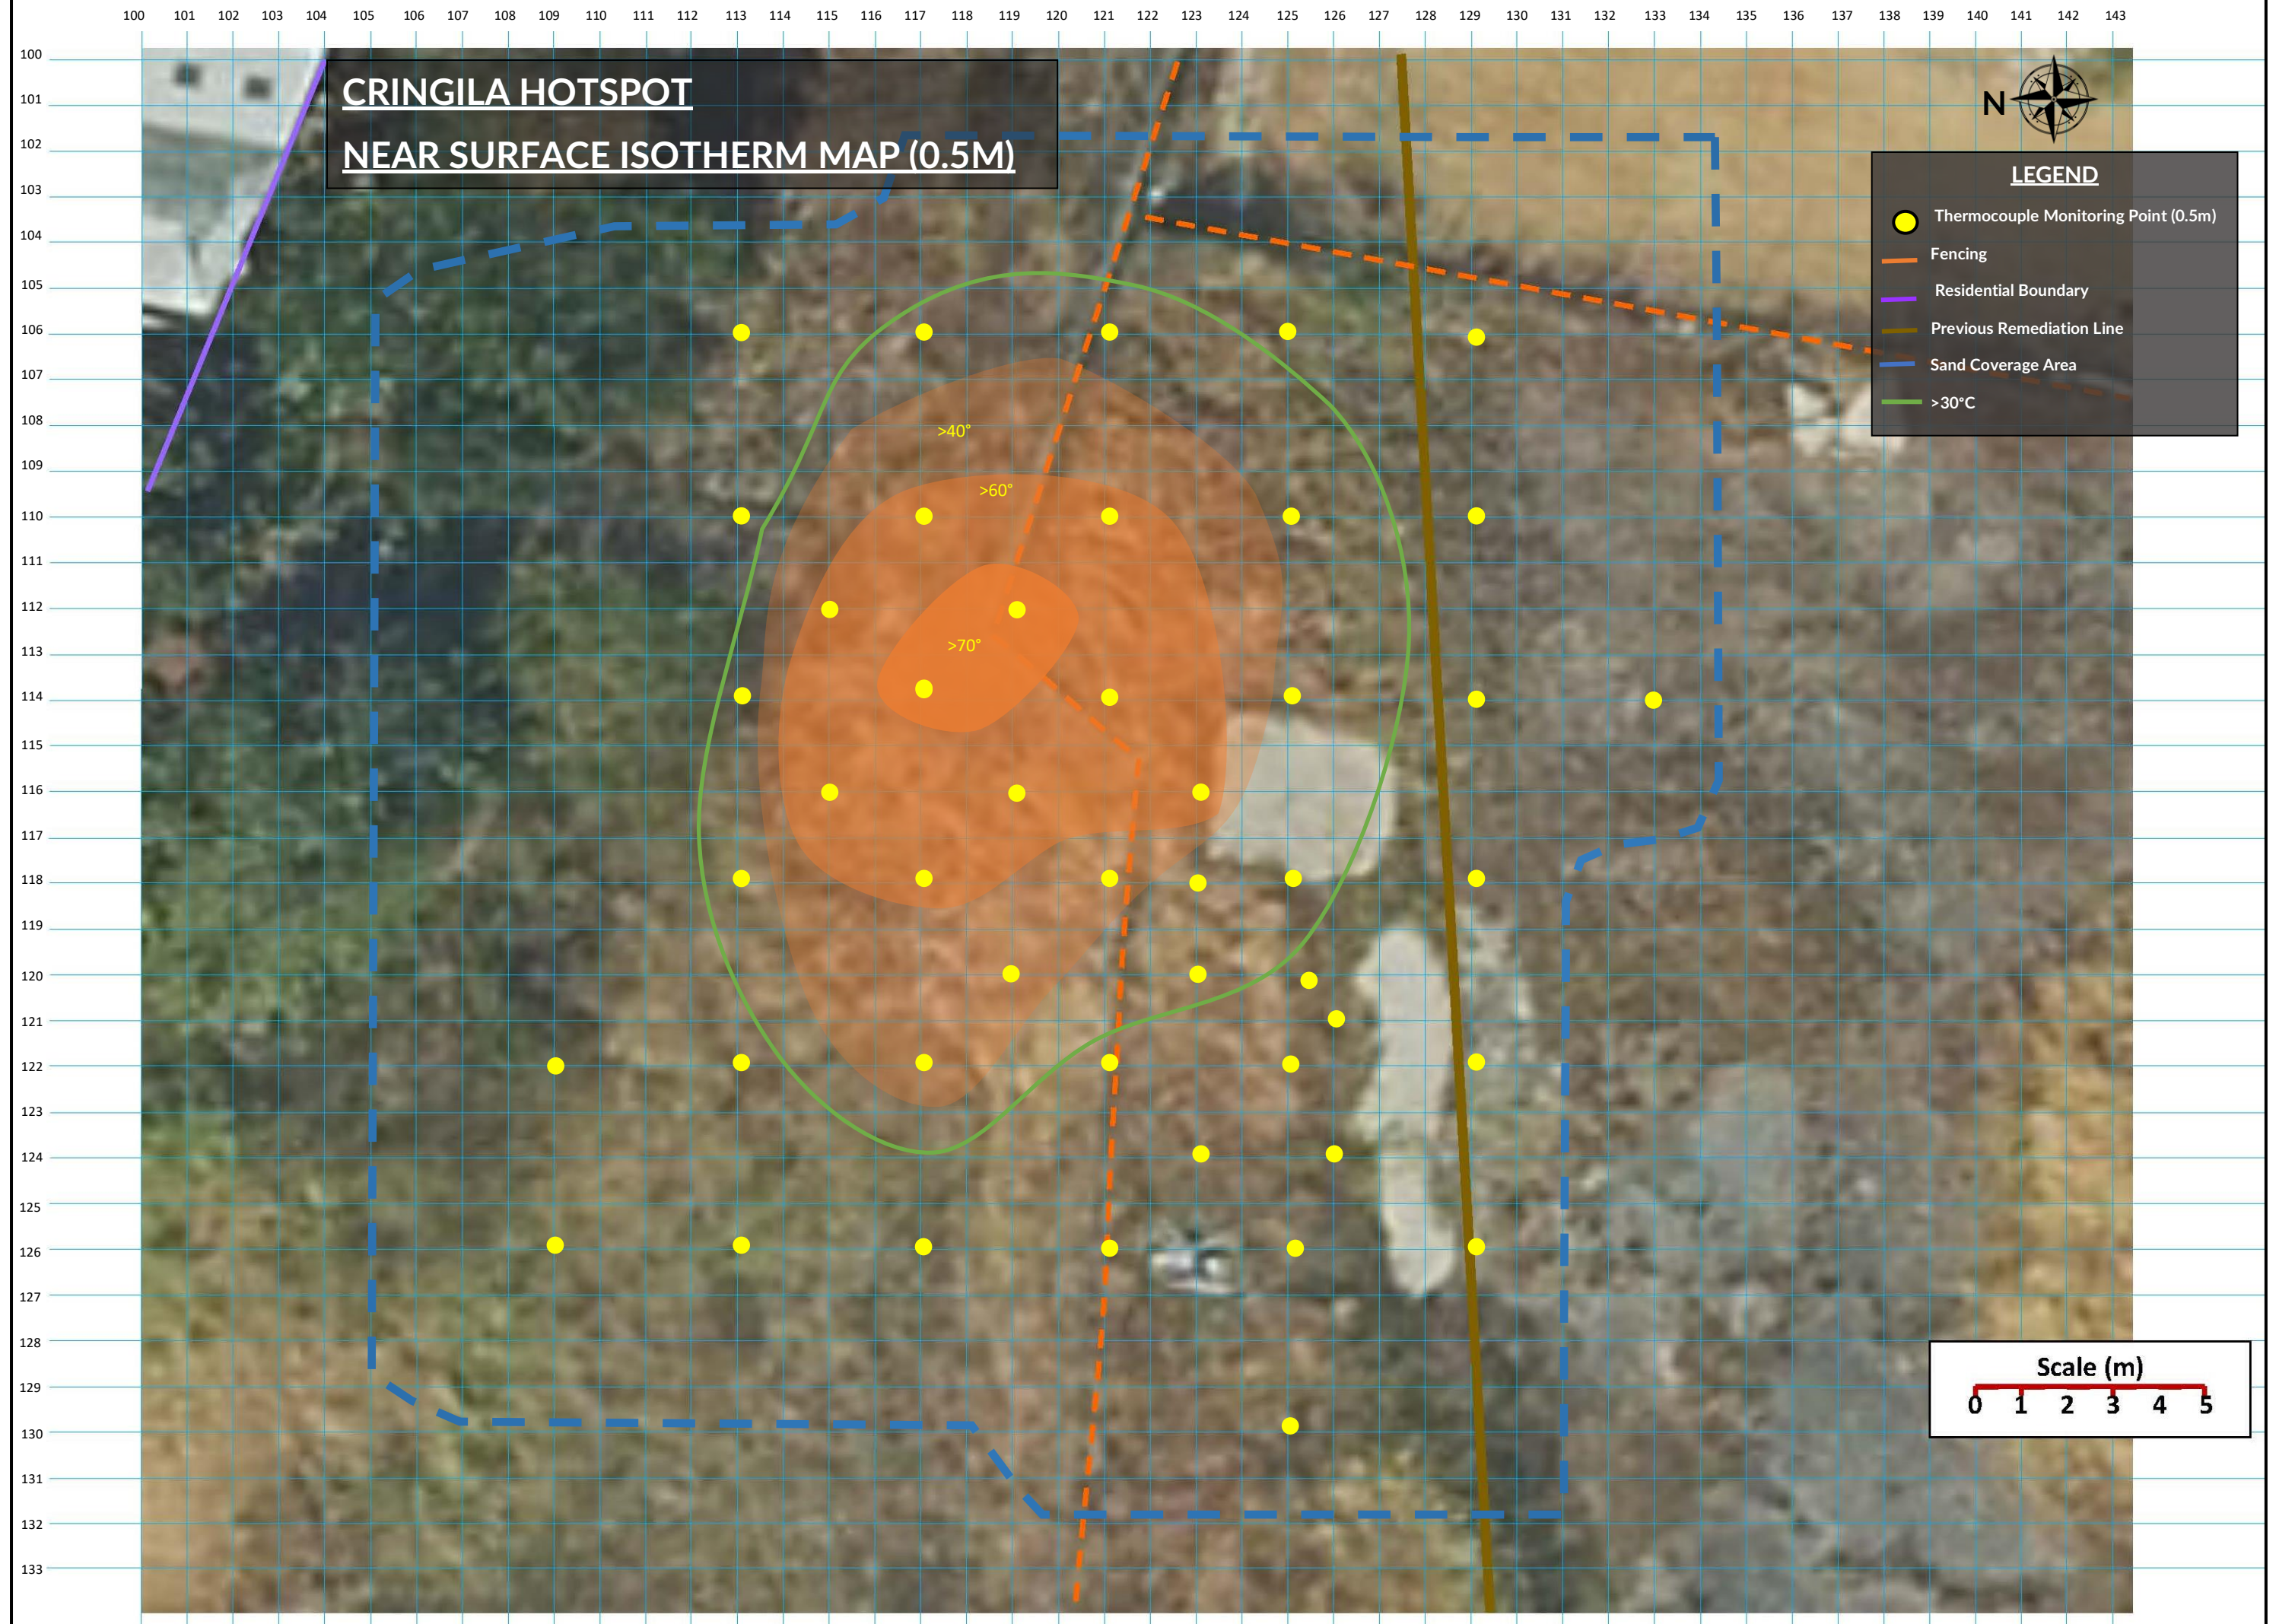
CRINGILA HOTSPOT NEAR SURFACE ISOTHERM MAP (0.5M)

The isotherm map shows the general zone of influence for temperatures between 30°C and 70°C at 0.5m, coloured orange. The isotherm map suggests that the hotspot may extend deeper than 0.5m and that the increased temperature in these areas is a result of heat venting to the surface.

It is noted that temperature at the near-surface may be variable across the hotspot due to inconsistencies in the consolidation and compaction of subsurface materials.

It is recommended that weekly site inspections and recording are continued to monitor the near-surface temperatures surrounding the subsurface hotspot identified at the site.
