CRINGILA PUBLIC SCHOOL
NEAR-SURFACE TEMPERATURE
MONITORING INVESTIGATION

Summary Report
10/08/2020 – 21/08/2020

Cringila Public School

August 2020
C107471: J153825-04: TO/RC

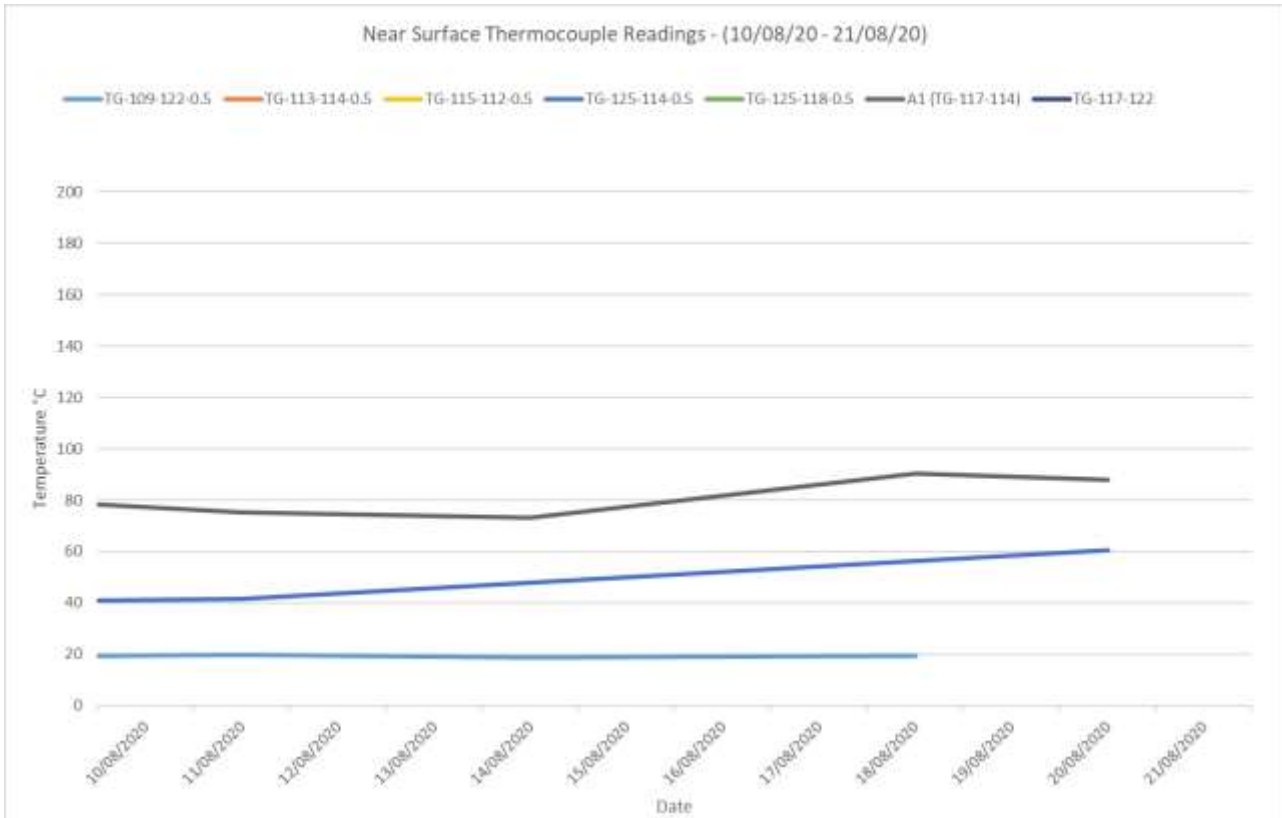
3.2. Near-Surface Temperature Graph – Selected Points (Fortnightly)

Near-surface temperature measurements for key thermocouple locations, over the monitoring period – between 10th August 2020 and 21st August 2020 in the northwest Hotspot, situated on the Cringila Public School grounds. Please note – data from certain points was not available within this date range due to technical constraints.

Variations in the near-surface temperature at selected points across the northwest hotspot over the period of monitoring appear to coincide with the high rainfall events during the period.

Some variations in the near-surface temperature readings were identified during the period of monitoring. These variations appear to be influenced by the high rainfall recorded early within the monitoring period.

It is recommended that weekly site inspections and recording are continued to monitor the near-surface temperatures surrounding the subsurface hotspot identified at the site.

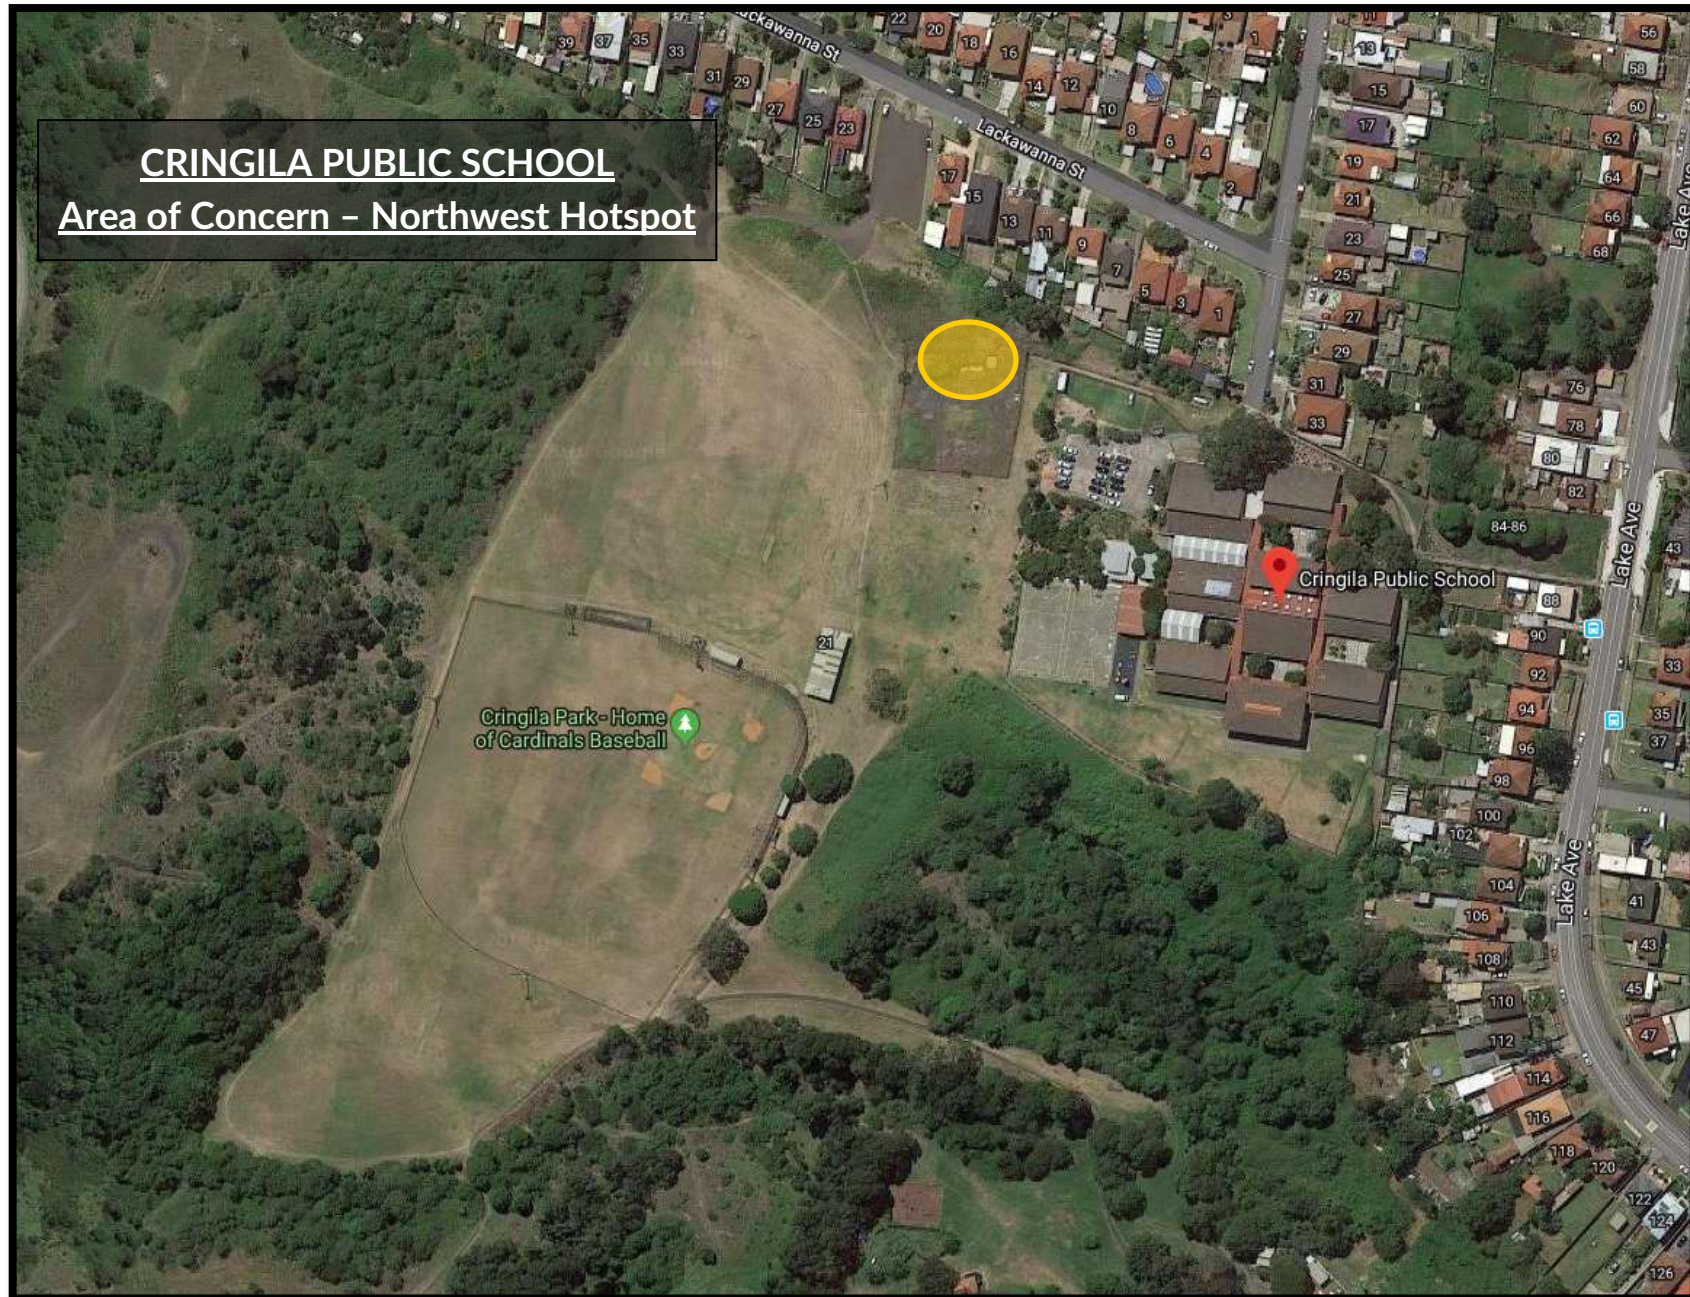
Appendix A: Area of Concern – Northwest Hotspot Map

CRINGILA PUBLIC SCHOOL
Area of Concern - Northwest Hotspot

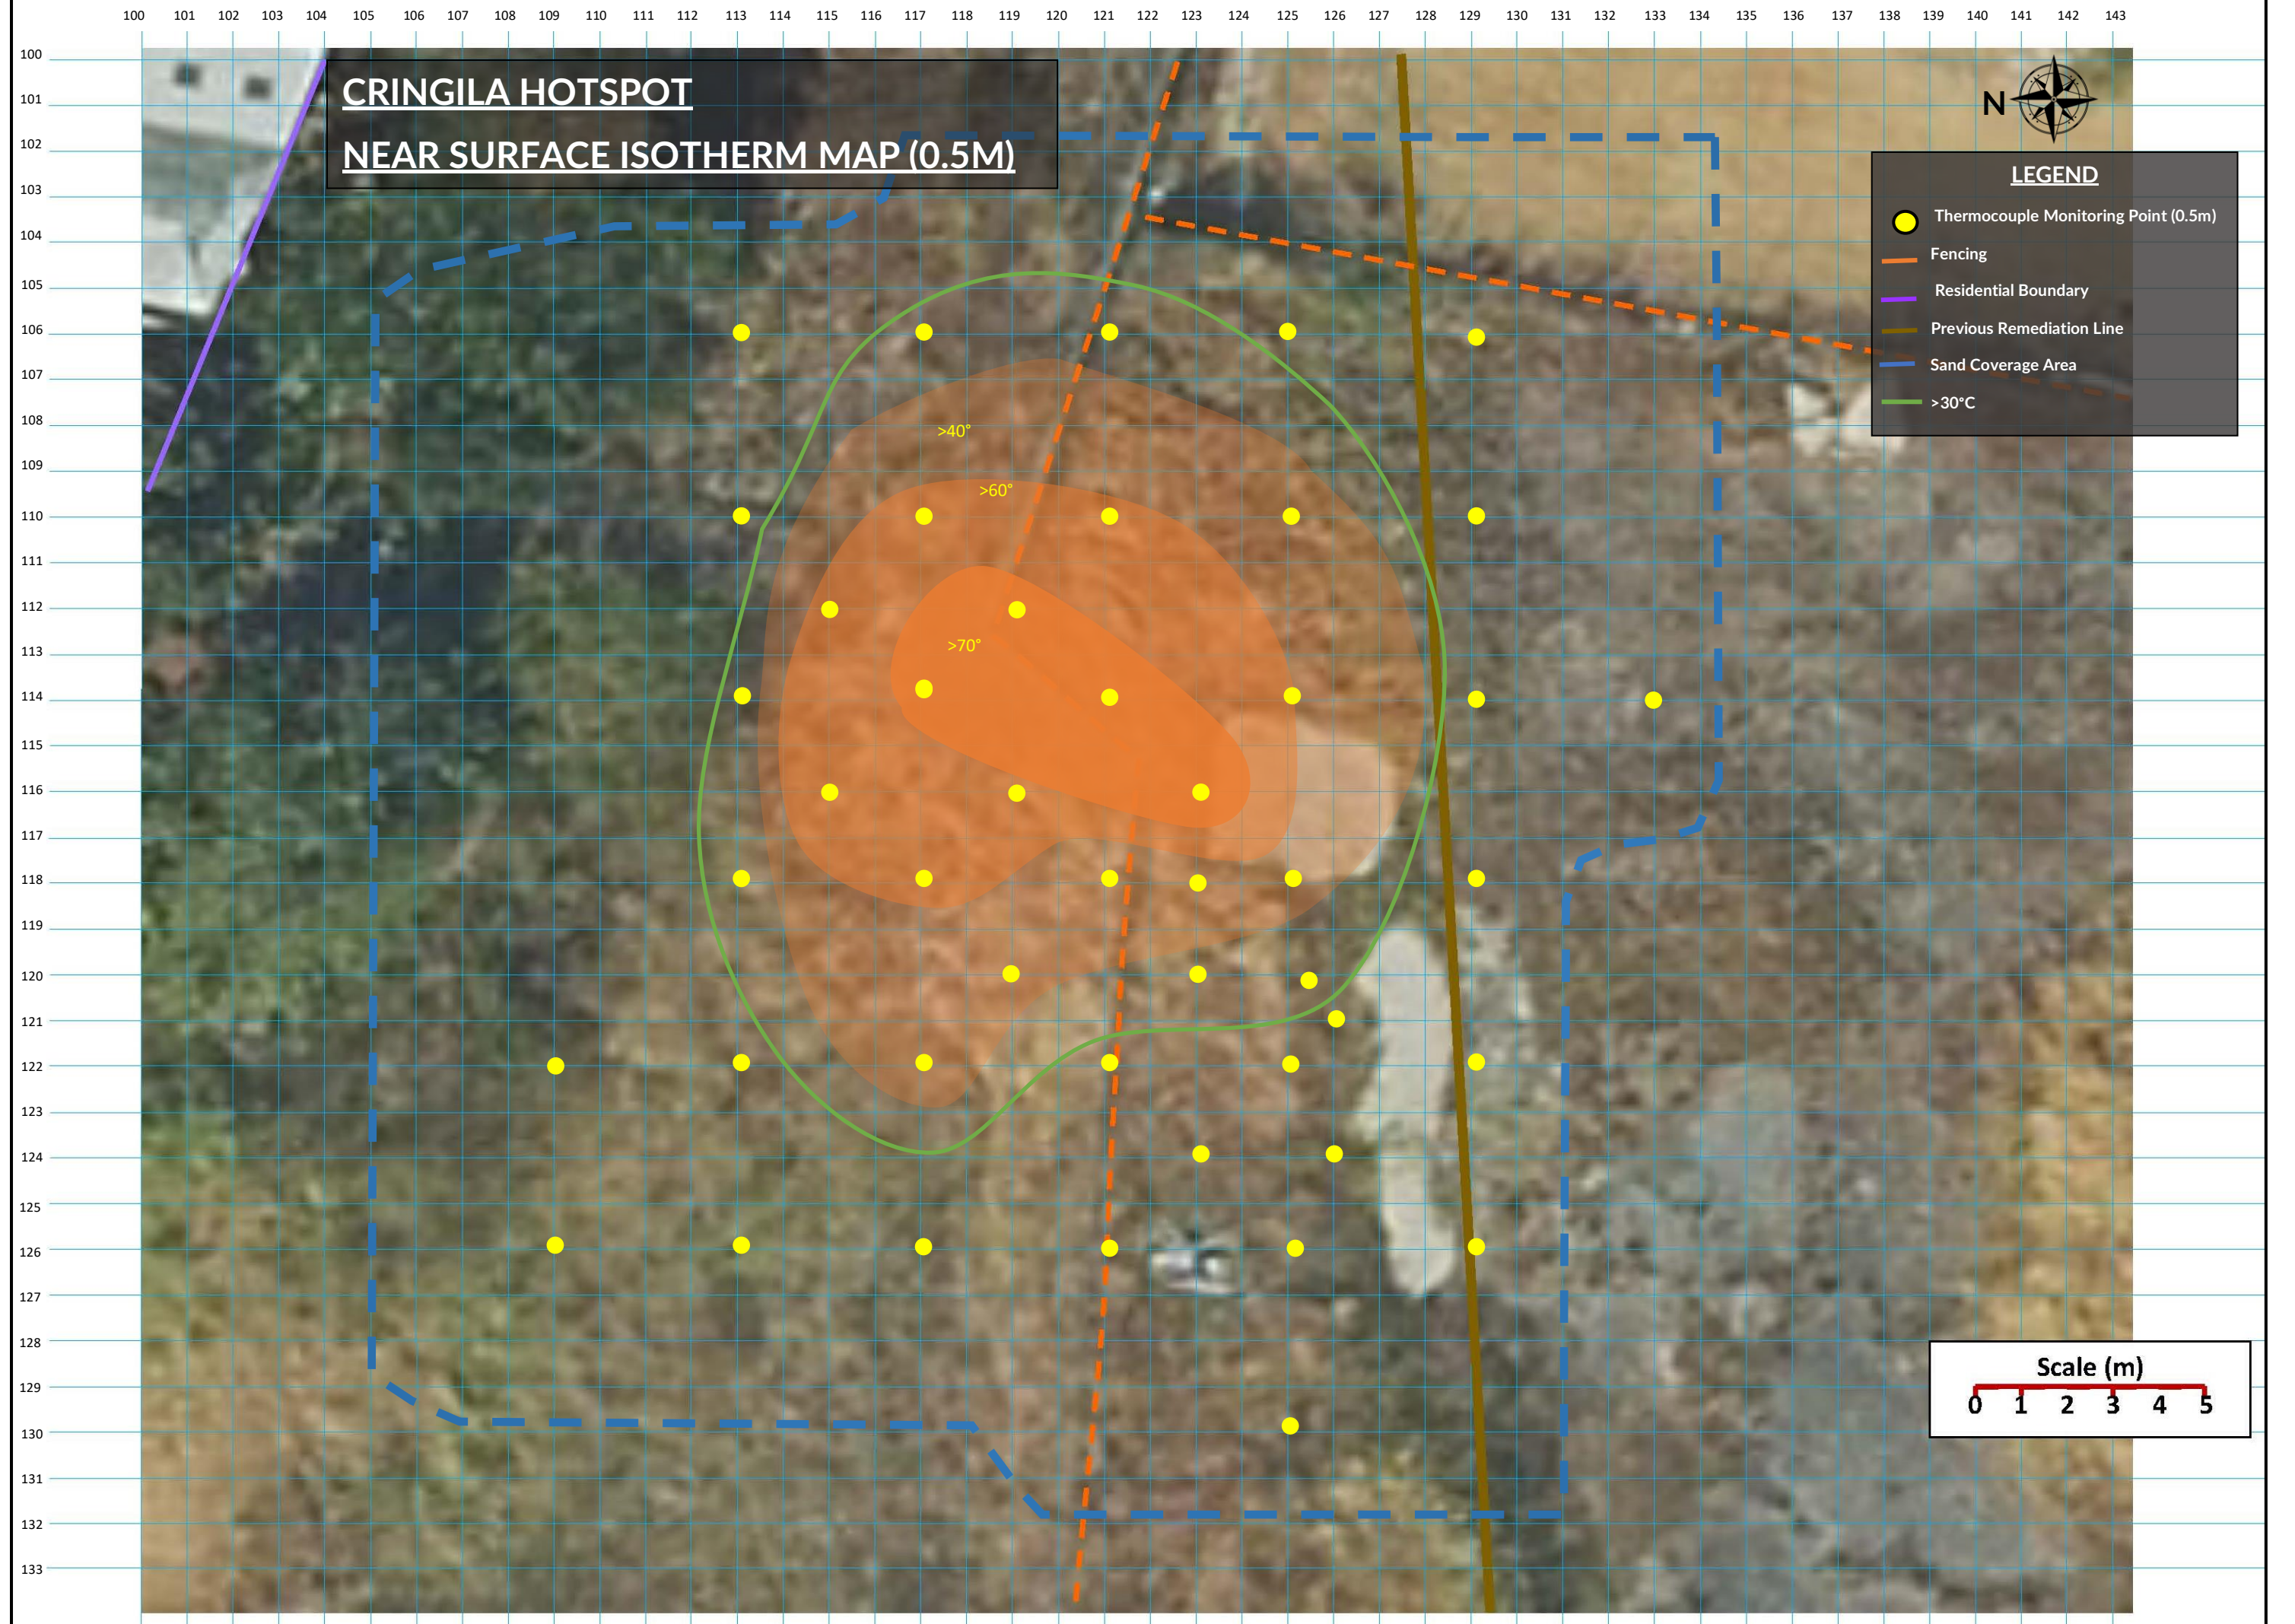
CRINGILA HOTSPOT NEAR SURFACE ISOTHERM MAP (0.5M)

The isotherm map shows the general zone of influence for temperatures between 30°C and 70°C at 0.5m, coloured orange. The isotherm map suggests that the hotspot may extend deeper than 0.5m and that the increased temperature in these areas is a result of heat venting to the surface.

It is noted that temperature at the near-surface may be variable across the hotspot due to inconsistencies in the consolidation and compaction of subsurface materials.

The near-surface temperature monitoring conducted between 10th August 2020 and 21st August 2020 indicates that the spatial extent of the northwest hotspot appears to remain localised.
