CRINGILA PUBLIC SCHOOL
NEAR-SURFACE TEMPERATURE
MONITORING INVESTIGATION

Summary Report
24/08/2020 – 04/09/2020

Cringila Public School

Near-Surface Temperature Monitoring

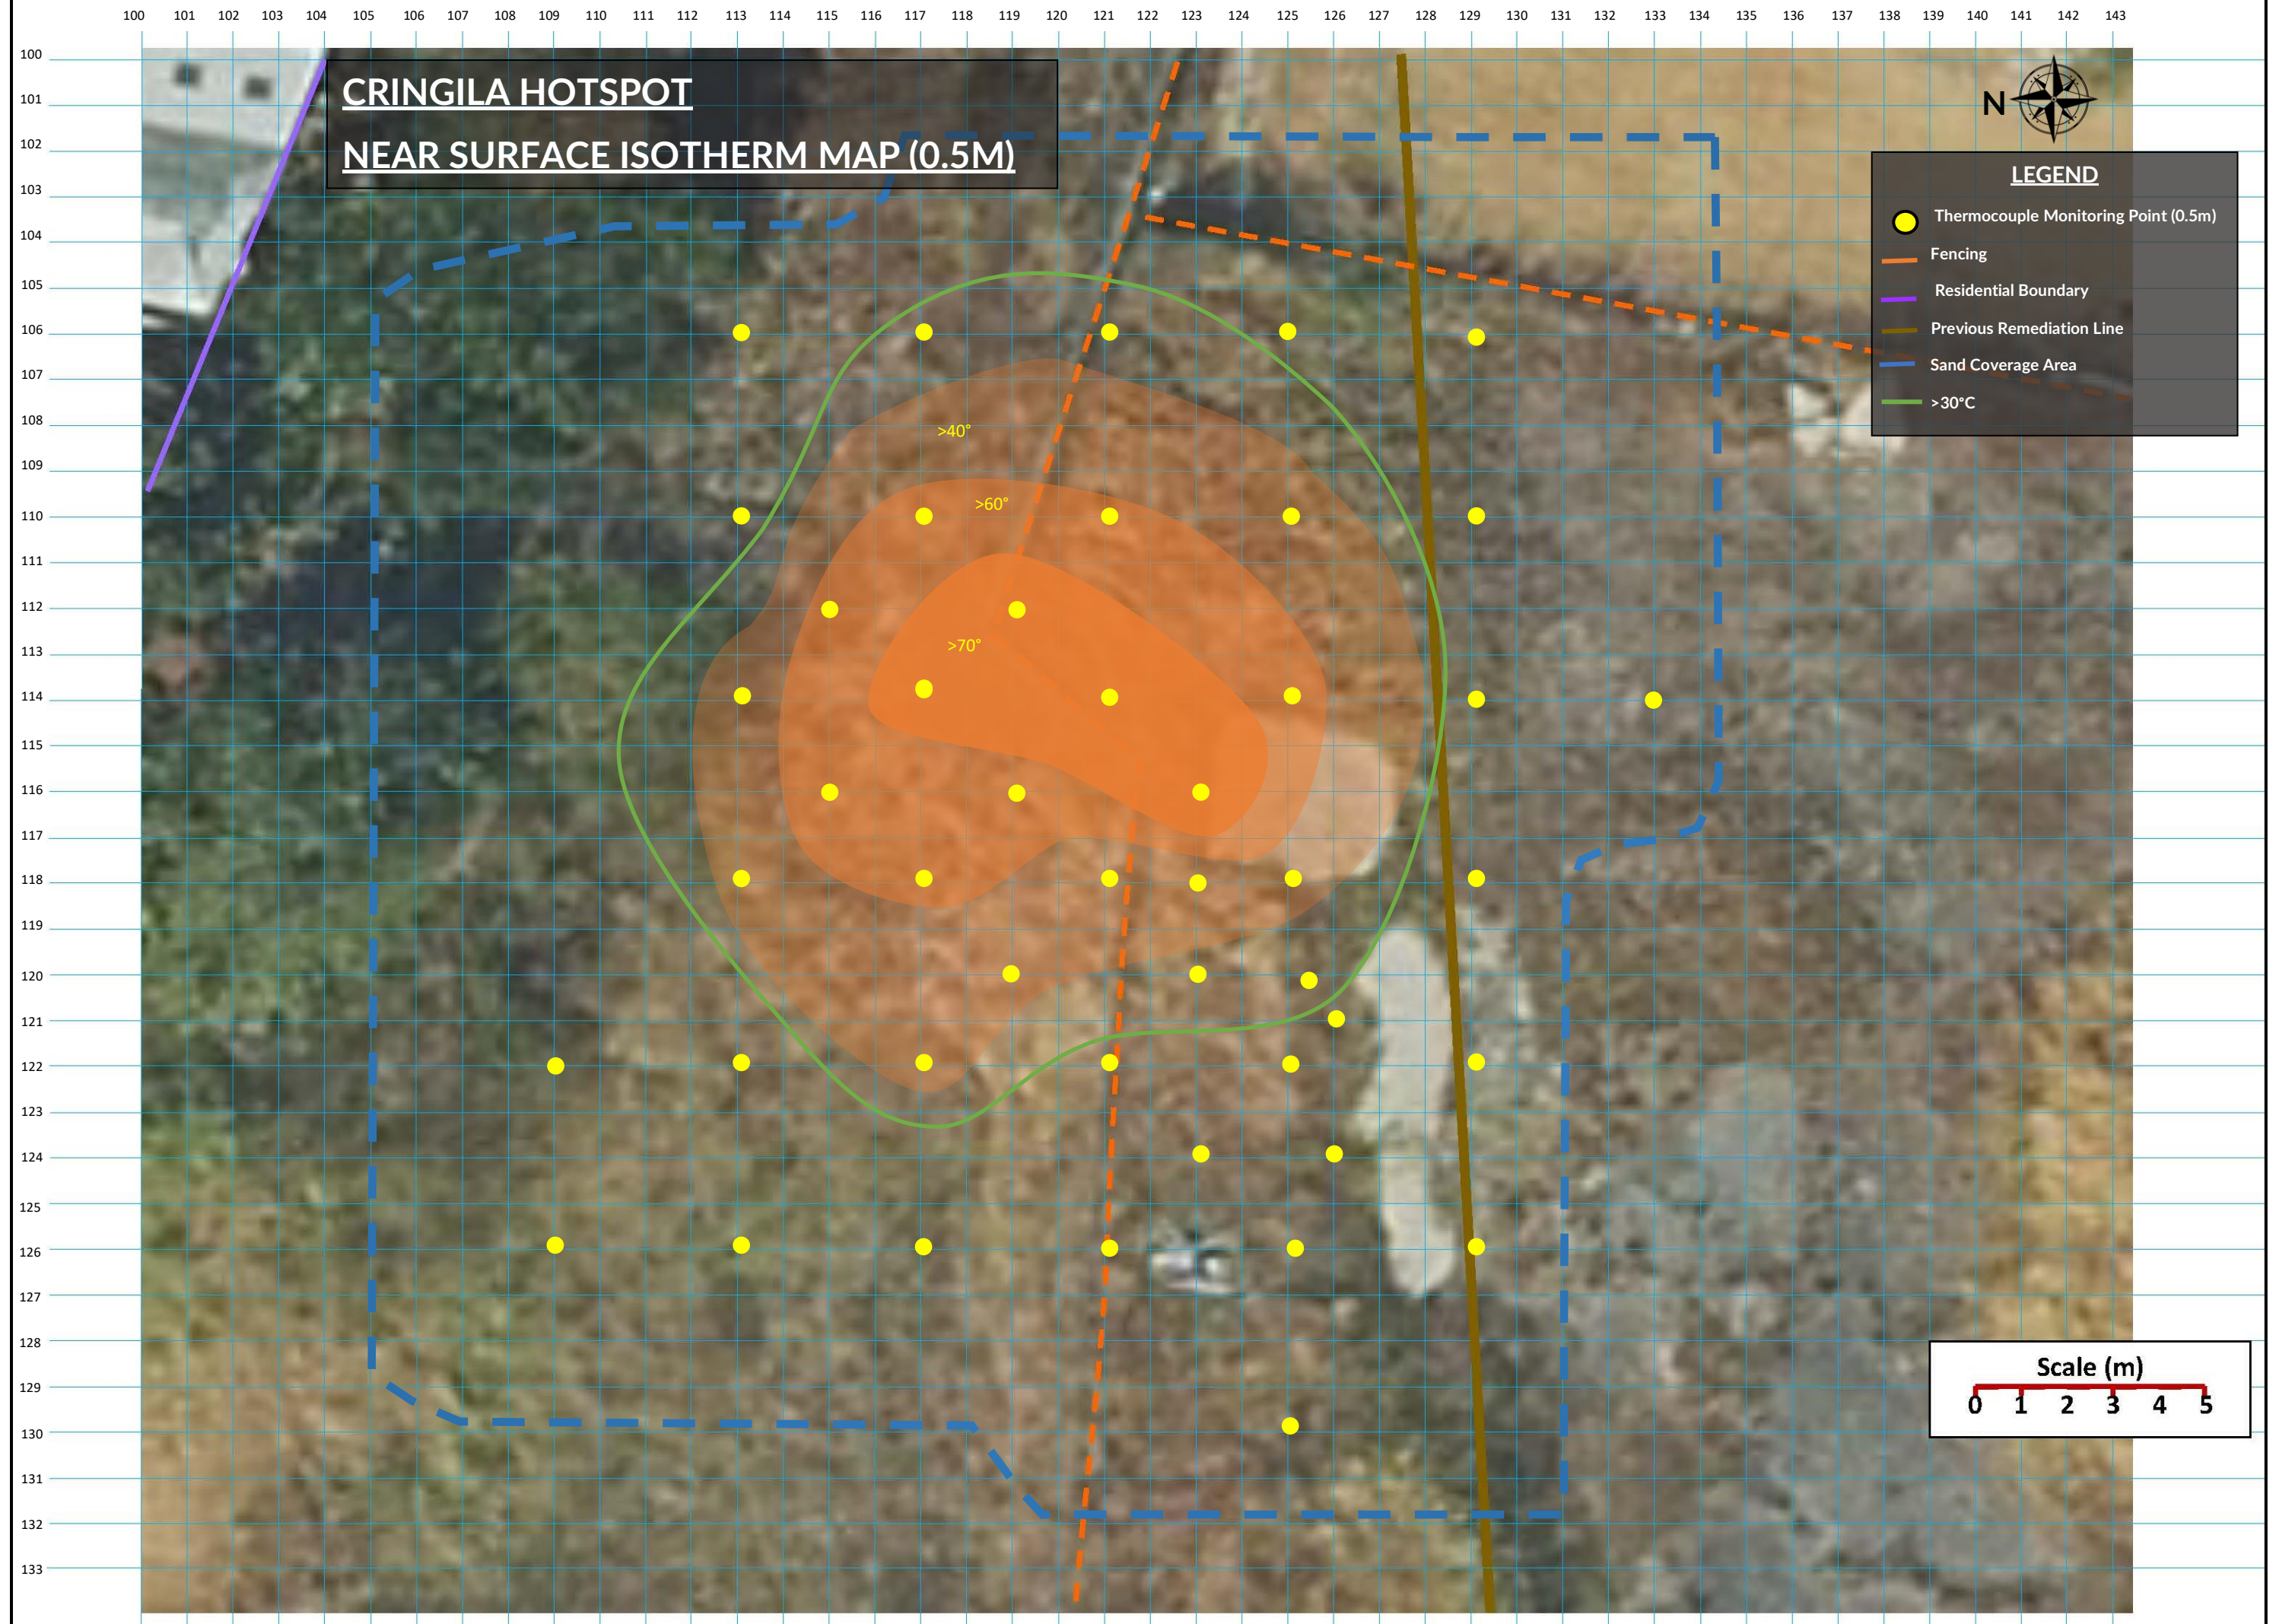
CRINGILA HOTSPOT NEAR SURFACE ISOTHERM MAP (0.5M)

The isotherm map shows the general zone of influence for temperatures between 30°C and 70°C at 0.5m, coloured orange. The isotherm map suggests that the hotspot may extend deeper than 0.5m and that the increased temperature in these areas is a result of heat venting to the surface.

It is noted that temperature at the near-surface may be variable across the hotspot due to inconsistencies in the consolidation and compaction of subsurface materials.

The near-surface temperature monitoring conducted between 24th August 2020 and 4th September 2020 indicates that the spatial extent of the northwest hotspot appears to remain localised.

It is recommended that weekly site inspections and recording are continued to monitor the near-surface temperatures surrounding the subsurface hotspot identified at the site.
