CRINGILA PUBLIC SCHOOL  
NEAR-SURFACE TEMPERATURE  
MONITORING INVESTIGATION

Summary Report  
07/09/2020 – 18/09/2020

Cringila Public School

September 2020  
C107471: J153825-04: TO

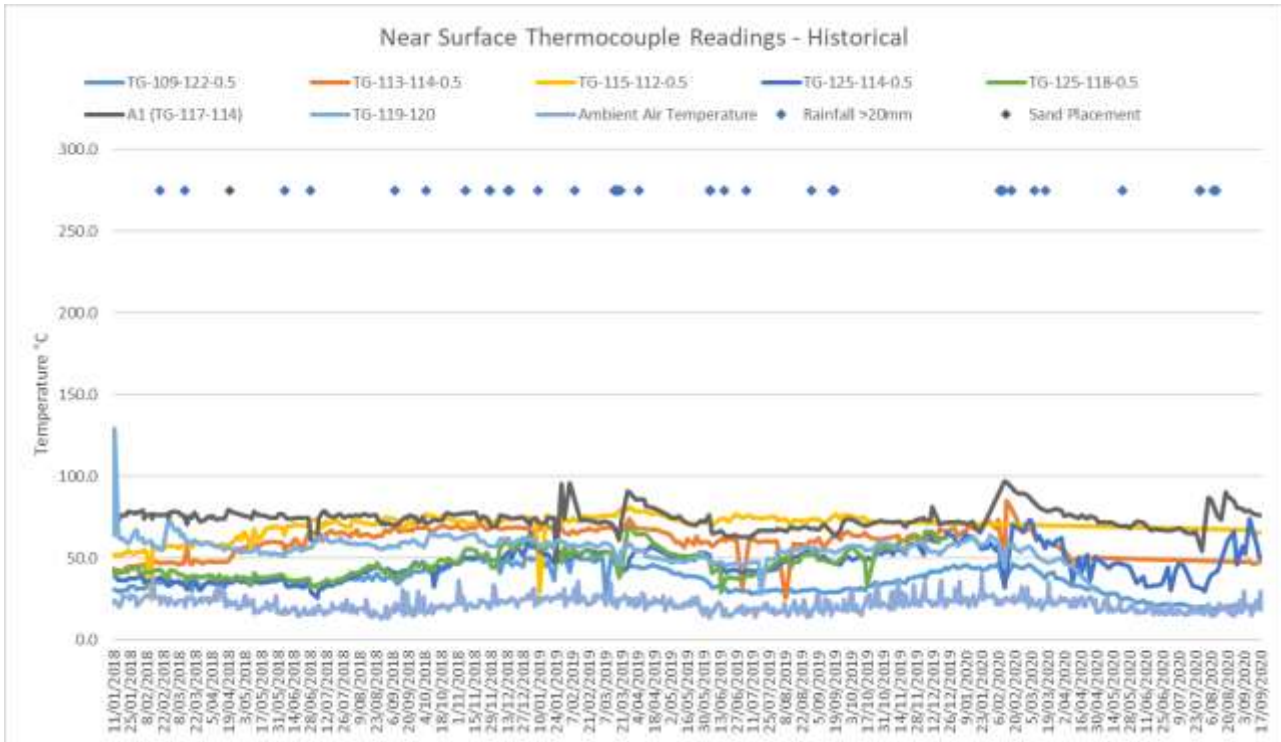
### 3.1. Near-Surface Temperature Graph – Selected Points (Historical)

Near surface temperature measurements for key thermocouple locations, progressive from Thursday 11<sup>th</sup> January 2018 to present.

The near-surface temperature appears to fluctuate seasonally across the surface of the northwest hotspot grid monitoring area.

Fluctuations in near-surface temperature are also evident following significant rain events (i.e. over 20mm rain).

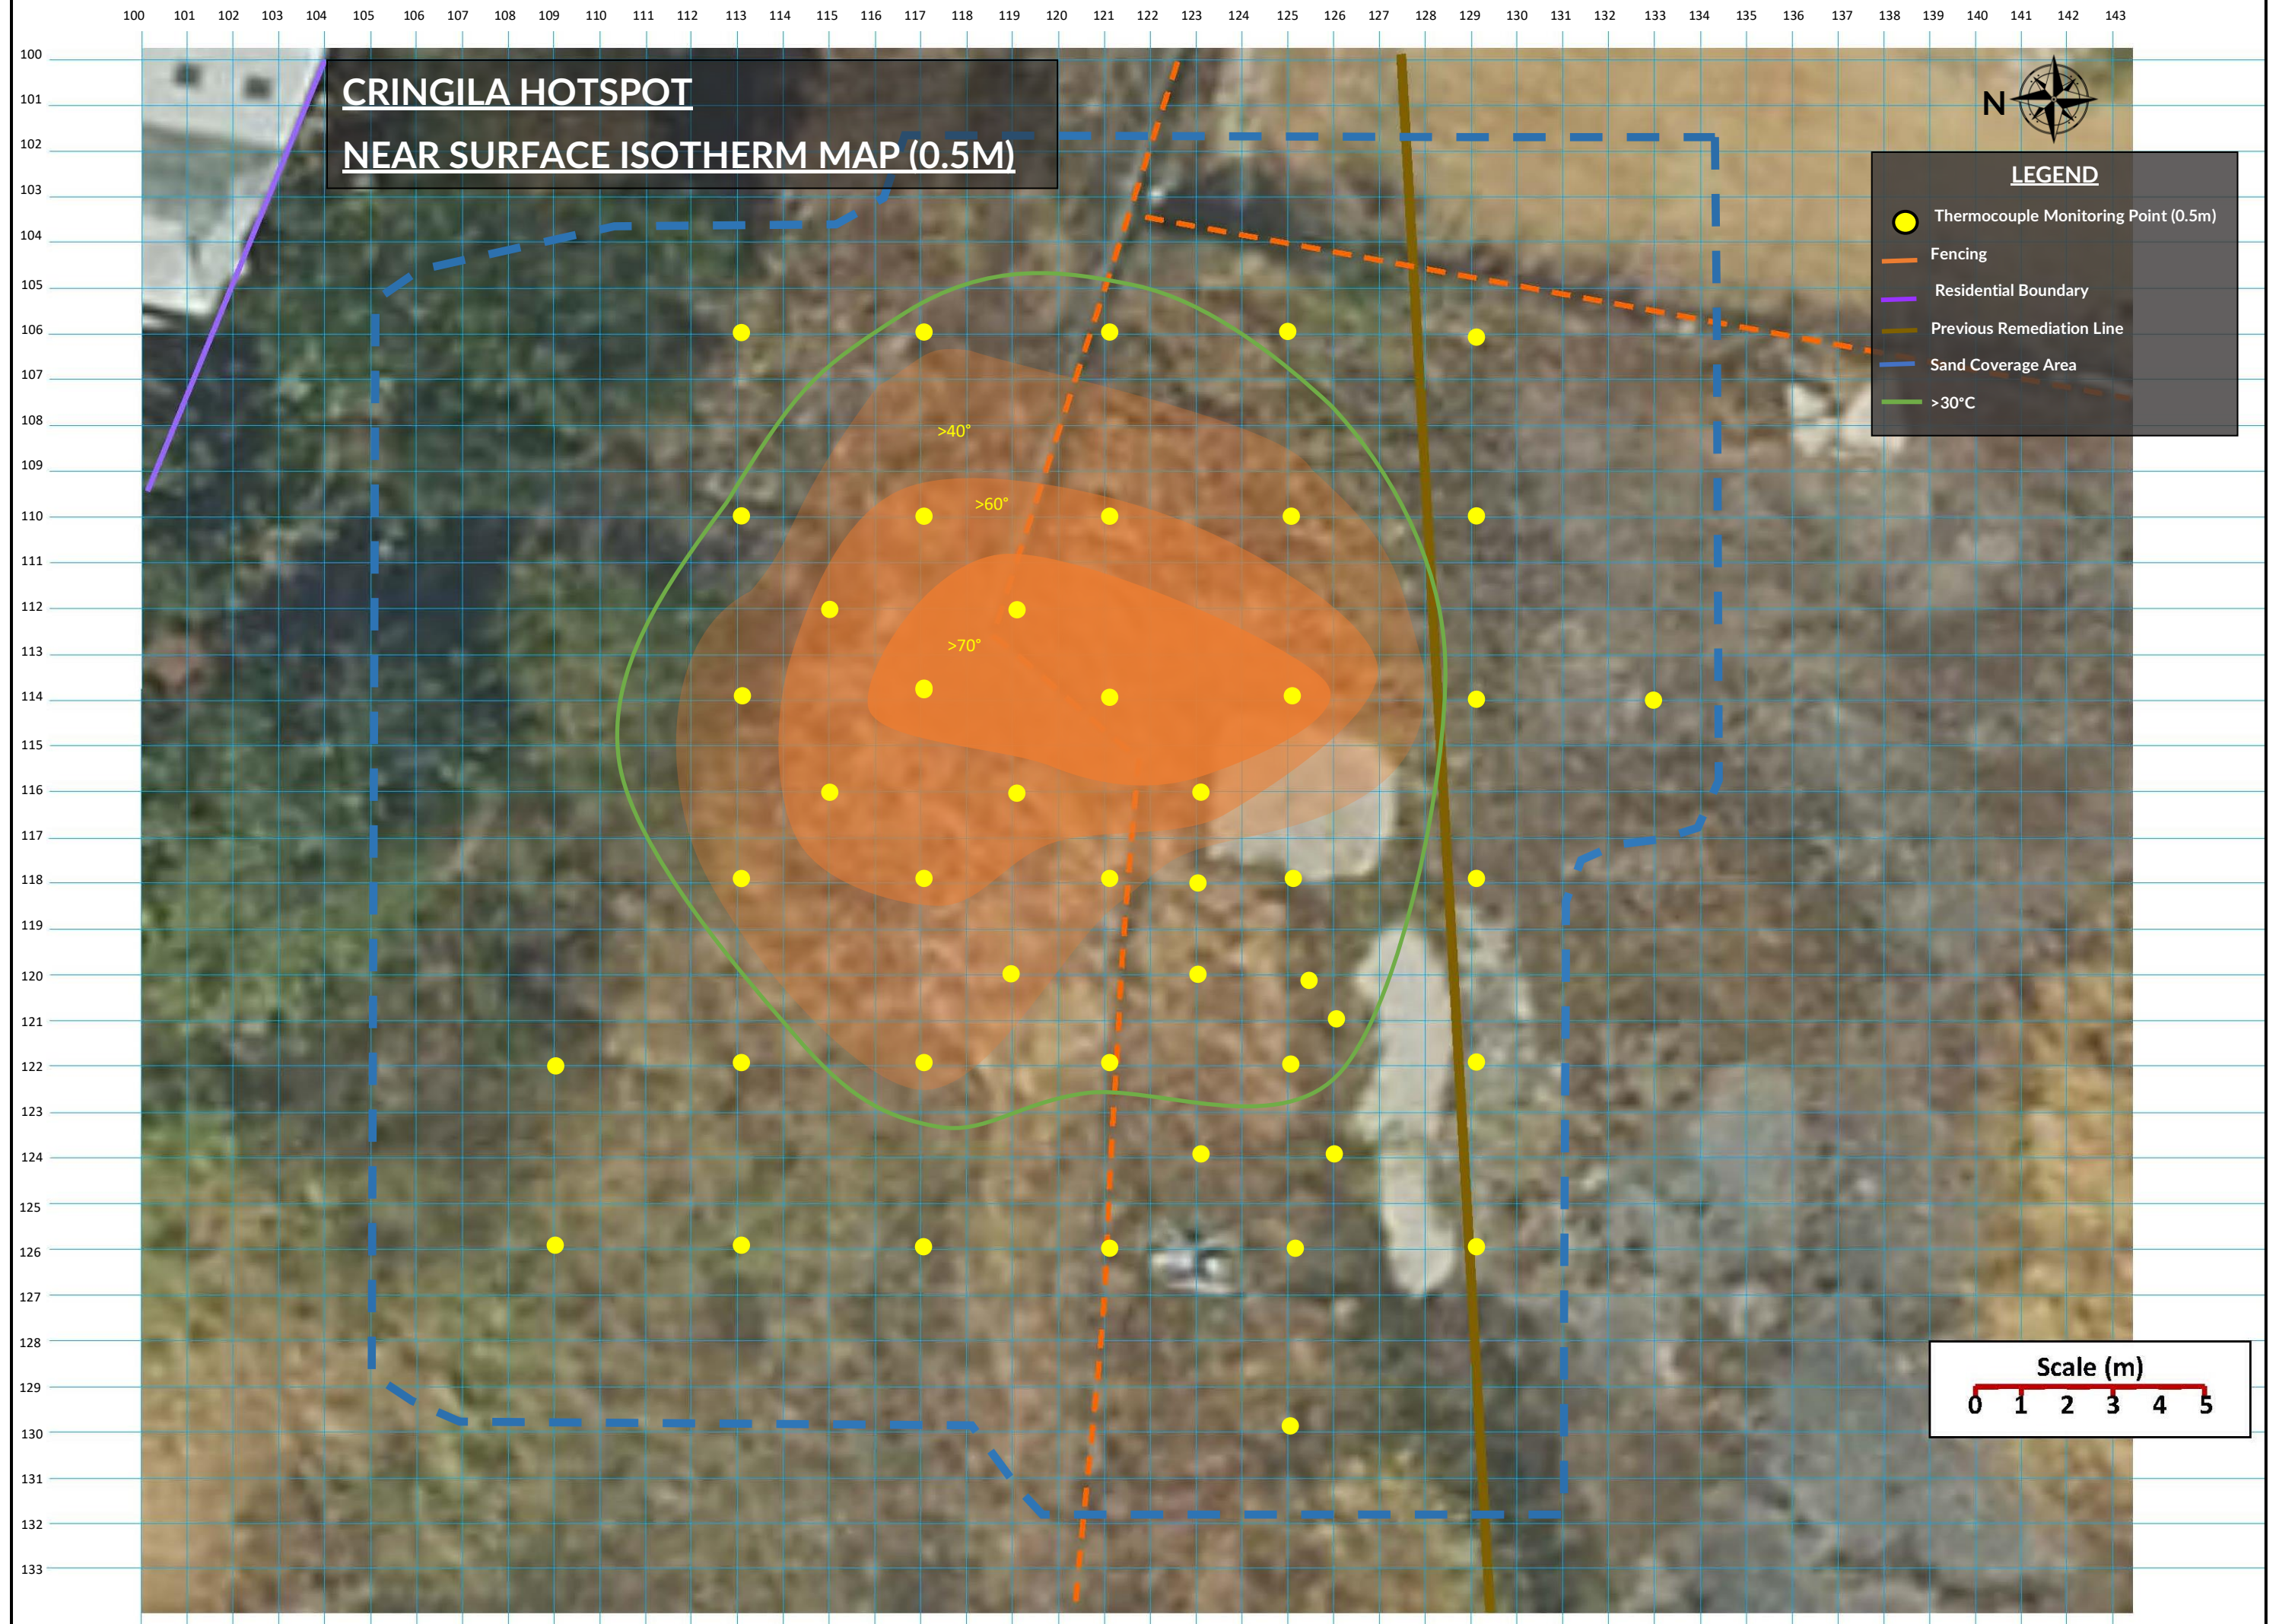
**Appendix B: Near-Surface Temperature Isotherm Map (0.5m)**

The isotherm map shows the general zone of influence for temperatures between 30°C and 70°C at 0.5m, coloured orange. The isotherm map suggests that the hotspot may extend deeper than 0.5m and that the increased temperature in these areas is a result of heat venting to the surface.

It is noted that temperature at the near-surface may be variable across the hotspot due to inconsistencies in the consolidation and compaction of subsurface materials.

The near-surface temperature monitoring conducted between 7<sup>th</sup> September 2020 and 18<sup>th</sup> September 2020 indicates that the spatial extent of the northwest hotspot appears to remain localised.

It is recommended that weekly site inspections and recording are continued to monitor the near-surface temperatures surrounding the subsurface hotspot identified at the site.
