CRINGILA PUBLIC SCHOOL
NEAR-SURFACE TEMPERATURE
MONITORING INVESTIGATION

Summary Report
21/09/2020 – 02/10/2020

Cringila Public School

Near-Surface Temperature Monitoring

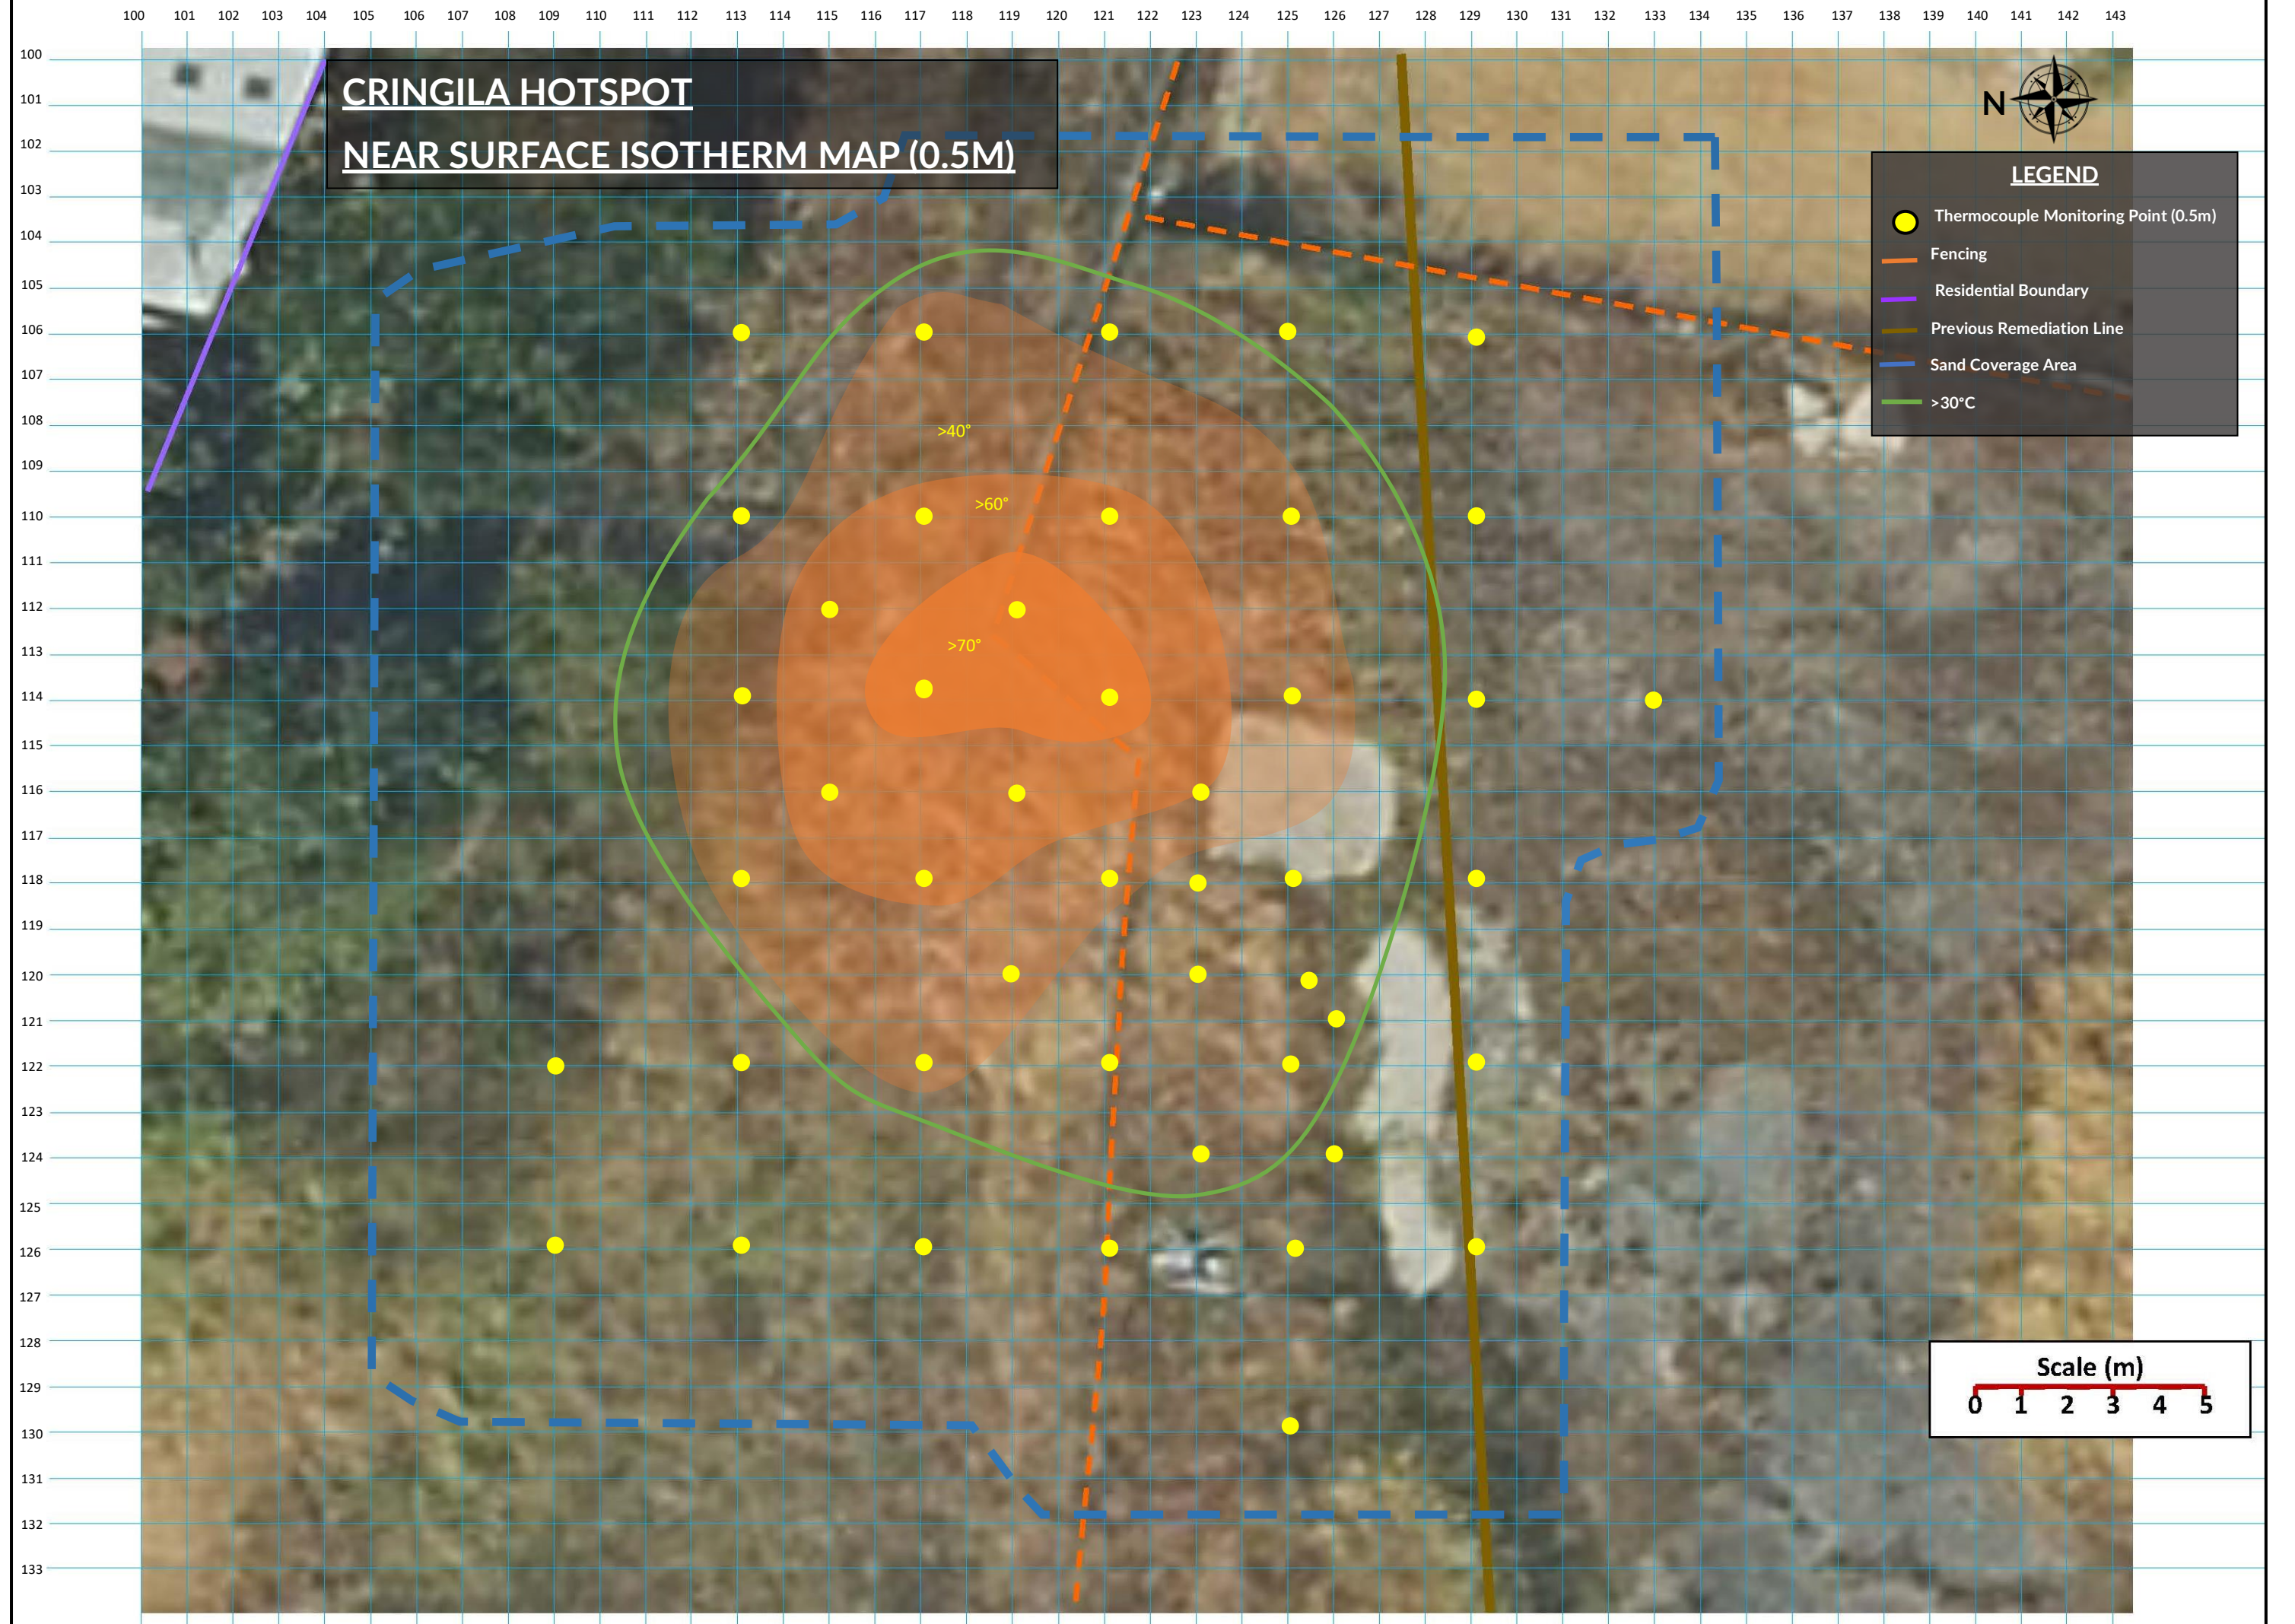
CRINGILA HOTSPOT NEAR SURFACE ISOTHERM MAP (0.5M)

The isotherm map shows the general zone of influence for temperatures between 30°C and 70°C at 0.5m, coloured orange. The isotherm map suggests that the hotspot may extend deeper than 0.5m and that the increased temperature in these areas is a result of heat venting to the surface.

It is noted that temperature at the near-surface may be variable across the hotspot due to inconsistencies in the consolidation and compaction of subsurface materials.

The near-surface temperature monitoring conducted between 21st September 2020 and 2nd October 2020 indicates that the spatial extent of the northwest hotspot appears to remain localised.

It is recommended that weekly site inspections and recording are continued to monitor the near-surface temperatures surrounding the subsurface hotspot identified at the site.
