CRINGILA PUBLIC SCHOOL
NEAR-SURFACE TEMPERATURE
MONITORING INVESTIGATION

Summary Report
05/10/2020 – 16/10/2020

Cringila Public School

Near-Surface Temperature Monitoring

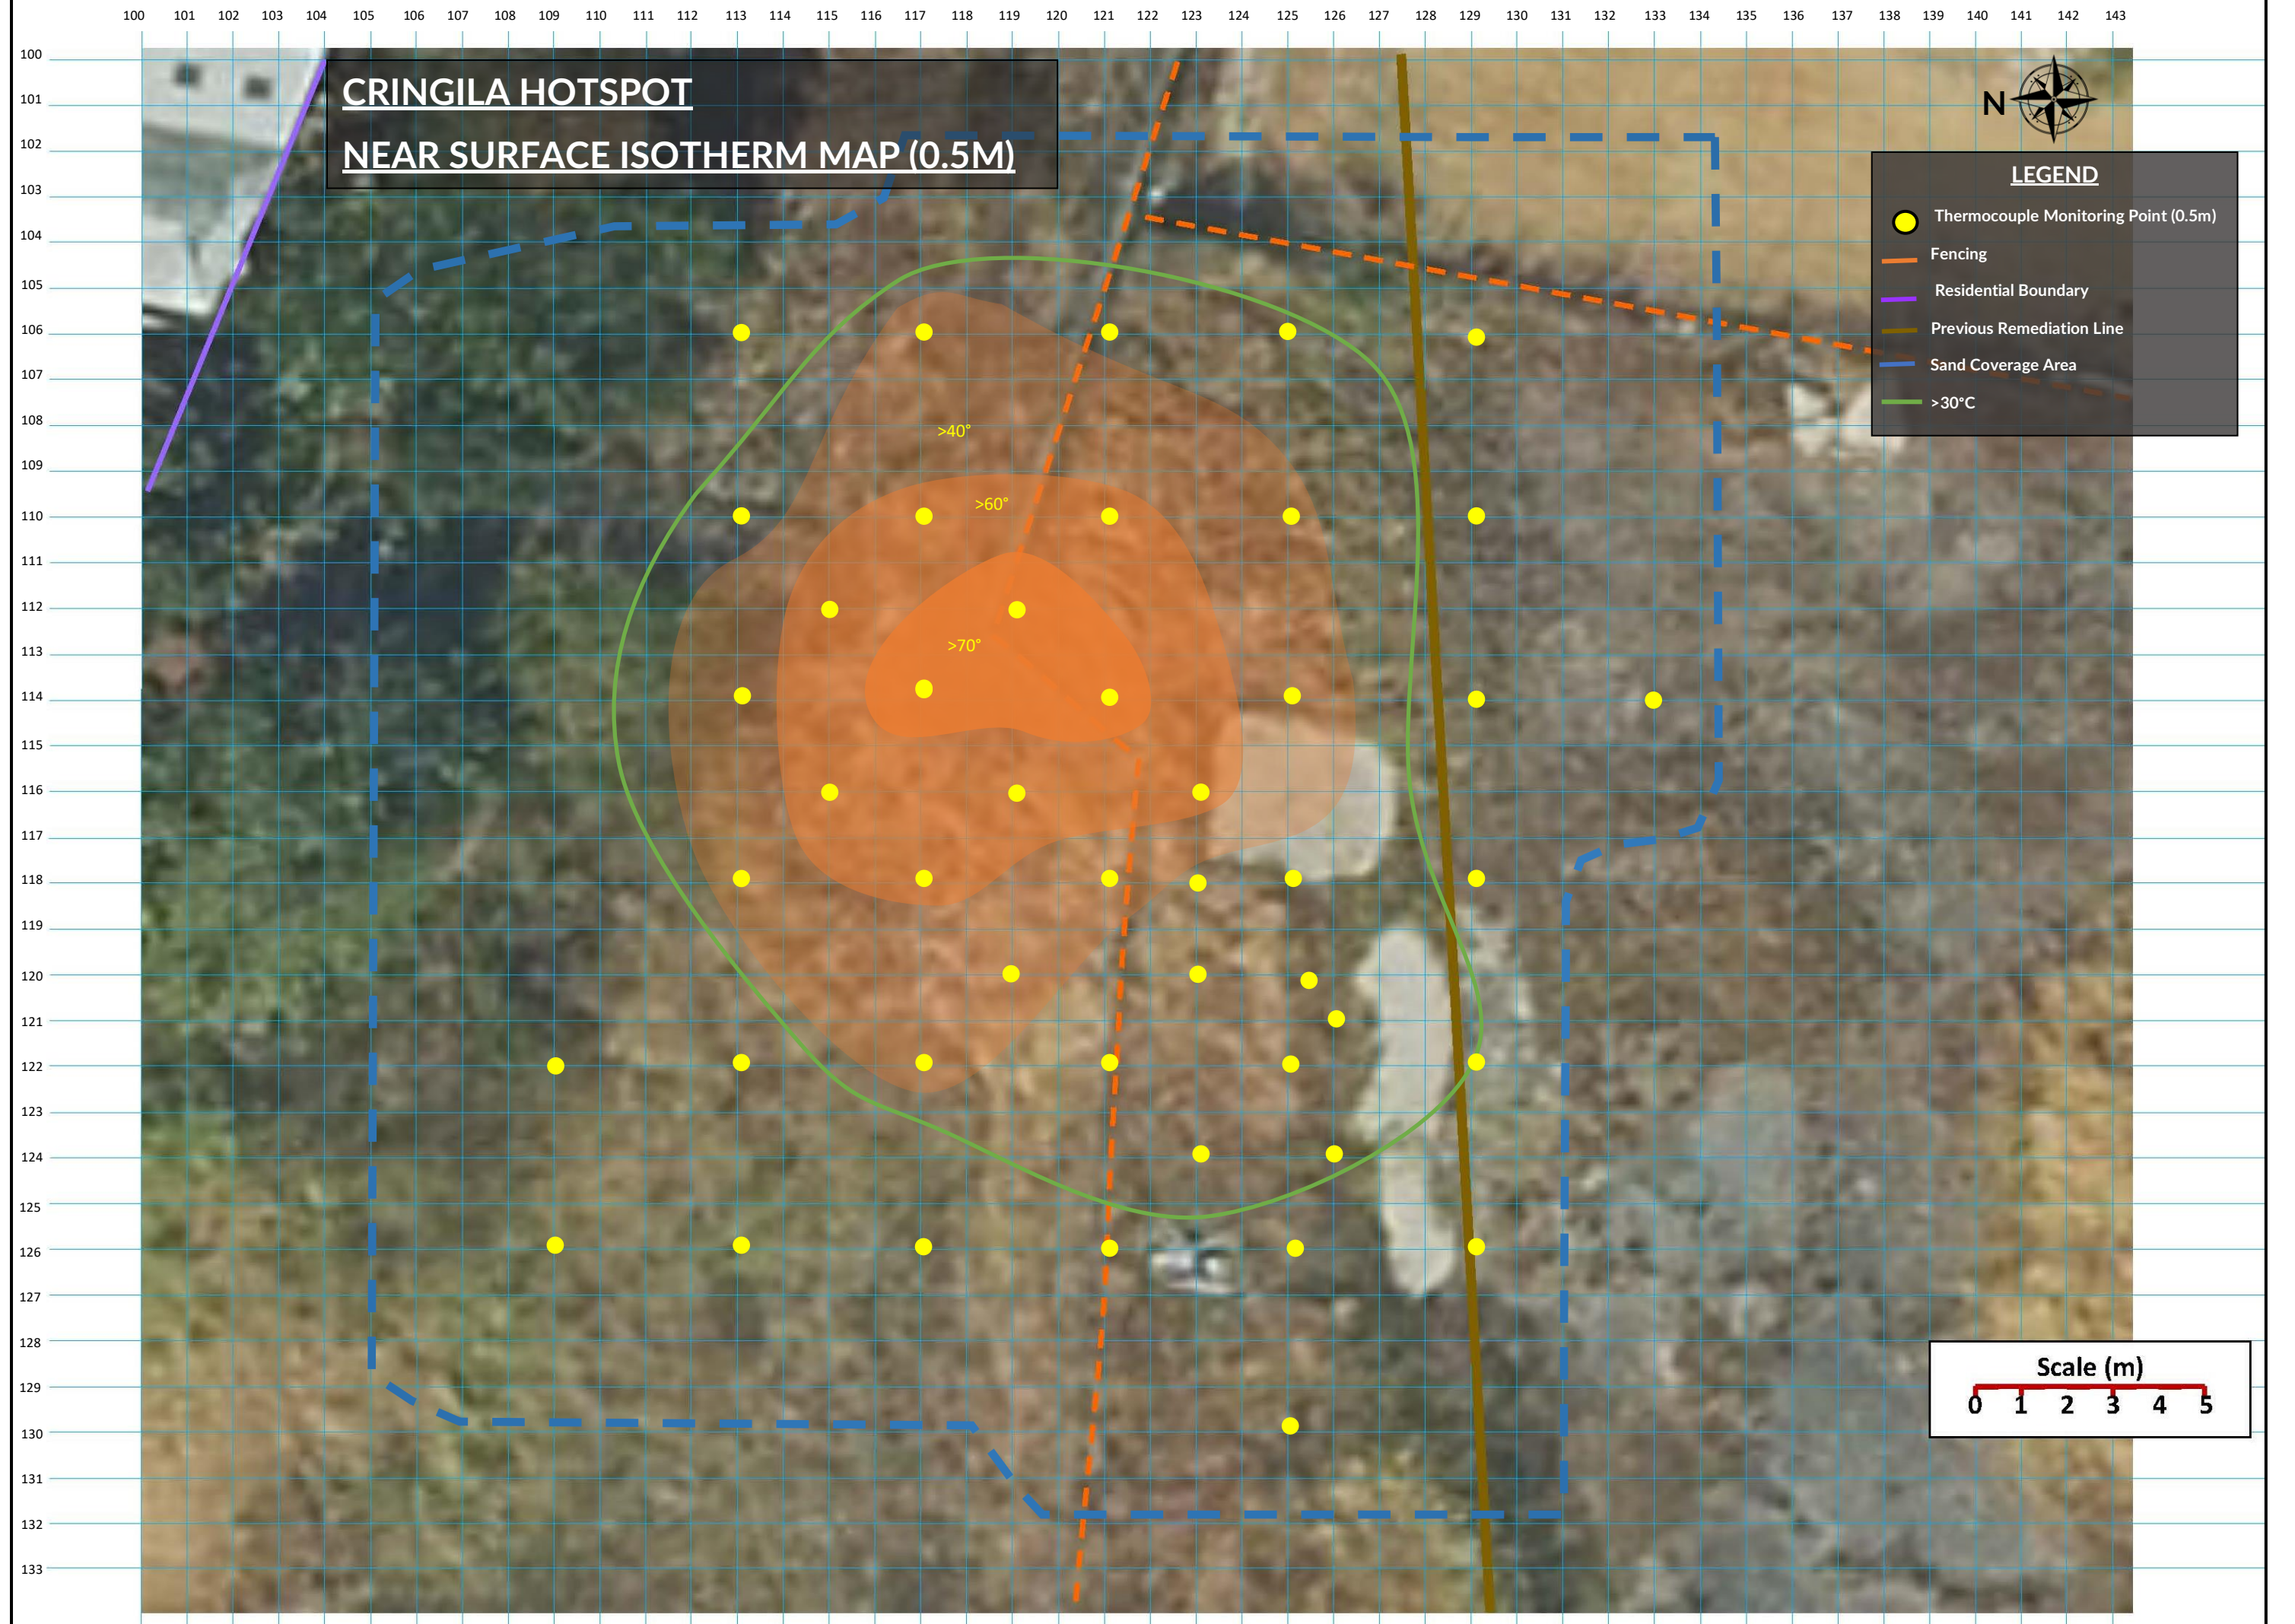
Appendix B: Near-Surface Temperature Isotherm Map (0.5m)

The isotherm map shows the general zone of influence for temperatures between 30°C and 70°C at 0.5m, coloured orange. The isotherm map suggests that the hotspot may extend deeper than 0.5m and that the increased temperature in these areas is a result of heat venting to the surface.

It is noted that temperature at the near-surface may be variable across the hotspot due to inconsistencies in the consolidation and compaction of subsurface materials.

CRINGILA HOTSPOT NEAR SURFACE ISOTHERM MAP (0.5M)

It is recommended that weekly site inspections and recording are continued to monitor the near-surface temperatures surrounding the subsurface hotspot identified at the site.
