CRINGILA PUBLIC SCHOOL  
MONTHLY SUBSURFACE GAS  
MONITORING REPORT

August 2020  
J153825-04

Cringila Public School

35 Sheffield Street  
Cringila NSW 2502

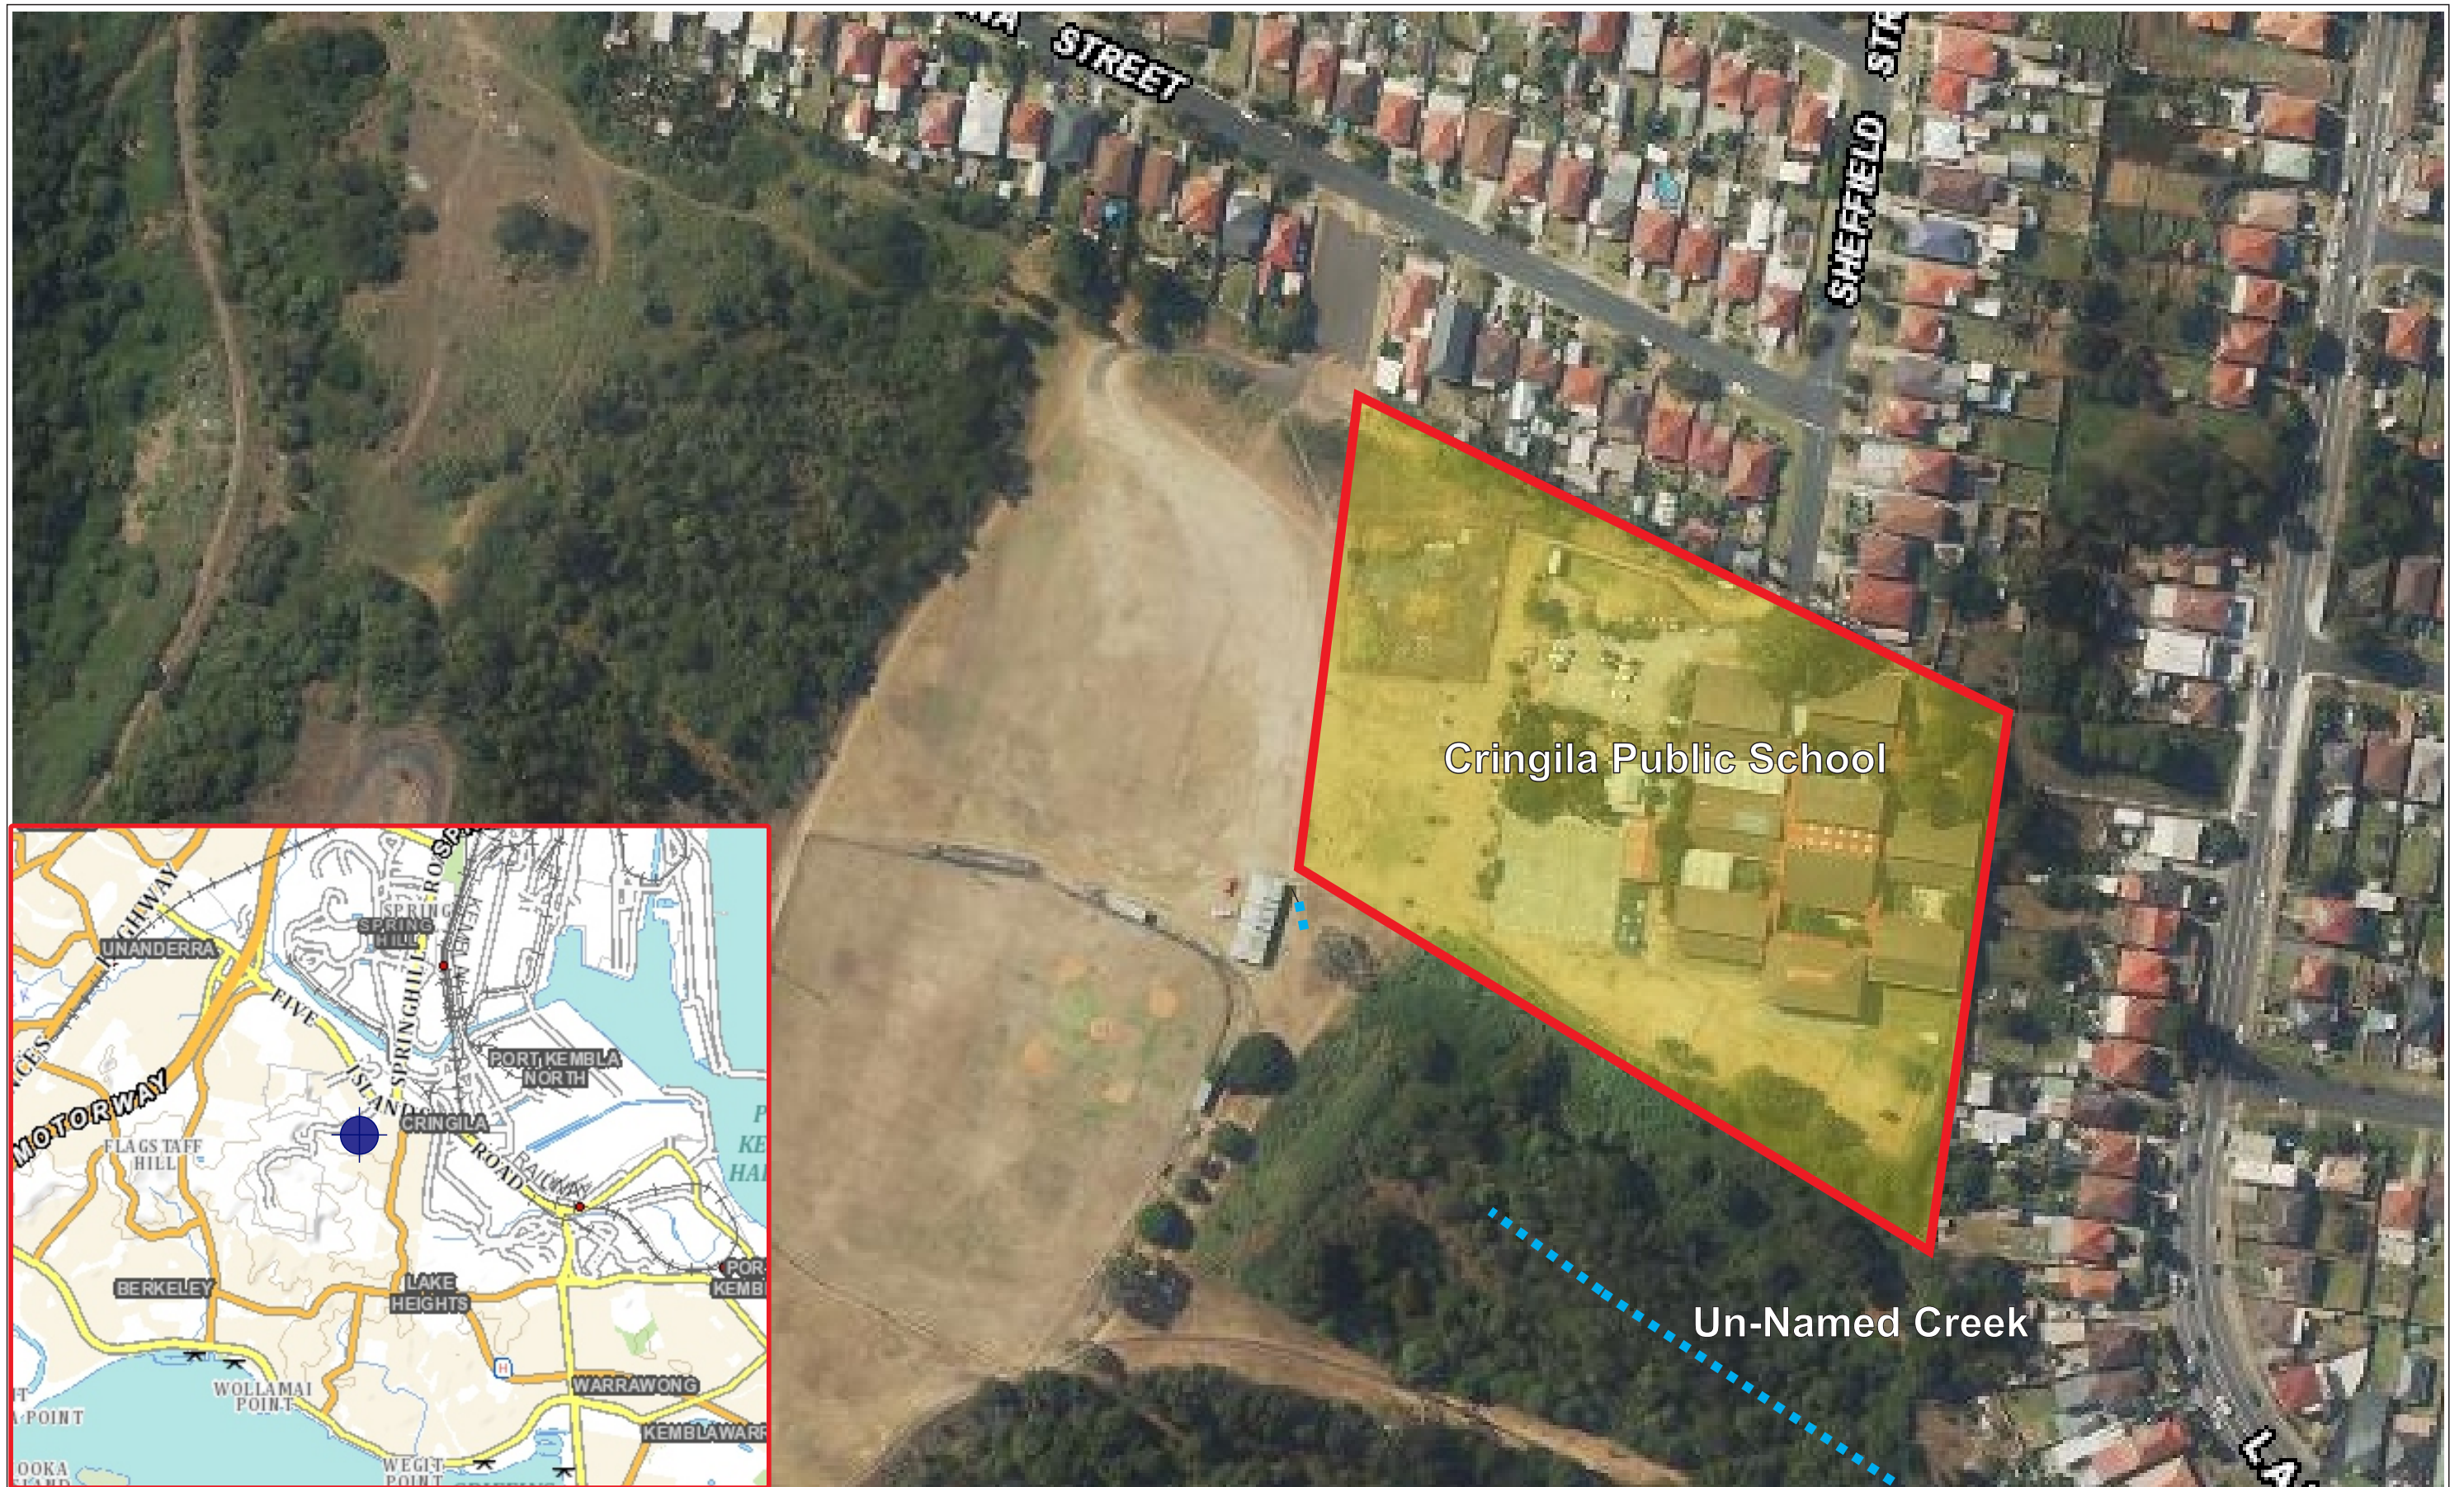
Client Name:		Department of Education		
Client Number:		C107471	Project Number: J155958	
Project Description: Monthly Monitoring Report- Cringila Public School				
Address:		Cringila Public School		
Prepared:	AMW	Reviewed:	MB	Date: 19/06/2018
Figure 1		Site Location and Regional Context

This report summarises the findings of the August 2020 monthly round of subsurface gas monitoring carried out at Cringila Public School, located at 35 Sheffield Street, Cringila NSW (refer **Figure 1** in **Appendix A** for site layout).

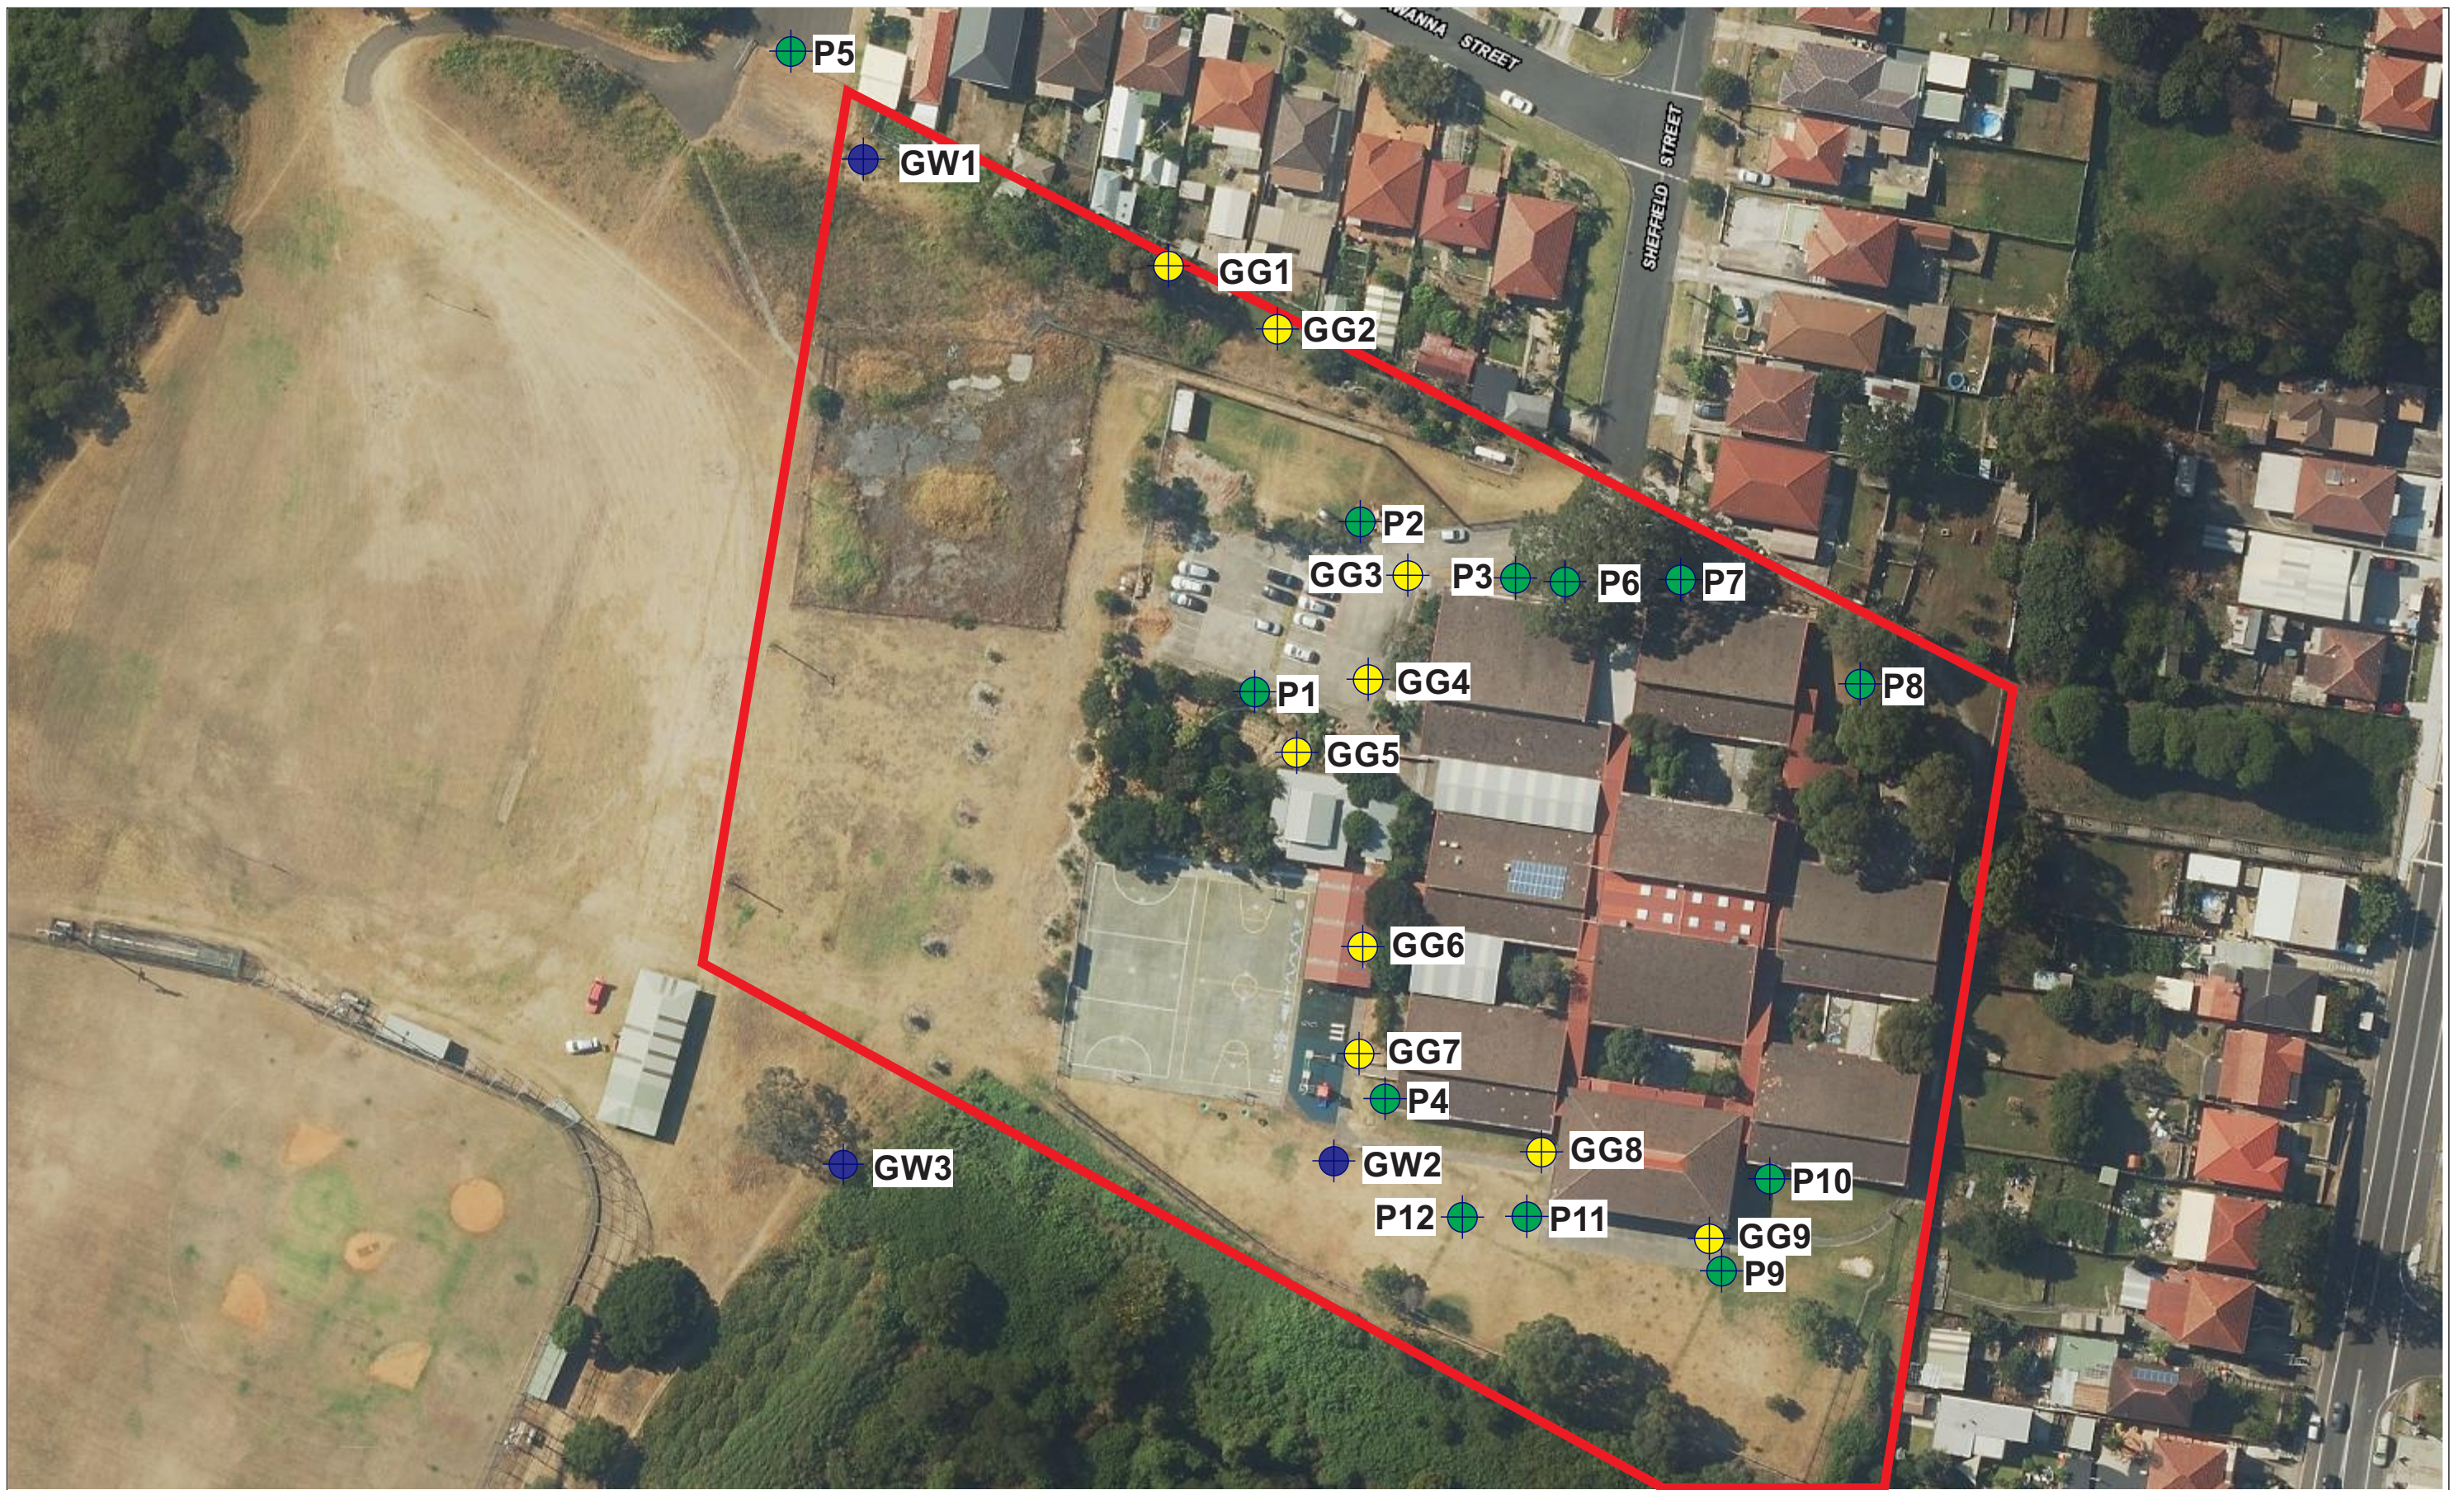
The monitoring ports of the GA5000 were fitted to the X-cap of each of the 9 (GG1 to GG9) subsurface monitoring wells. Subsurface gas and flow rate were recorded as well as concentrations of the following Hazardous Gases (refer to **Figure 2** of **Appendix A** for monitoring locations);

Service pits were assessed by inserting the GA5000 nozzle into the pits with the sampling tube inserted at least 30 cm below the cover grate for a minimum of 30 seconds. The locations of service pits monitored (P1 to P12) are presented in **Figure 2** of **Appendix A**.

- Site Boundary
- Groundwater Monitoring Well
- Ground Gas Monitoring Well
- Service Pit Location
