AIR MONITORING RISK ASSESSMENT  
CRINGILA PUBLIC SCHOOL - NW HOTSPOT  
35 SHEFFIELD STREET  
CRINGILA NSW 2502

Weekly Report  
22/01/18 - 26/01/18

# Air Monitoring Risk Assessment

Cringila Public School NW Hotspot – 35 Sheffield Street, Cringila NSW 2502

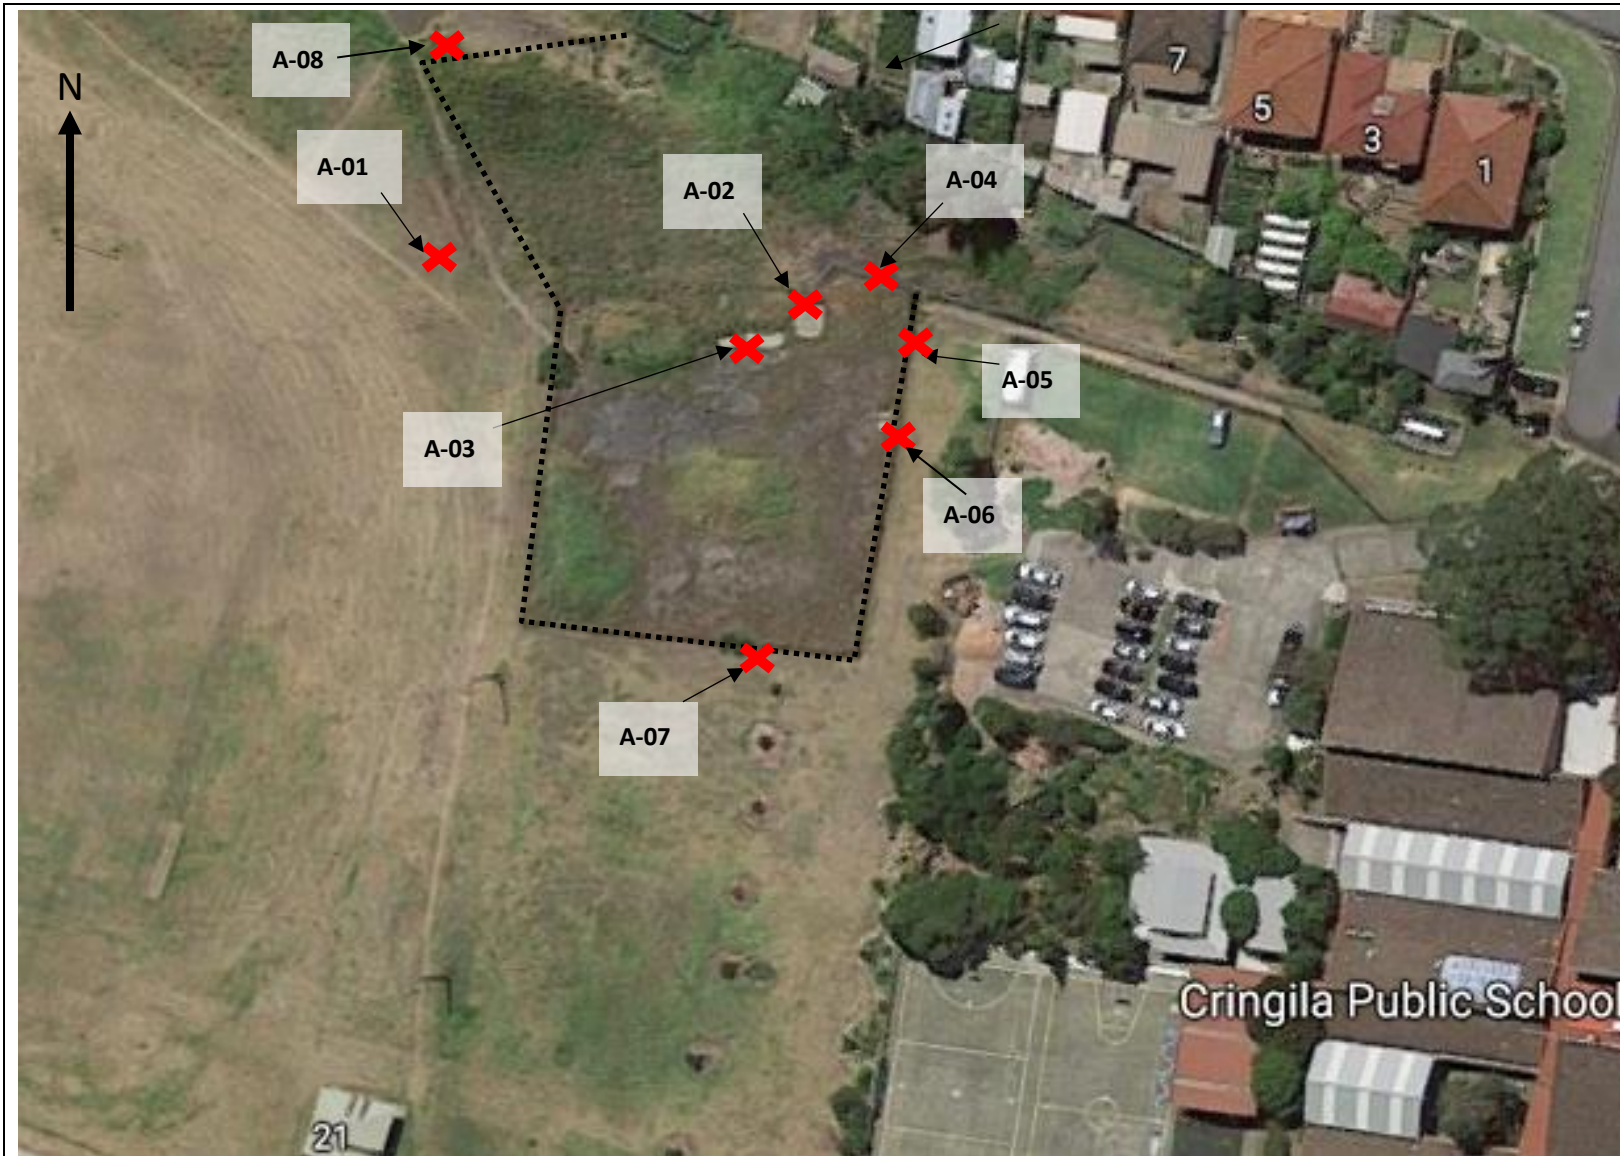
### **Appendix A: Site Map and Sampling Locations**

Spot measurements were taken within the North-Western Hotspot area and at surrounding locations to determine whether potential air pollutants from the subsurface hotspot were present. These monitoring locations included the following:

- A-01 General Background
- A-02 NW Hotspot – Concrete Cap Surface
- A-03 NW Hotspot – Small Mound
- A-04 NW Hotspot – NE fence line
- A-05 Exclusion Area Fence Line East of Hotspot (Approx. 10m)
- A-06 Exclusion Area Fence Line Southeast of Hotspot (Approx. 15m)
- A-07 Exclusion Area Fence Line South of Hotspot (Approx. 30m)
- A-08 Exclusion Area Fence Line Northwest of Hotspot, adjacent 17 Lackawanna Street (Approx. 50m)

The atmospheric pollutant results for each monitoring event are summarised below in Table 3, and locations can be viewed in **Appendix A**.
