AIR MONITORING RISK ASSESSMENT
CRINGILA PUBLIC SCHOOL - NW HOTSPOT
35 SHEFFIELD STREET
CRINGILA NSW 2502

Weekly Report
19/02/18 - 23/02/18

February 2018
C107826 : J153825 : RC

Document Quality Management Details.		
Report Name:	AMR-13 Air Monitoring Risk Assessment	
Site Details:	Cringila PS NW Hotspot – 35 Sheffield Street, Cringila NSW 2502	
Client Name:	NSW Department of Education	
Client Number:	C107826	
Signatures:	Prepared By:

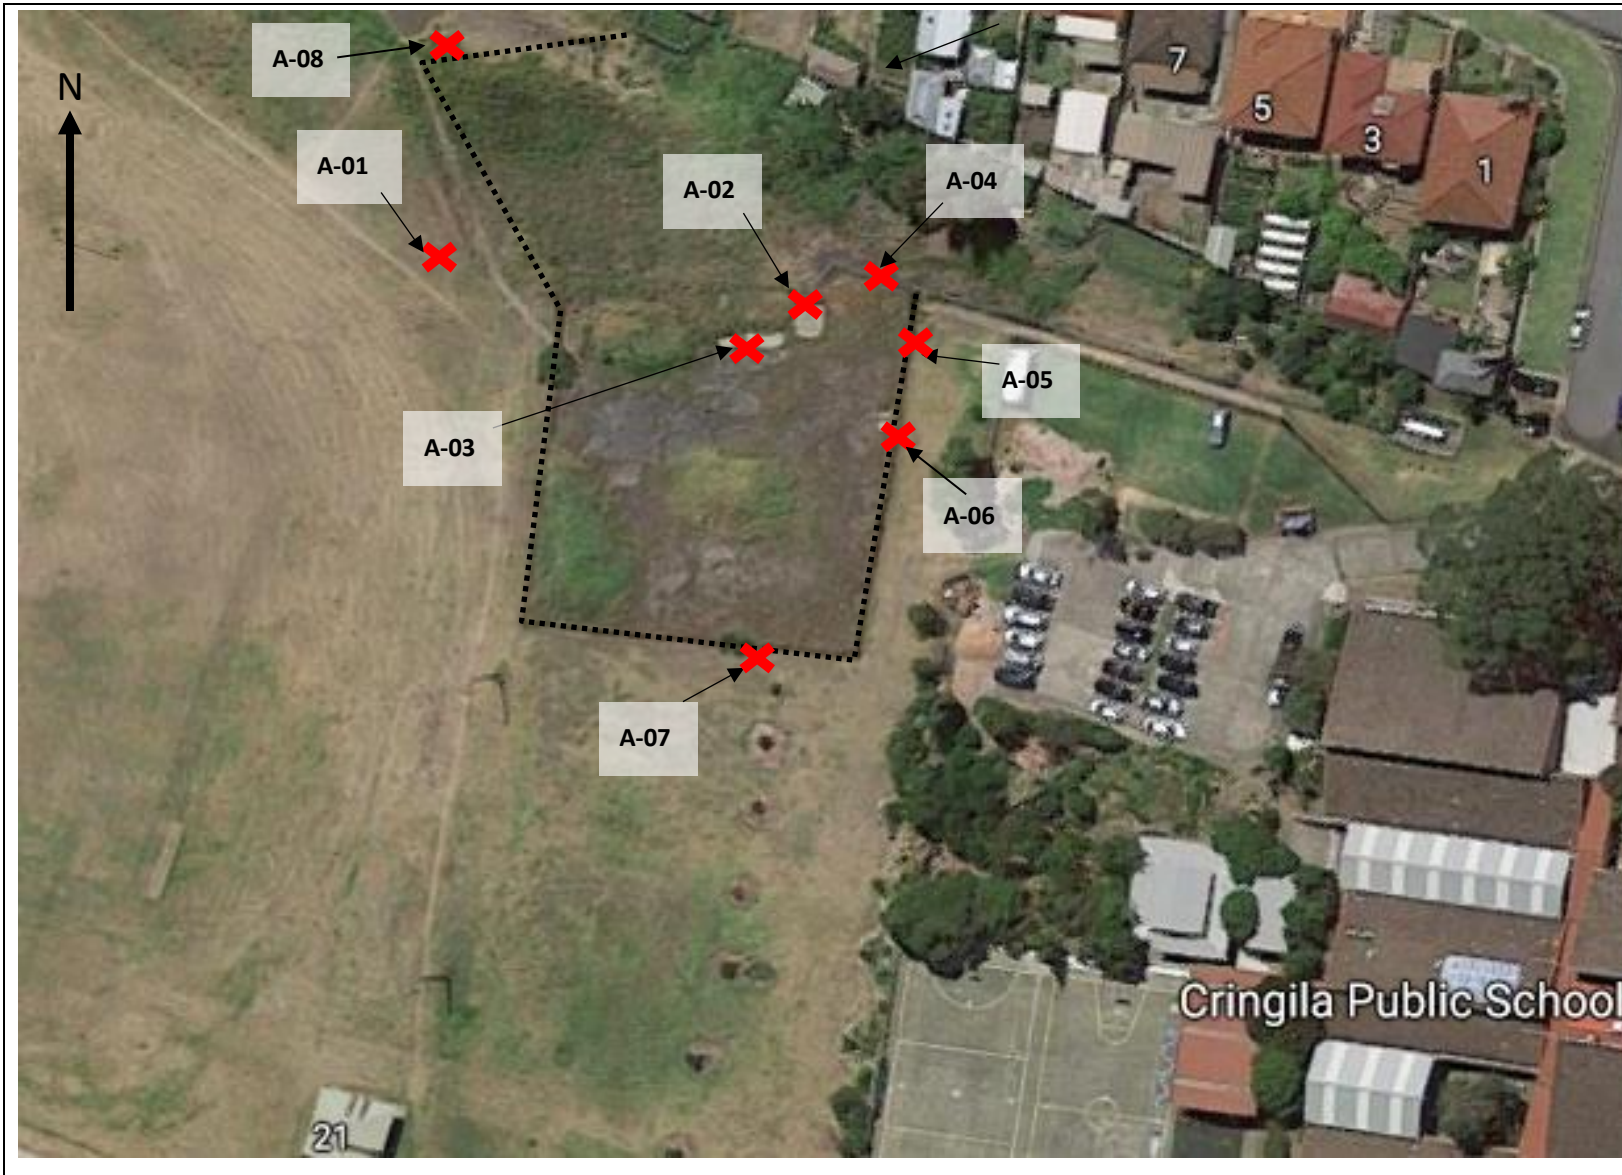
Appendix A: Site Map and Sampling Locations

- A-01 General Background
- A-02 NW Hotspot – Concrete Cap Surface
- A-03 NW Hotspot – Small Mound
- A-04 NW Hotspot – NE fence line
- A-05 Exclusion Area Fence Line East of Hotspot (Approx. 10m)
- A-06 Exclusion Area Fence Line Southeast of Hotspot (Approx. 15m)
- A-07 Exclusion Area Fence Line South of Hotspot (Approx. 30m)
- A-08 Exclusion Area Fence Line Northwest of Hotspot, adjacent 17 Lackawanna Street (Approx. 50m)

The atmospheric pollutant results for each monitoring event are summarised below in Table 3, and locations can be viewed in **Appendix A**.
