AIR MONITORING RISK ASSESSMENT  
CRINGILA PUBLIC SCHOOL  
35 SHEFFIELD STREET  
CRINGILA NSW 2502

Weekly Report  
19-10-2018

# Air Monitoring Risk Assessment - IAQ

Cringila Public School, 35 Sheffield Street, Cringila NSW 2502

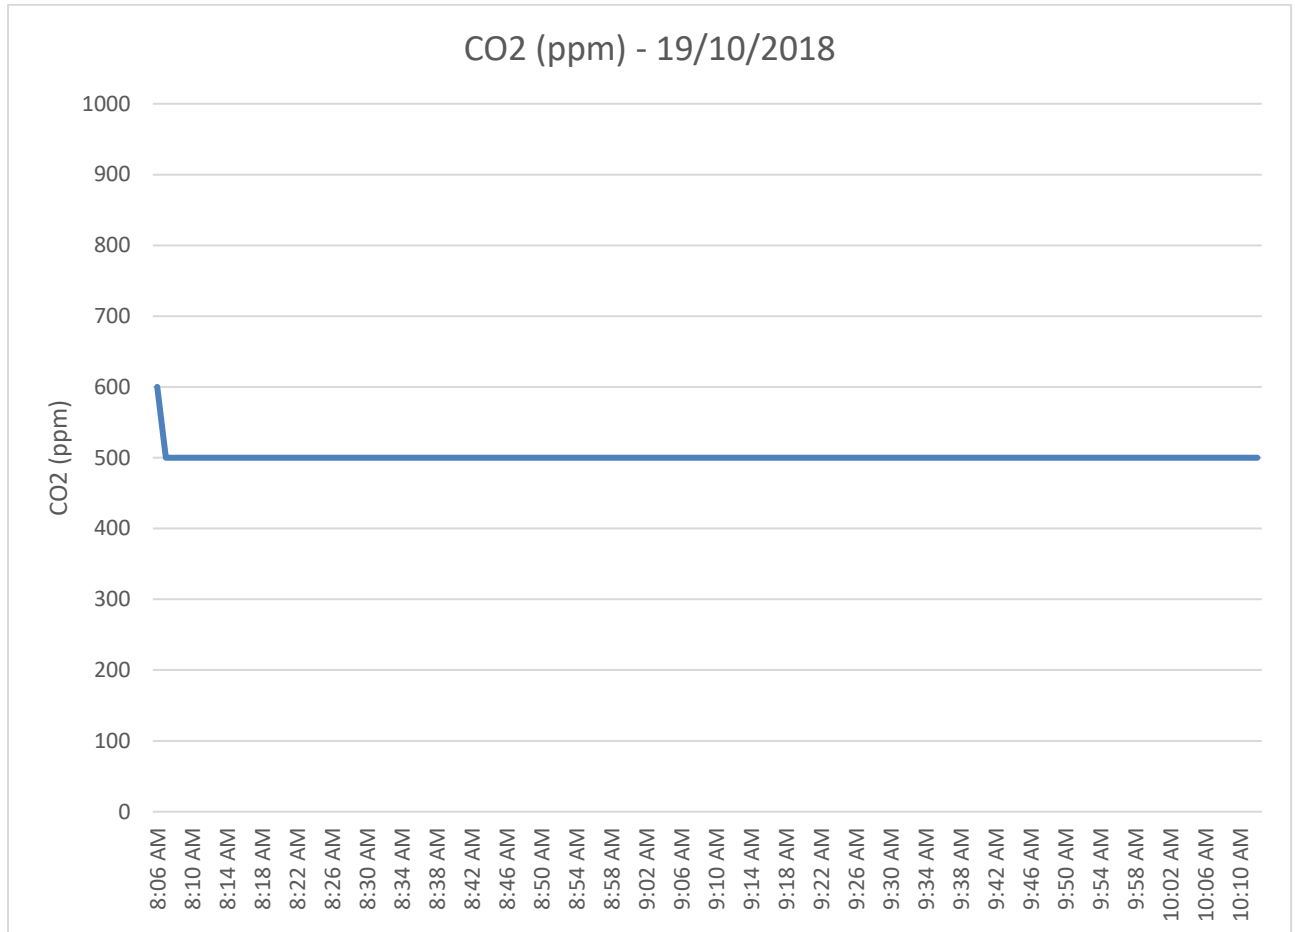
The CO<sub>2</sub> concentration results for the monitoring conducted on 19/10/2018 are summarised below in Figure 1. Monitoring locations are displayed in **Appendix A: Site Map and Sampling Locations**.

Generally, the monitoring results for CO<sub>2</sub> within the staffroom at Cringila Public School were between 500 ppm and 600 ppm during the monitoring. All results were below the ASHRAE guideline level of 1,000 ppm.

This concludes the weekly indoor air quality monitoring report for monitoring conducted on the 19<sup>th</sup> of October 2018. It is recommended that interim assessments are continued in order to gain firm and reliable data sets regarding the concentration of CO<sub>2</sub> within indoor environments at the school whilst further investigation of the site is undertaken.
