AIR MONITORING RISK ASSESSMENT
CRINGILA PUBLIC SCHOOL
35 SHEFFIELD STREET
CRINGILA NSW 2502

Weekly Report
23-10-2018

NSW Department
of Education

Air Monitoring Risk Assessment - IAQ

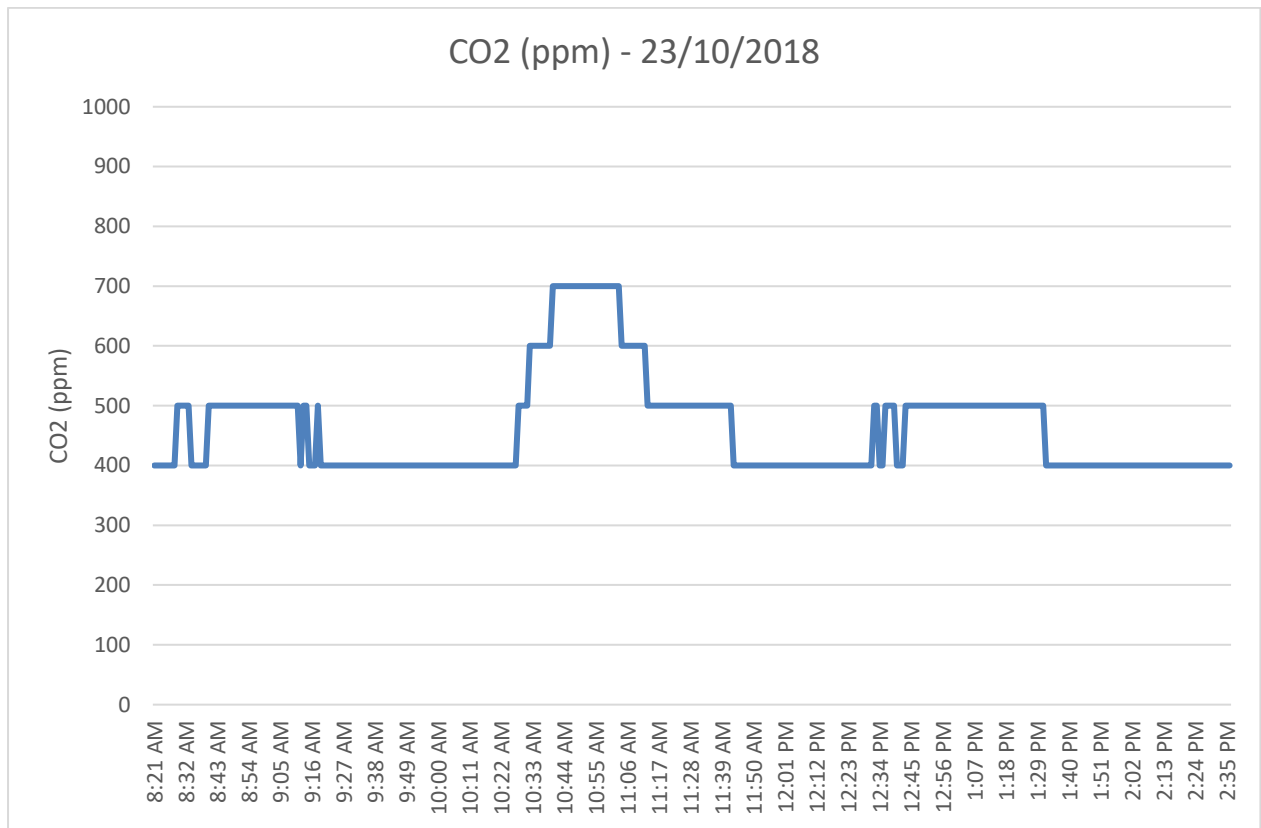
The CO₂ concentration results for the monitoring conducted on 23/10/2018 are summarised below in Figure 1. Monitoring locations are displayed in **Appendix A: Site Map and Sampling Locations**.

Generally, the monitoring results for CO₂ within the staffroom at Cringila Public School were between 400 ppm and 700 ppm during the monitoring. All results were below the ASHRAE guideline level of 1,000 ppm.

This concludes the weekly indoor air quality monitoring report for monitoring conducted on the 23rd of October 2018. It is recommended that interim assessments are continued in order to gain firm and reliable data sets regarding the concentration of CO₂ within indoor environments at the school whilst further investigation of the site is undertaken.
