AIR MONITORING RISK ASSESSMENT  
CRINGILA PUBLIC SCHOOL  
35 SHEFFIELD STREET  
CRINGILA NSW 2502

Weekly Report  
31-10-2018

# Air Monitoring Risk Assessment - IAQ

Cringila Public School, 35 Sheffield Street, Cringila NSW 2502

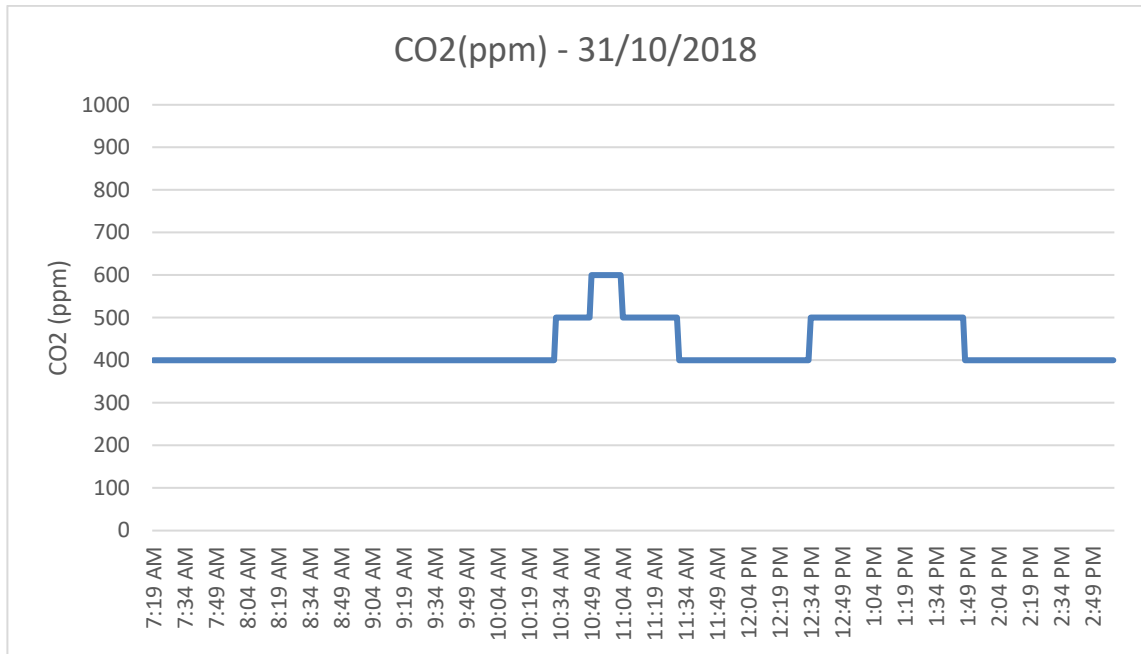
The CO<sub>2</sub> concentration results for the monitoring conducted on 31/10/2018 are summarised below in Figure 1. Monitoring locations are displayed in **Appendix A: Site Map and Sampling Locations**.

Generally, the monitoring results for CO<sub>2</sub> within the staffroom at Cringila Public School were between 400 ppm and 600 ppm during the monitoring. All results were below the ASHRAE guideline level of 1,000 ppm.

This concludes the weekly indoor air quality monitoring report for monitoring conducted on the 31<sup>st</sup> October 2018. It is recommended that interim assessments are continued in order to gain firm and reliable data sets regarding the concentration of CO<sub>2</sub> within indoor environments at the school whilst further investigation of the site is undertaken.

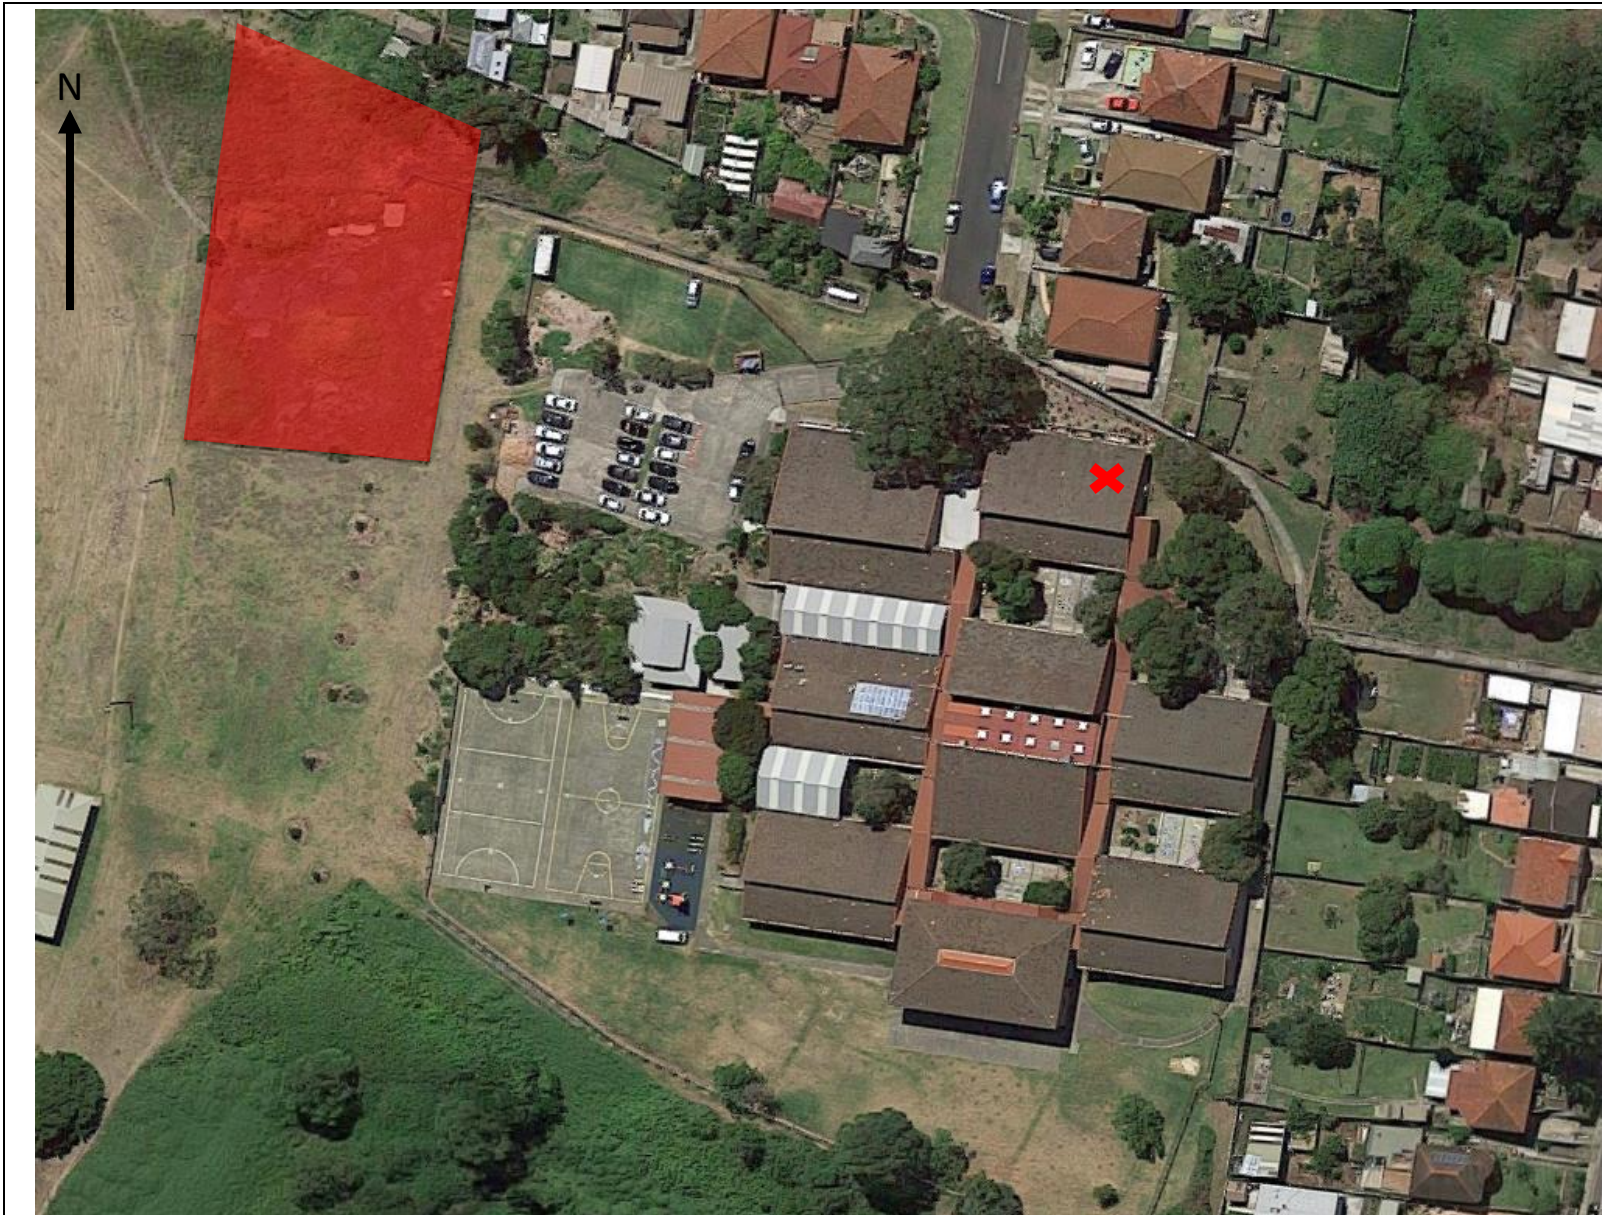
### **Appendix A: Site Map and Sampling Locations**

- ✕ Air monitor location
- North West Hotspot Investigation Area

Site	Cringila Public School
Area	Staffroom (Building B007)
Consultant	Rowan Clark/Tom Oyston
Date	Wednesday, 31 October 2018
Job Number	J153825
Report	AMR-IAQ-04
Version	1.0
