AIR MONITORING RISK ASSESSMENT  
CRINGILA PUBLIC SCHOOL  
35 SHEFFIELD STREET  
CRINGILA NSW 2502

Weekly Report  
06-11-2018

# Air Monitoring Risk Assessment - IAQ

Cringila Public School, 35 Sheffield Street, Cringila NSW 2502

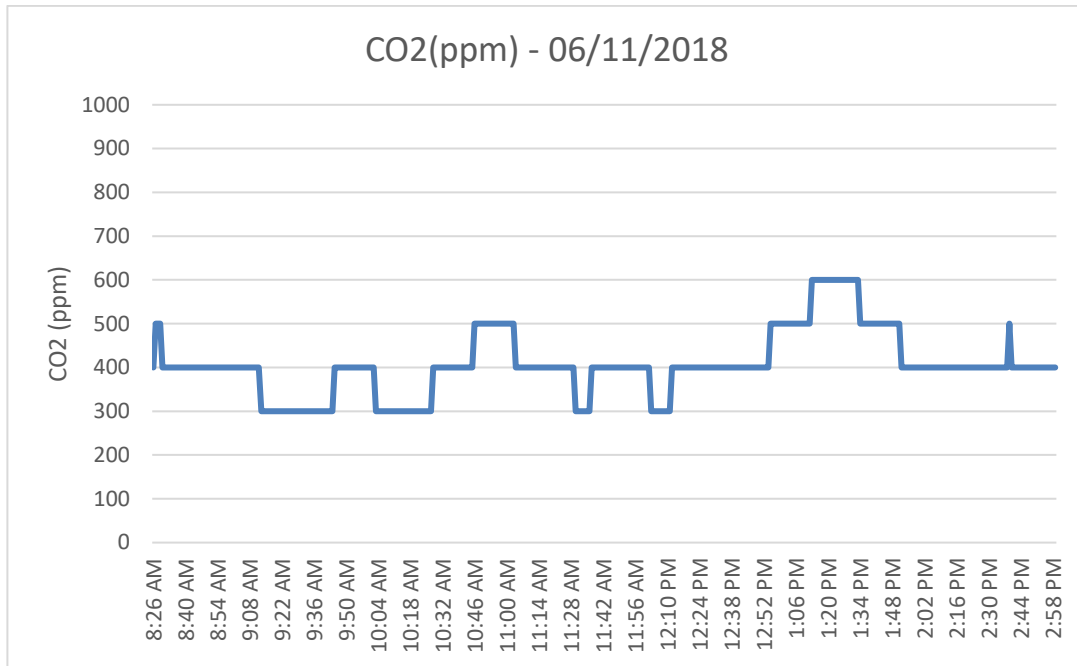
The CO<sub>2</sub> concentration results for the monitoring conducted on 06/11/2018 are summarised below in Figure 1. Monitoring locations are displayed in **Appendix A: Site Map and Sampling Locations**.

Generally, the monitoring results for CO<sub>2</sub> within the staffroom at Cringila Public School were between 300 ppm and 600 ppm during the monitoring. All results were below the ASHRAE guideline level of 1,000 ppm.

This concludes the weekly indoor air quality monitoring report for monitoring conducted on the 6<sup>th</sup> November 2018. It is recommended that interim assessments are continued in order to gain firm and reliable data sets regarding the concentration of CO<sub>2</sub> within indoor environments at the school whilst further investigation of the site is undertaken.
