AIR MONITORING RISK ASSESSMENT
CRINGILA PUBLIC SCHOOL
35 SHEFFIELD STREET
CRINGILA NSW 2502

Weekly Report
14-11-2018

NSW Department
of Education

Cringila Public School

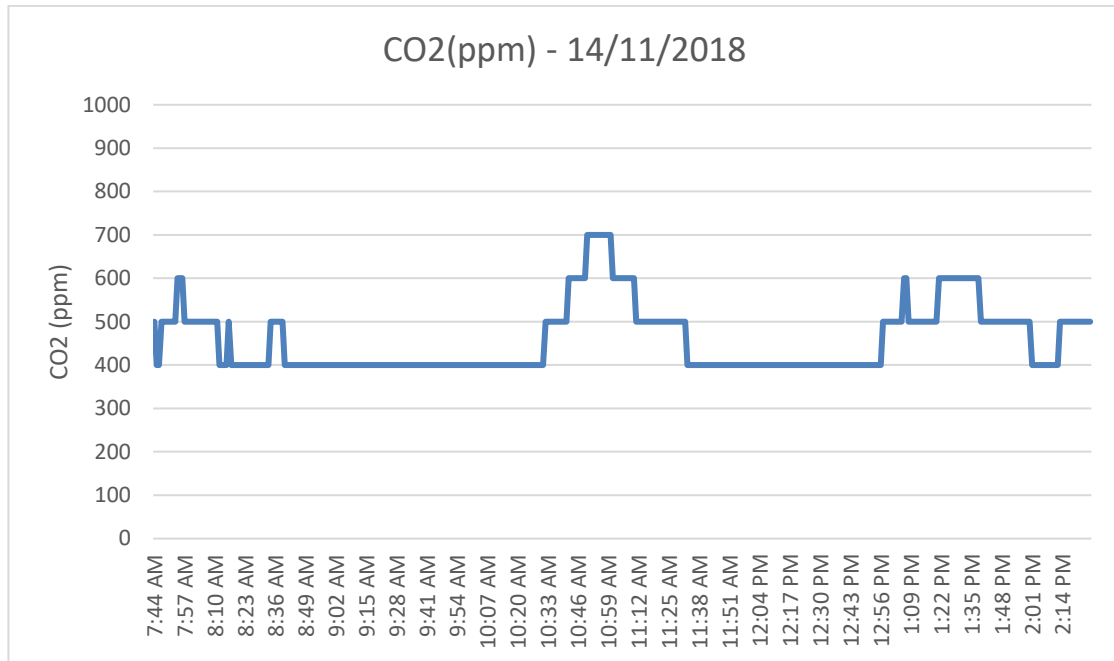
The CO₂ concentration results for the monitoring conducted on 14/11/2018 are summarised below in Figure 1. Monitoring locations are displayed in **Appendix A: Site Map and Sampling Locations**.

Generally, the monitoring results for CO₂ within the staffroom at Cringila Public School were between 400 ppm and 700 ppm during the monitoring. All results were below the ASHRAE guideline level of 1,000 ppm.

This concludes the weekly indoor air quality monitoring report for monitoring conducted on the 14th November 2018. It is recommended that interim assessments are continued in order to gain firm and reliable data sets regarding the concentration of CO₂ within indoor environments at the school whilst further investigation of the site is undertaken.

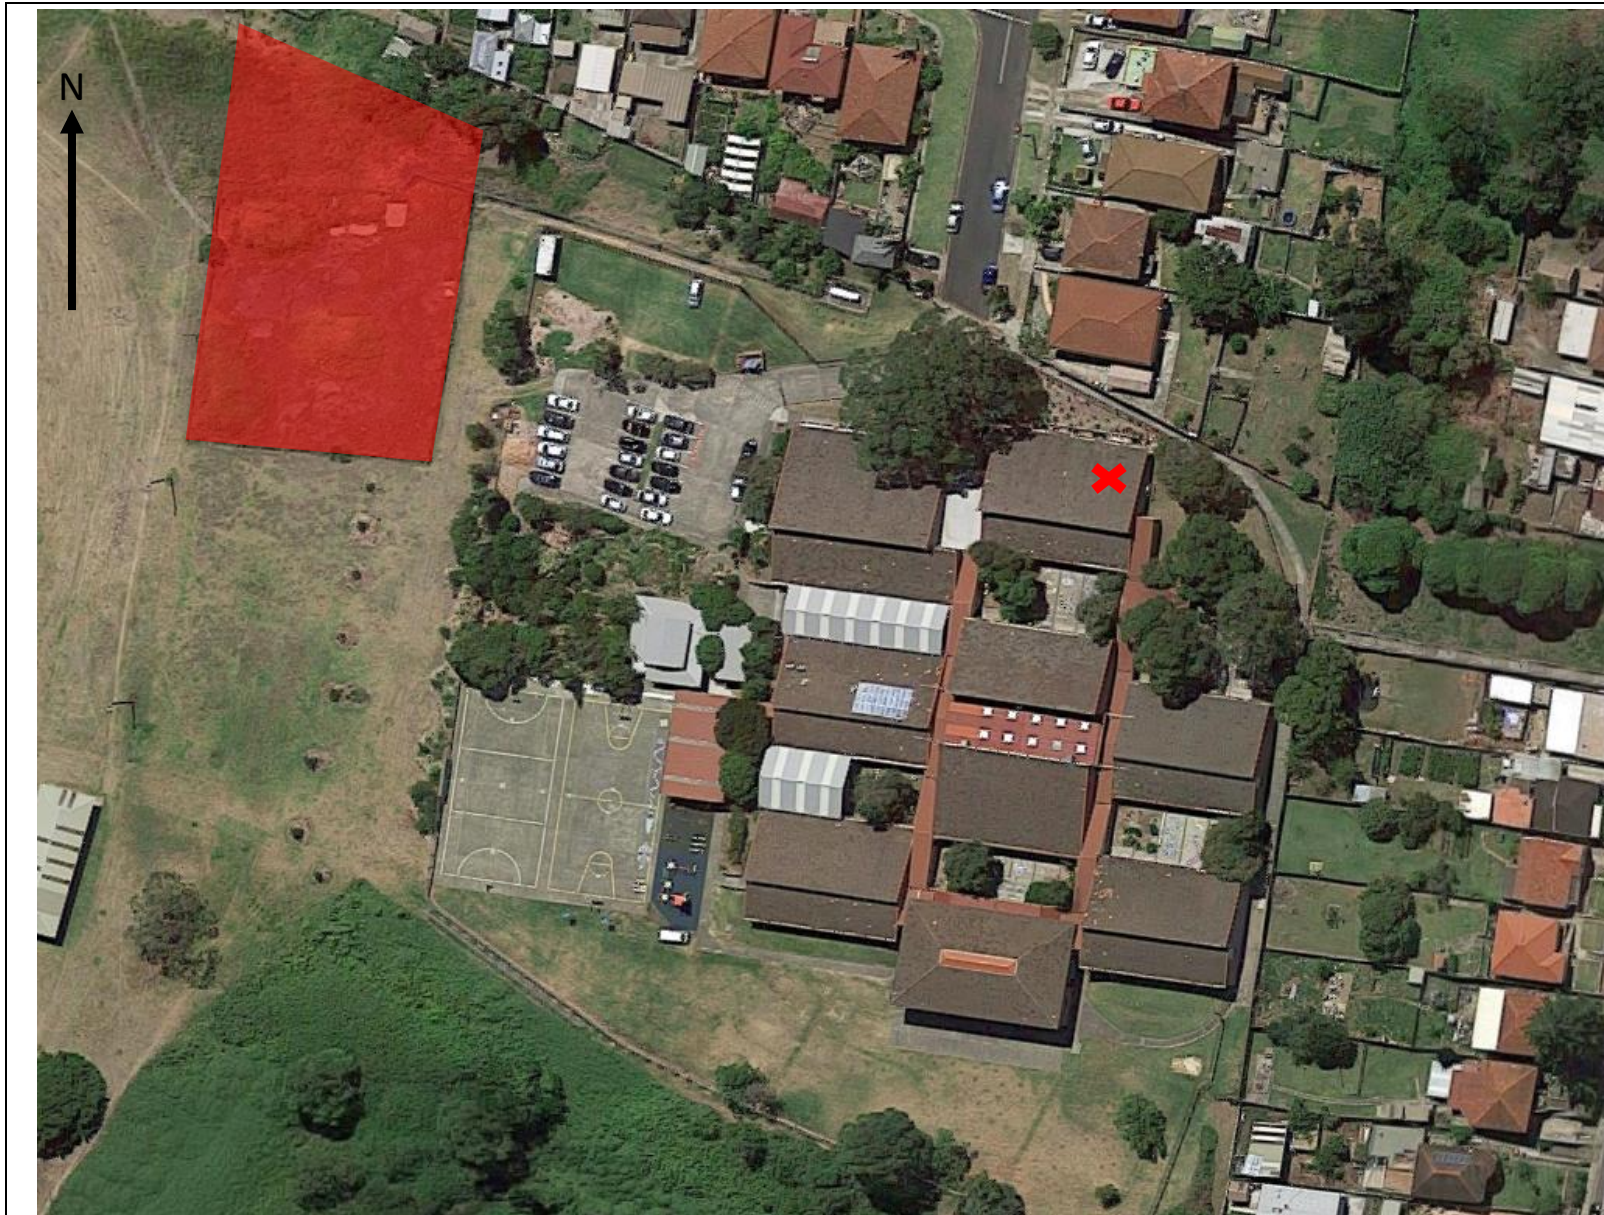
Appendix A: Site Map and Sampling Locations

- ✕ Air monitor location
- North West Hotspot Investigation Area

Site	Cringila Public School
Area	Staffroom (Building B007)
Consultant	Rowan Clark/Tom Oyston
Date	Wednesday, 14 November 2018
Job Number	J153825
Report	AMR-IAQ-05
Version	1.0
