NEAR SURFACE TEMPERATURE MONITORING CRINGILA PUBLIC SCHOOL - NW HOTSPOT

Weekly Summary Report
30/04/2018 – 04/05/2018

Cringila Public School

C107826: J153825: RC

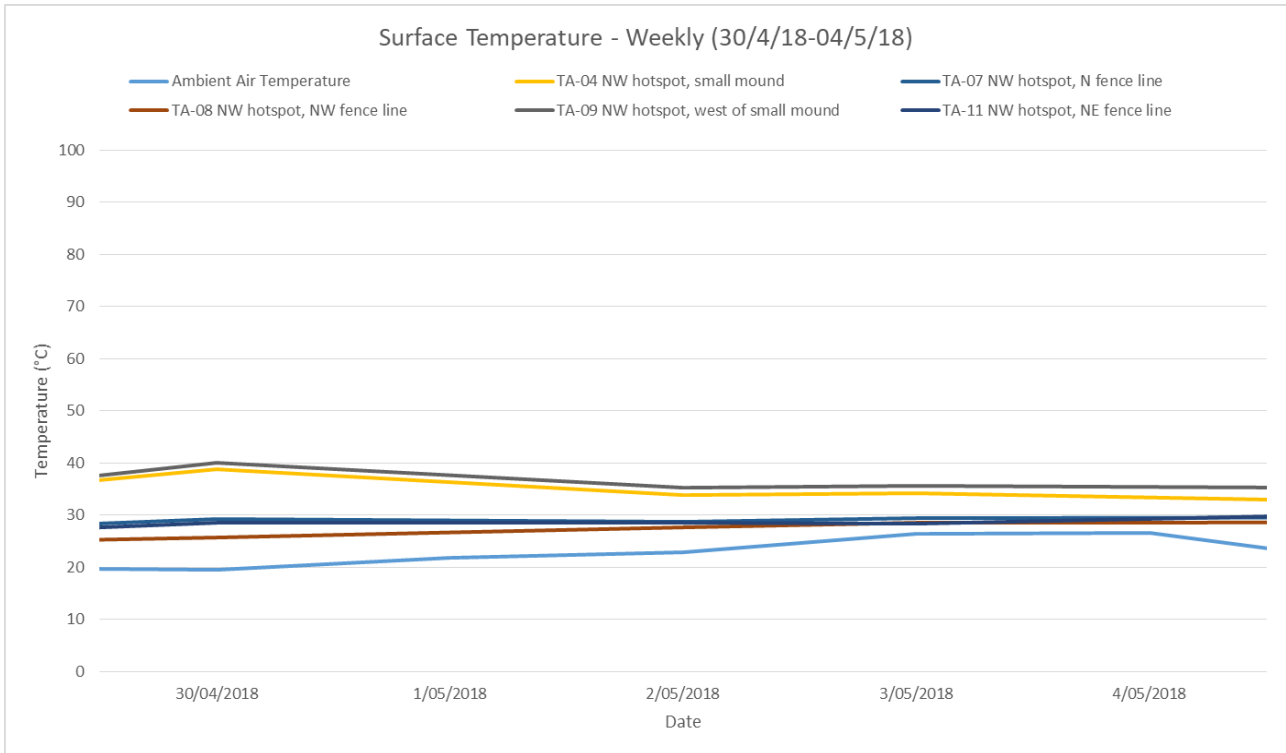
3.2. Surface Temperature Graph – Selected Points (Weekly)

Surface temperature measurements for key locations, over monitoring week - 30/4/2018 to 04/5/2018.

The surface temperature at selected points across the northwest hotspot over the week of monitoring – 30/4/2018 to 04/5/2018, appear to remain consistent.

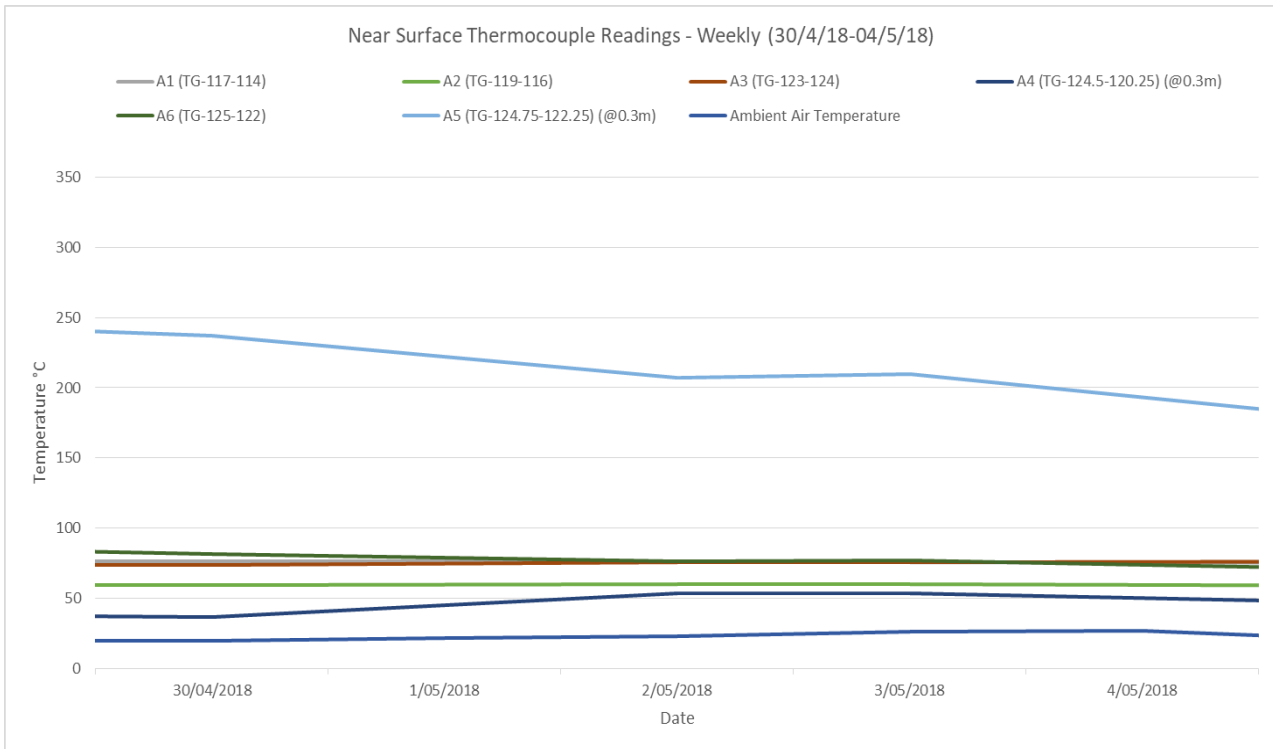
3.4. Near Surface Temperature Graph – Selected Points (Weekly)

Near surface temperature measurements for key thermocouple locations, over monitoring week - 30/4/2018 to 04/5/2018.

The near surface temperature at selected points across the northwest hotspot over the week of monitoring – 30/4/2018 to 04/5/2018, appear to remain consistent.

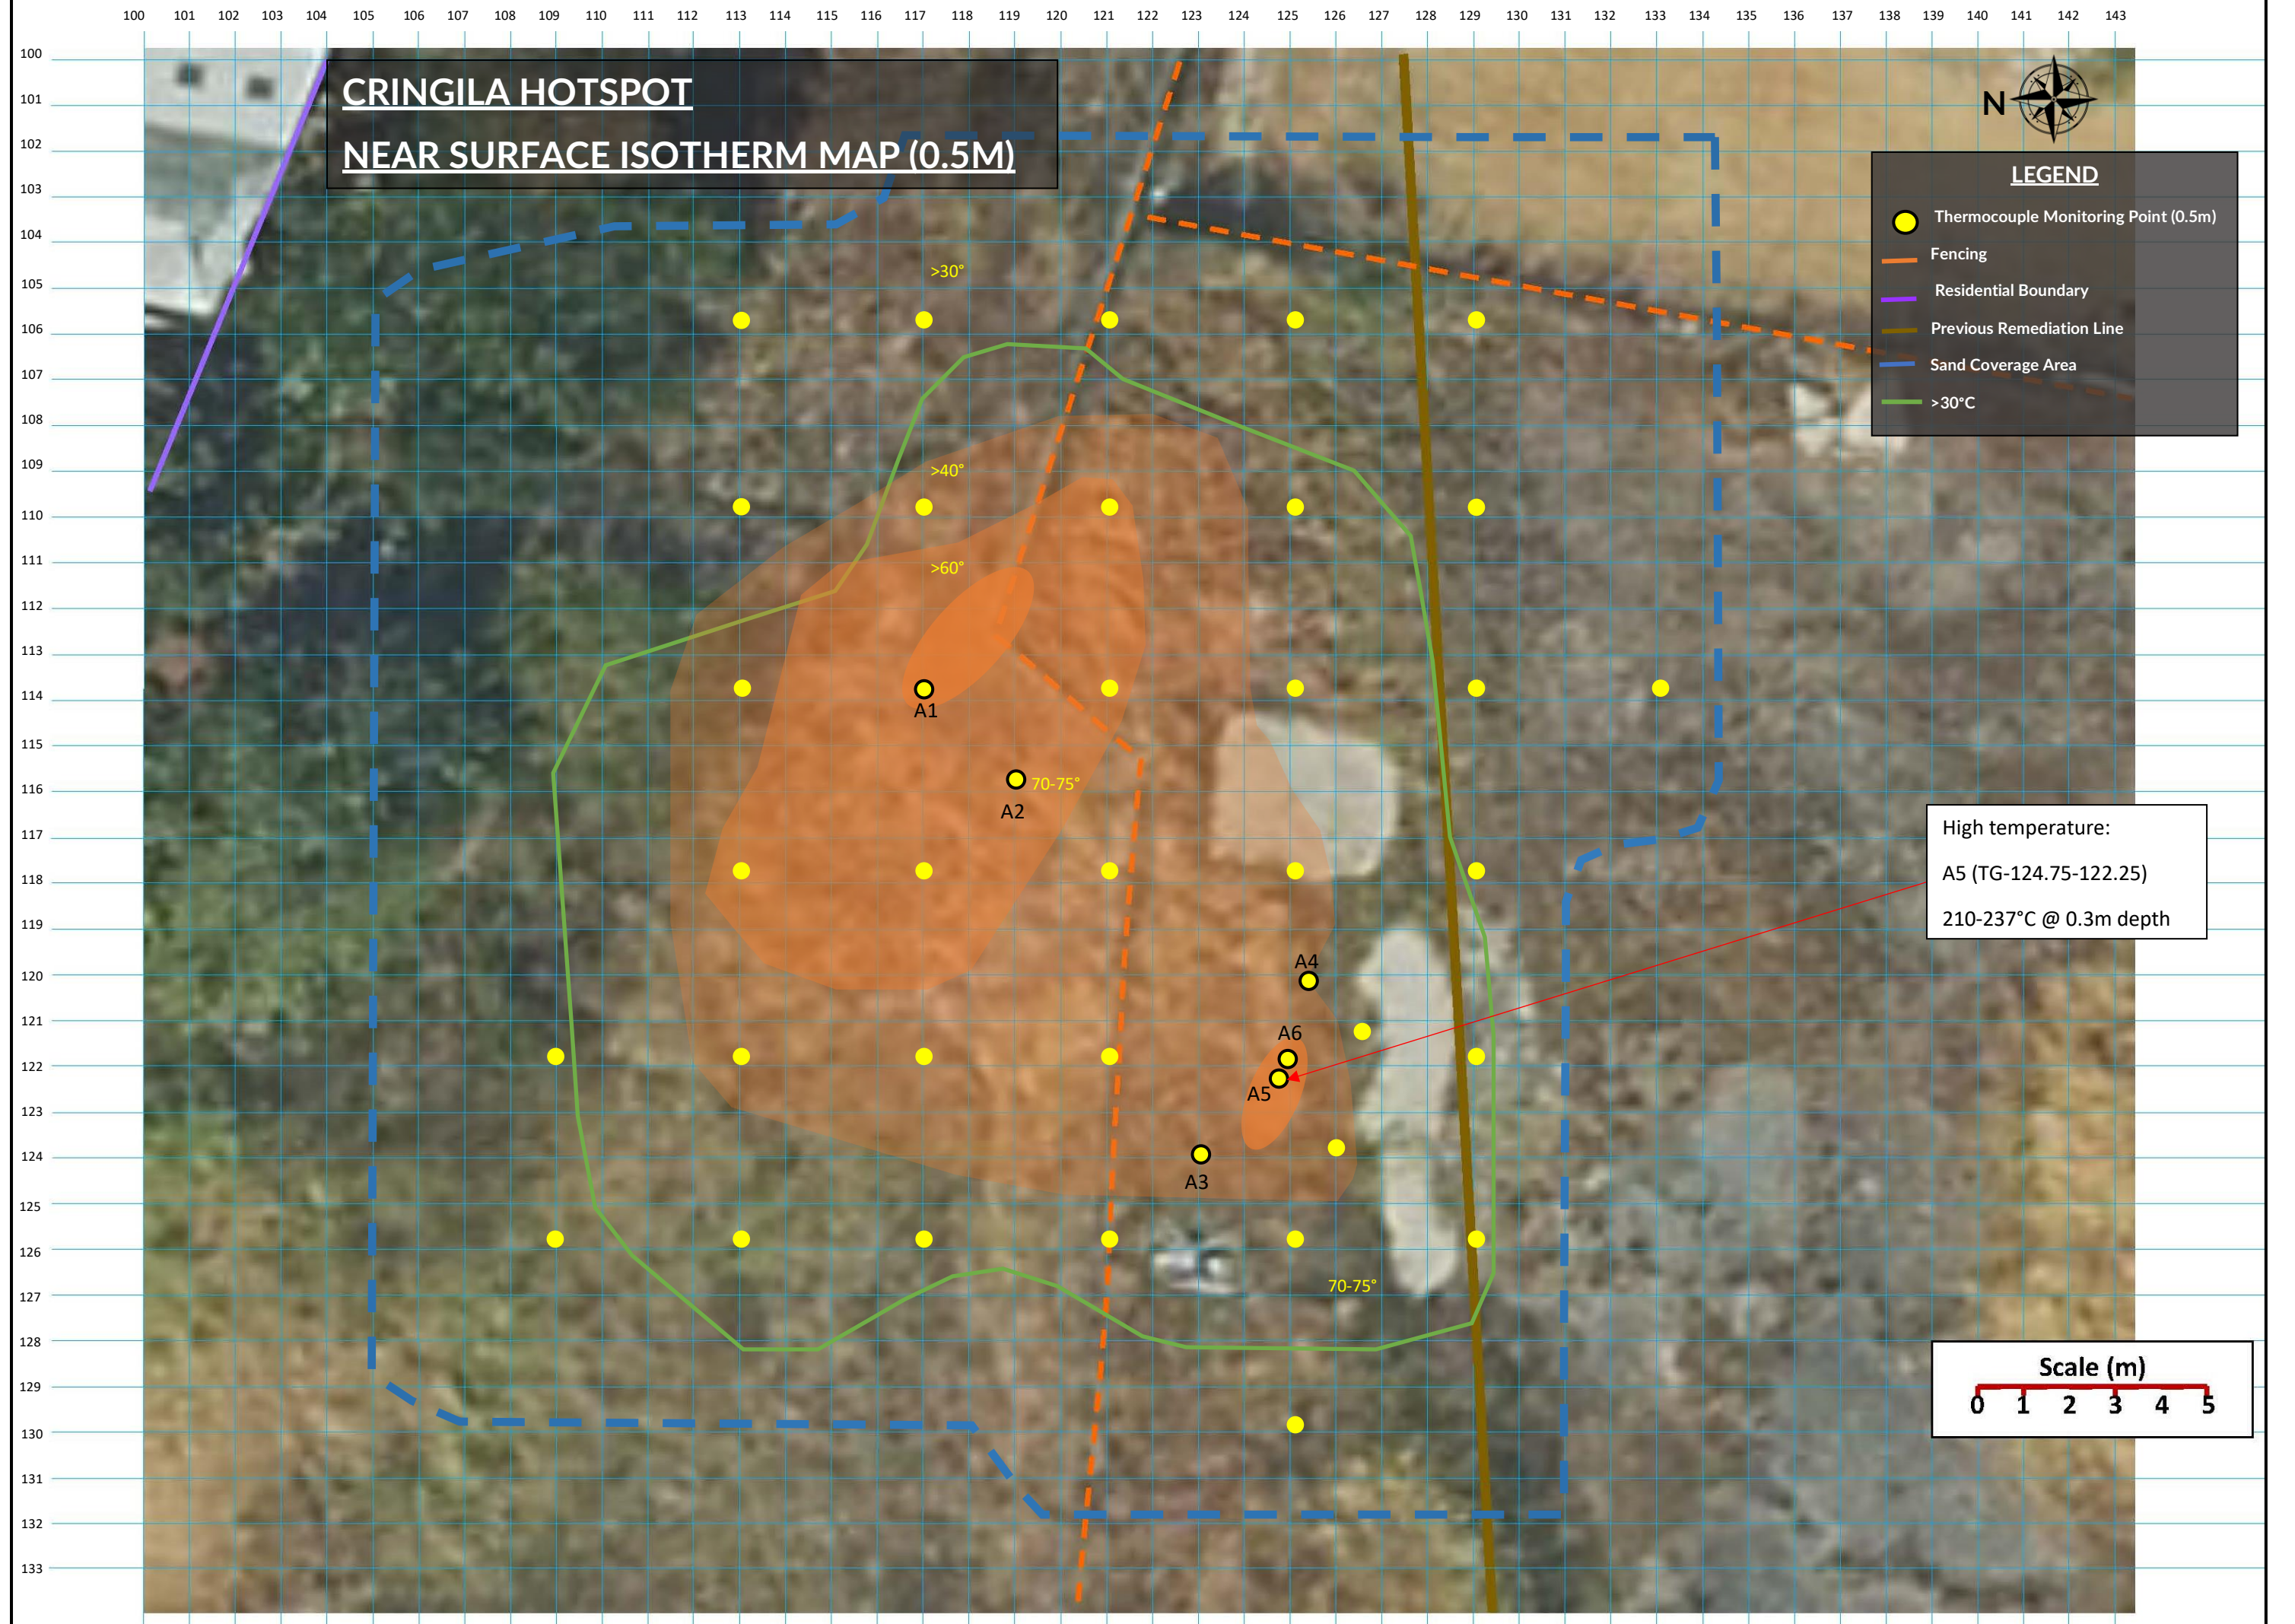
CRINGILA HOTSPOT NEAR SURFACE ISOTHERM MAP (0.5M)

The isotherm mapping indicates a maximum temperature of over 200°C beneath the small mound west of the concrete cap (monitoring point A6 at 0.3m depth) within the northwest hotspot. The isotherm map shows the general zone of influence for temperatures between 30°C and 75°C at 0.5m, coloured orange. The isotherm map suggests that the hotspot may extend deeper than 0.5m and that the increased temperature in these areas is a result of heat venting to the surface.

It is noted that temperature at the near-surface may be variable across the hotspot due to inconsistencies in the consolidation and compaction of subsurface materials.

High temperature:
A5 (TG-124.75-122.25)
210-237°C @ 0.3m depth

It is recommended that weekly site inspections and recording are continued to monitor the surface and near surface temperatures surrounding the hotspot identified at the site.
