## NEAR SURFACE TEMPERATURE MONITORING CRINGILA PUBLIC SCHOOL - NW HOTSPOT

Weekly Summary Report  
07/05/2018 – 11/05/2018

Cringila Public School

C107826: J153825: RC

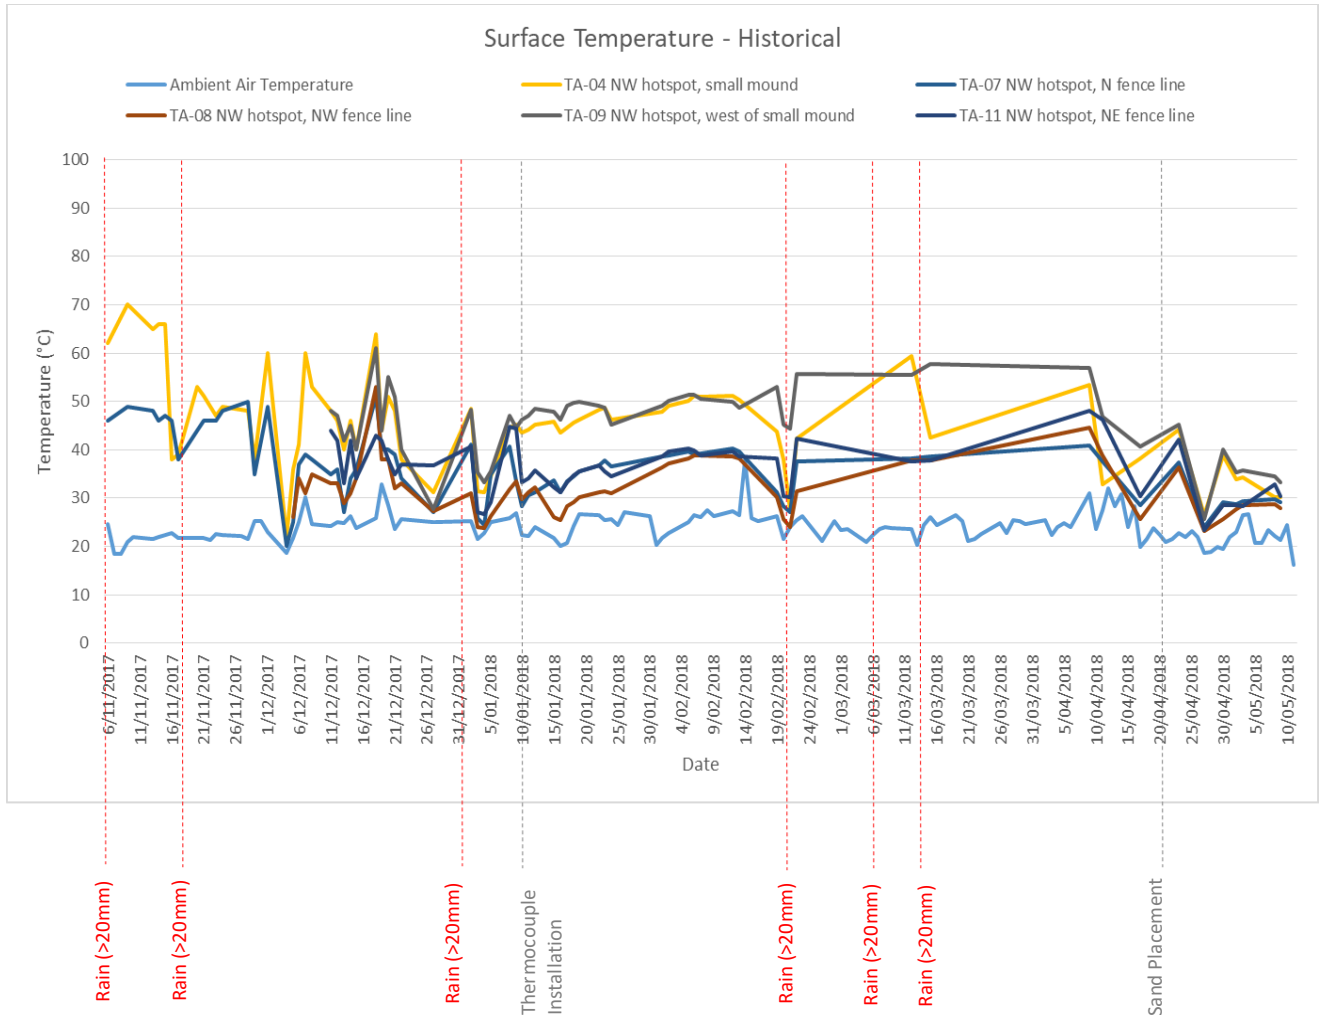
### 3.1. Surface Temperature Graph – Selected Points (Historical)

Surface temperature measurements for key locations, progressive from Monday 6<sup>th</sup> November 2017 to present.

The surface temperature appears to have decreased and stabilised following the placement of sand (approximately 100mm) across the surface of the northwest hotspot grid monitoring area.

Fluctuations in surface temperature are evident following significant rain events (i.e. over 20mm rain). Surface temperature also appears to correlate with the ambient air temperature.

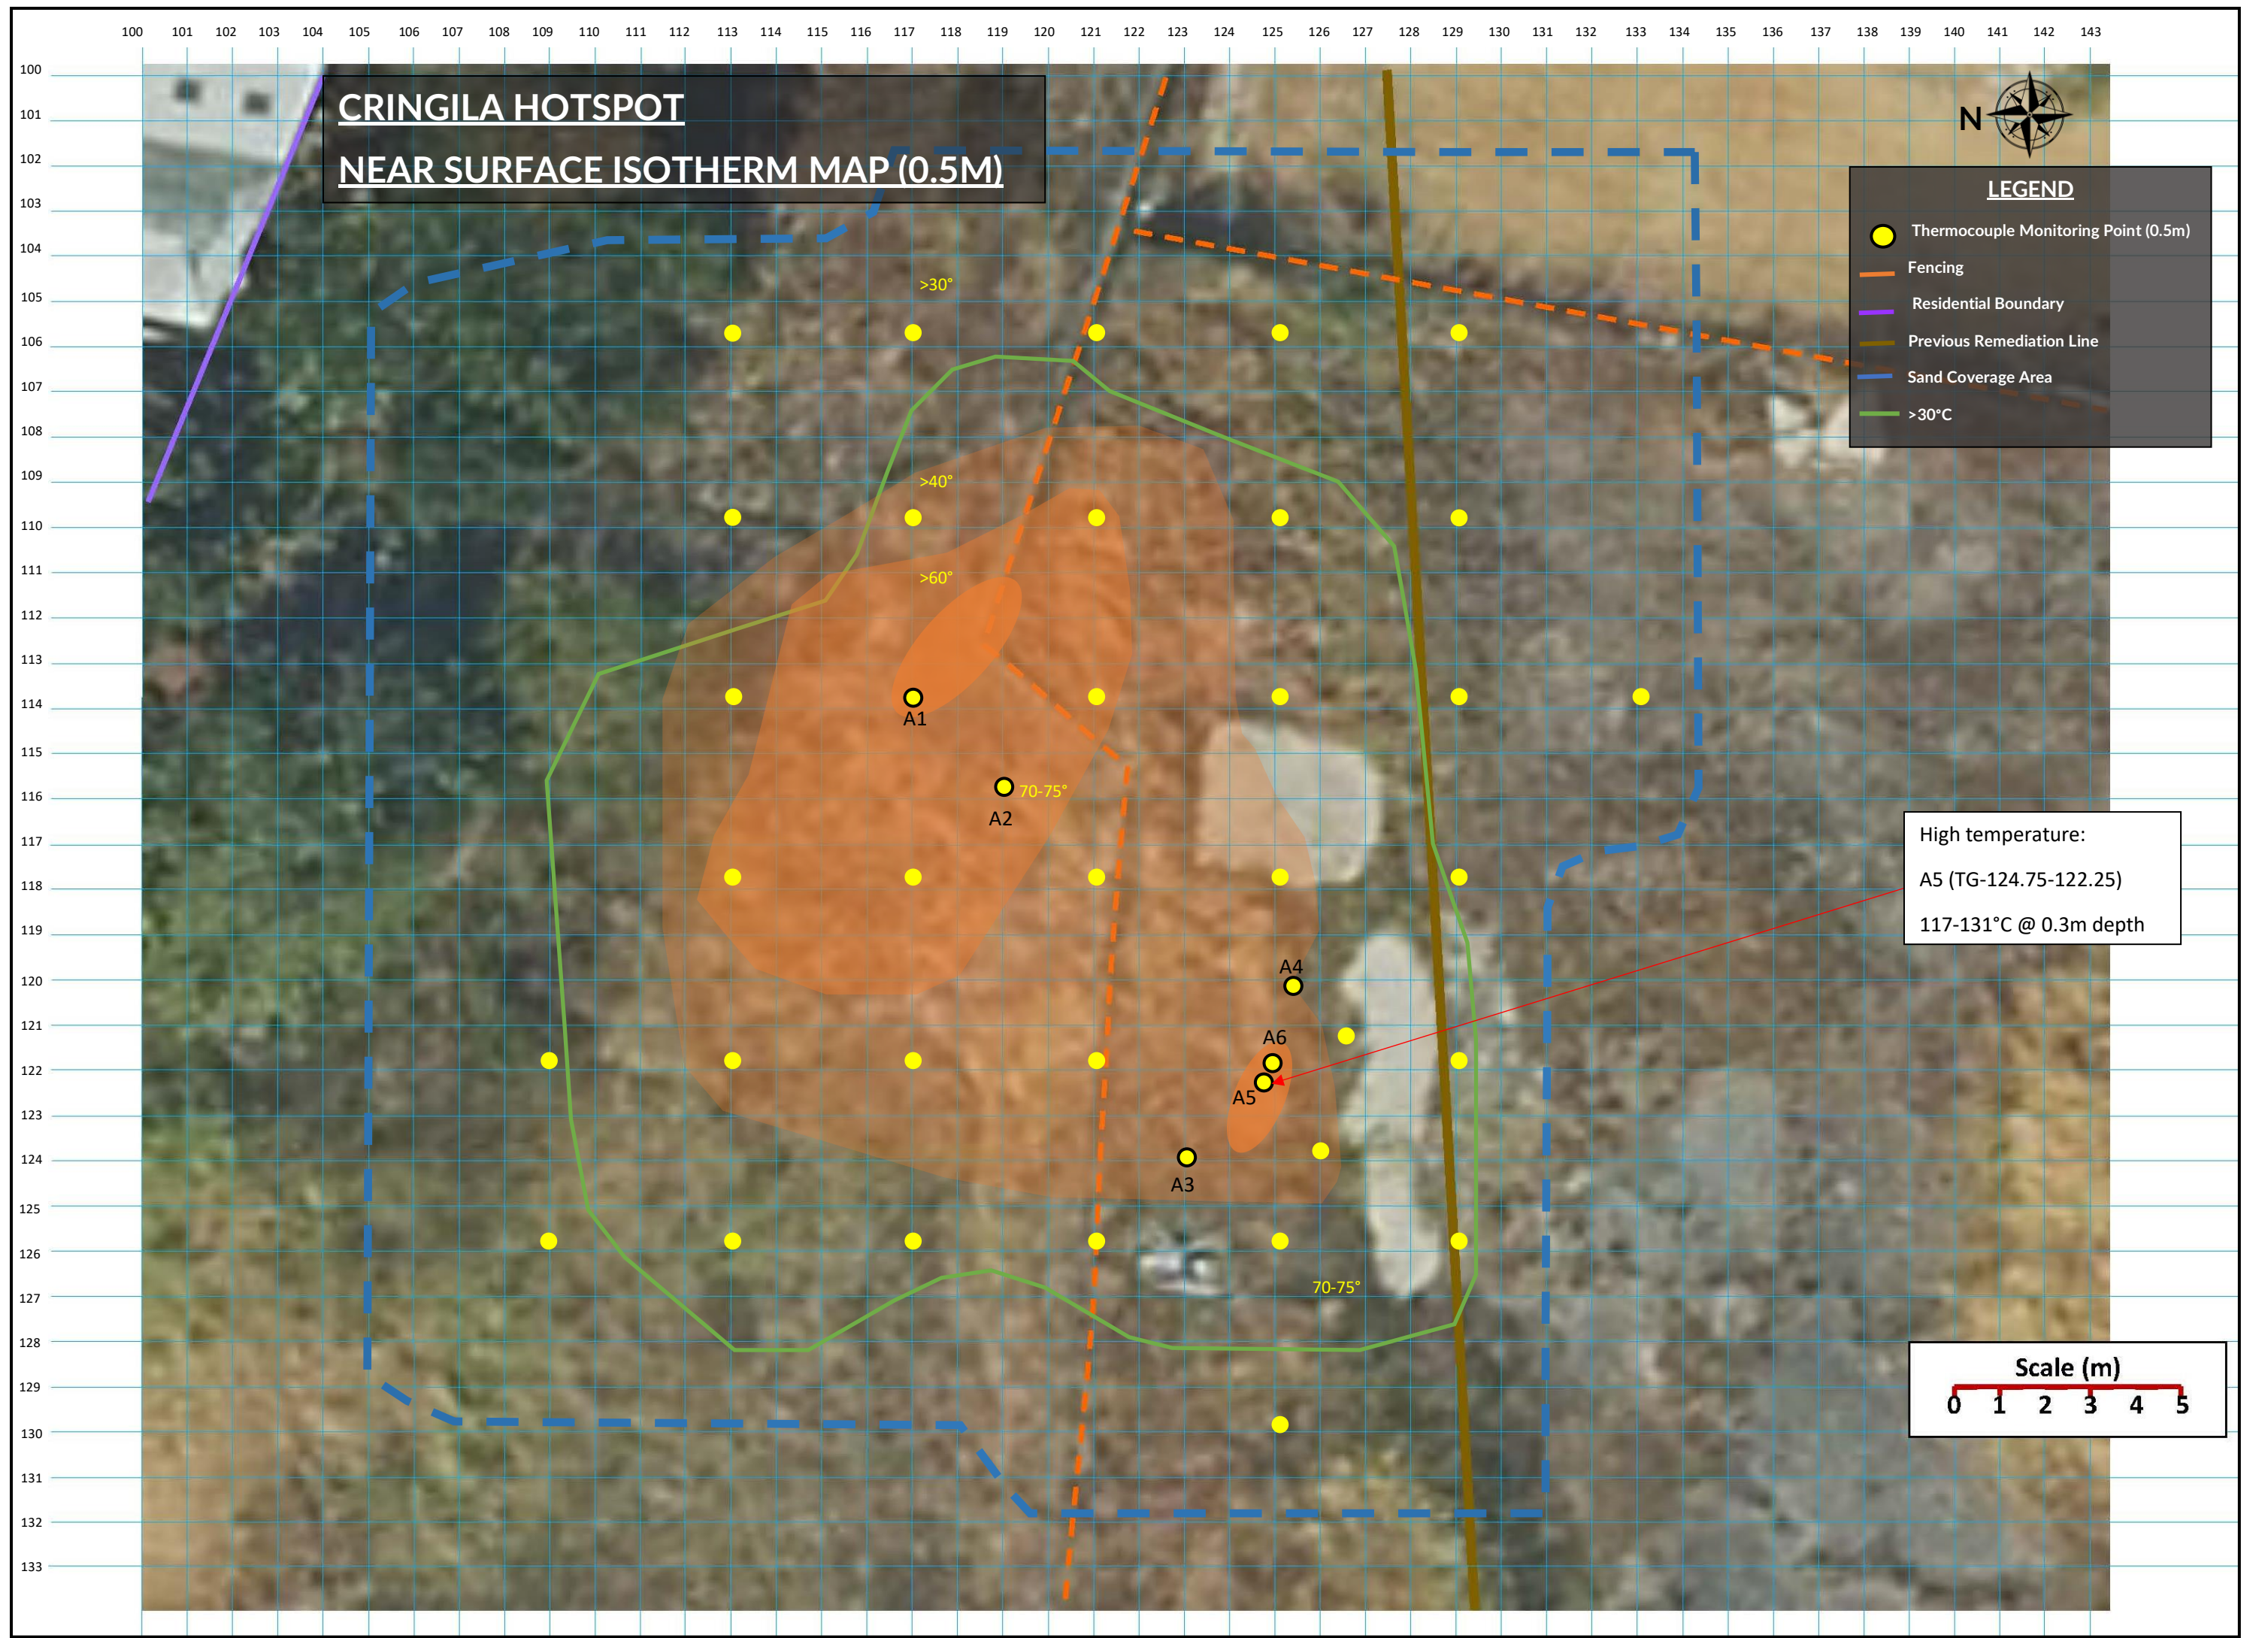
### Appendix C: Near Surface Temperature Isotherm Map (0.5m)

The isotherm mapping indicates a maximum temperature of over 100°C beneath the small mound west of the concrete cap (monitoring point A5 at 0.3m depth) within the northwest hotspot. The isotherm map shows the general zone of influence for temperatures between 30°C and 75°C at 0.5m, coloured orange. The isotherm map suggests that the hotspot may extend deeper than 0.5m and that the increased temperature in these areas is a result of heat venting to the surface.

It is noted that temperature at the near-surface may be variable across the hotspot due to inconsistencies in the consolidation and compaction of subsurface materials.

High temperature:  
A5 (TG-124.75-122.25)  
117-131°C @ 0.3m depth

It is recommended that weekly site inspections and recording are continued to monitor the surface and near surface temperatures surrounding the hotspot identified at the site.
