NEAR SURFACE TEMPERATURE MONITORING CRINGILA PUBLIC SCHOOL - NW HOTSPOT

Weekly Summary Report
14/05/2018 – 18/05/2018

Cringila Public School

35 Sheffield Street
Cringila NSW 2502

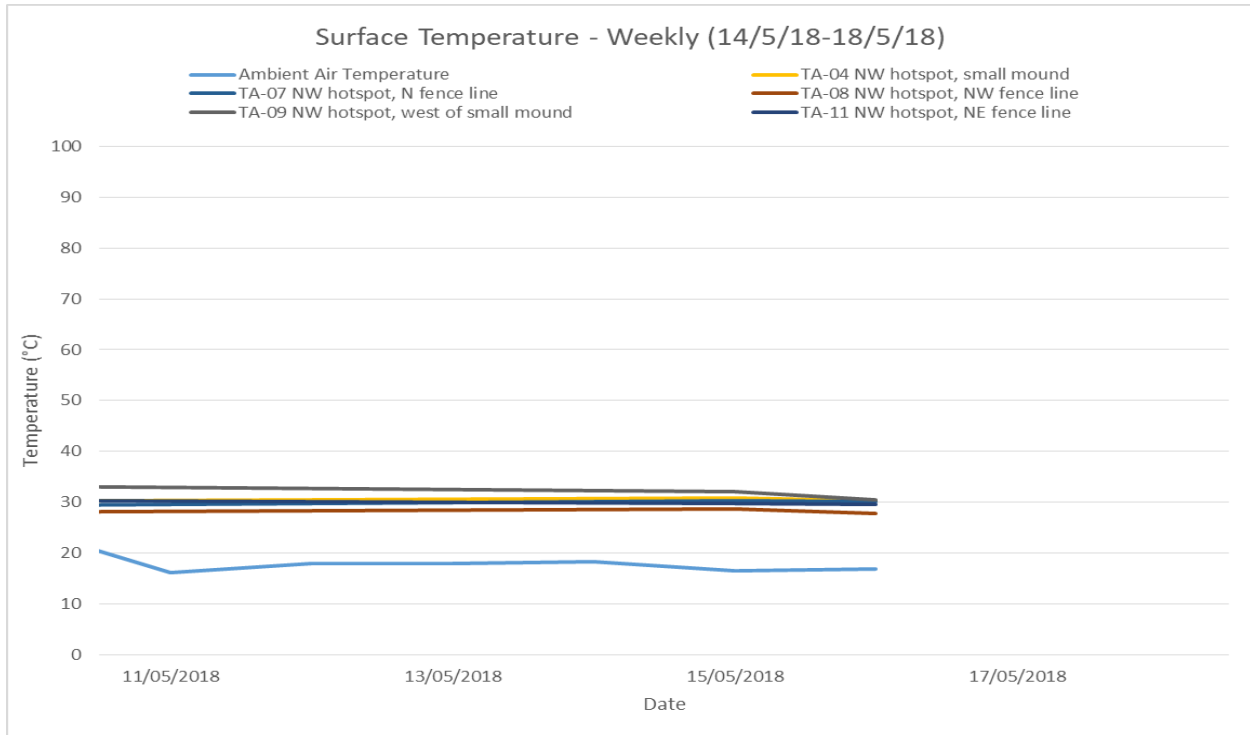
3.2. Surface Temperature Graph – Selected Points (Weekly)

Surface temperature measurements for key locations, over monitoring week – 14/5/2018 to 18/5/2018.

The surface temperature at selected points across the northwest hotspot over the week of monitoring – 14/5/2018 to 18/5/2018, appear to remain consistent.

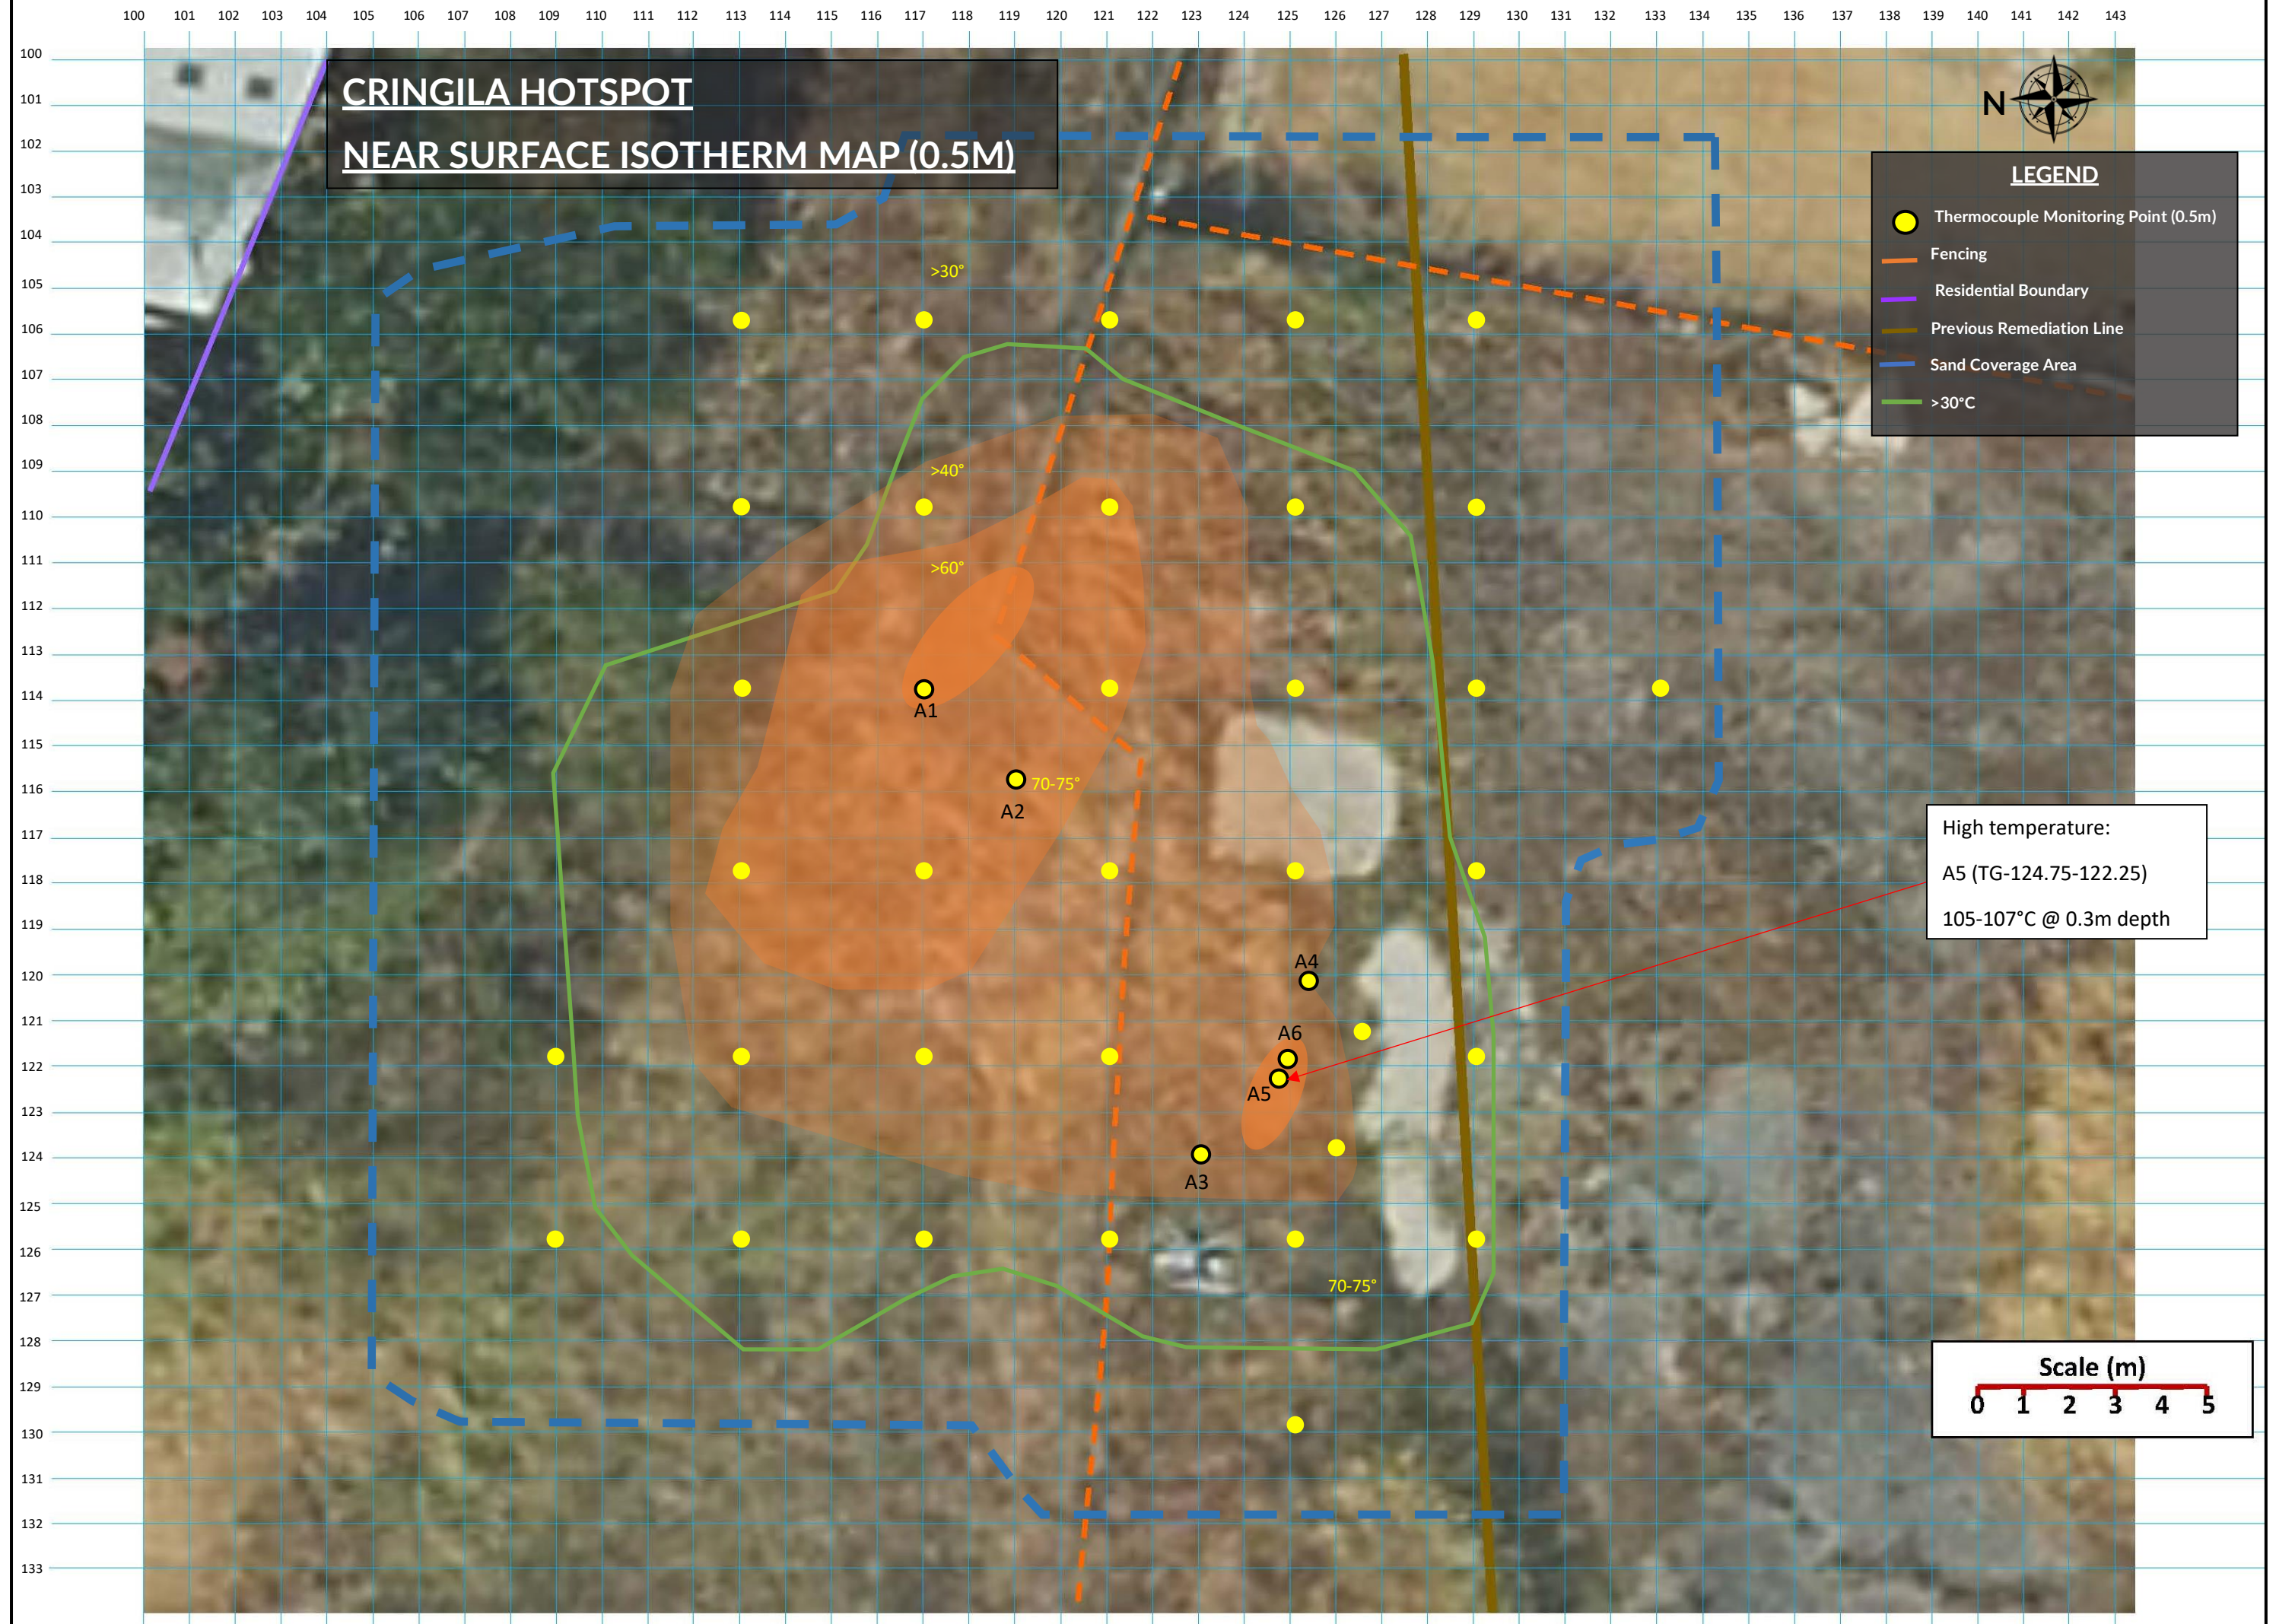
Appendix C: Near Surface Temperature Isotherm Map (0.5m)

The isotherm mapping indicates a maximum temperature of over 100°C beneath the small mound west of the concrete cap (monitoring point A5 at 0.3m depth) within the northwest hotspot. The isotherm map shows the general zone of influence for temperatures between 30°C and 75°C at 0.5m, coloured orange. The isotherm map suggests that the hotspot may extend deeper than 0.5m and that the increased temperature in these areas is a result of heat venting to the surface.

It is noted that temperature at the near-surface may be variable across the hotspot due to inconsistencies in the consolidation and compaction of subsurface materials.

CRINGILA HOTSPOT NEAR SURFACE ISOTHERM MAP (0.5M)

High temperature:
A5 (TG-124.75-122.25)
105-107°C @ 0.3m depth

It is recommended that weekly site inspections and recording are continued to monitor the surface and near surface temperatures surrounding the hotspot identified at the site.
