NEAR SURFACE TEMPERATURE MONITORING CRINGILA PUBLIC SCHOOL - NW HOTSPOT

Weekly Summary Report
21/05/2018 – 25/05/2018

Cringila Public School

C107826: J153825: RC

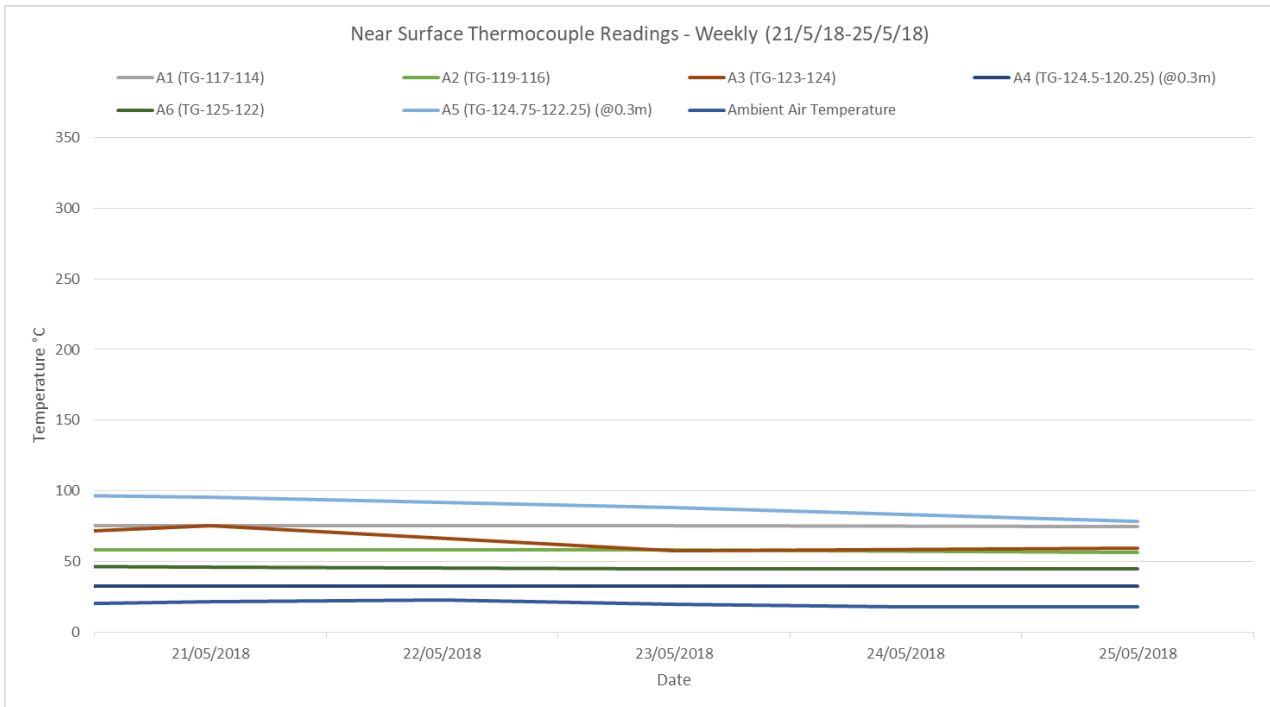
3.4. Near Surface Temperature Graph – Selected Points (Weekly)

Near surface temperature measurements for key thermocouple locations, over monitoring week – 21/5/2018 to 25/5/2018.

The near surface temperature at selected points across the northwest hotspot over the week of monitoring – 21/5/2018 to 25/5/2018, appear to remain consistent.

Generally, the near surface and surface temperatures appear to remain relatively consistent over the week period. Fluctuations in temperature were identified at monitoring point *TG-124.75-122.25* at 0.3m depth, which indicated a slight decrease in temperature during the week of monitoring.

It is recommended that weekly site inspections and recording are continued to monitor the surface and near surface temperatures surrounding the hotspot identified at the site.

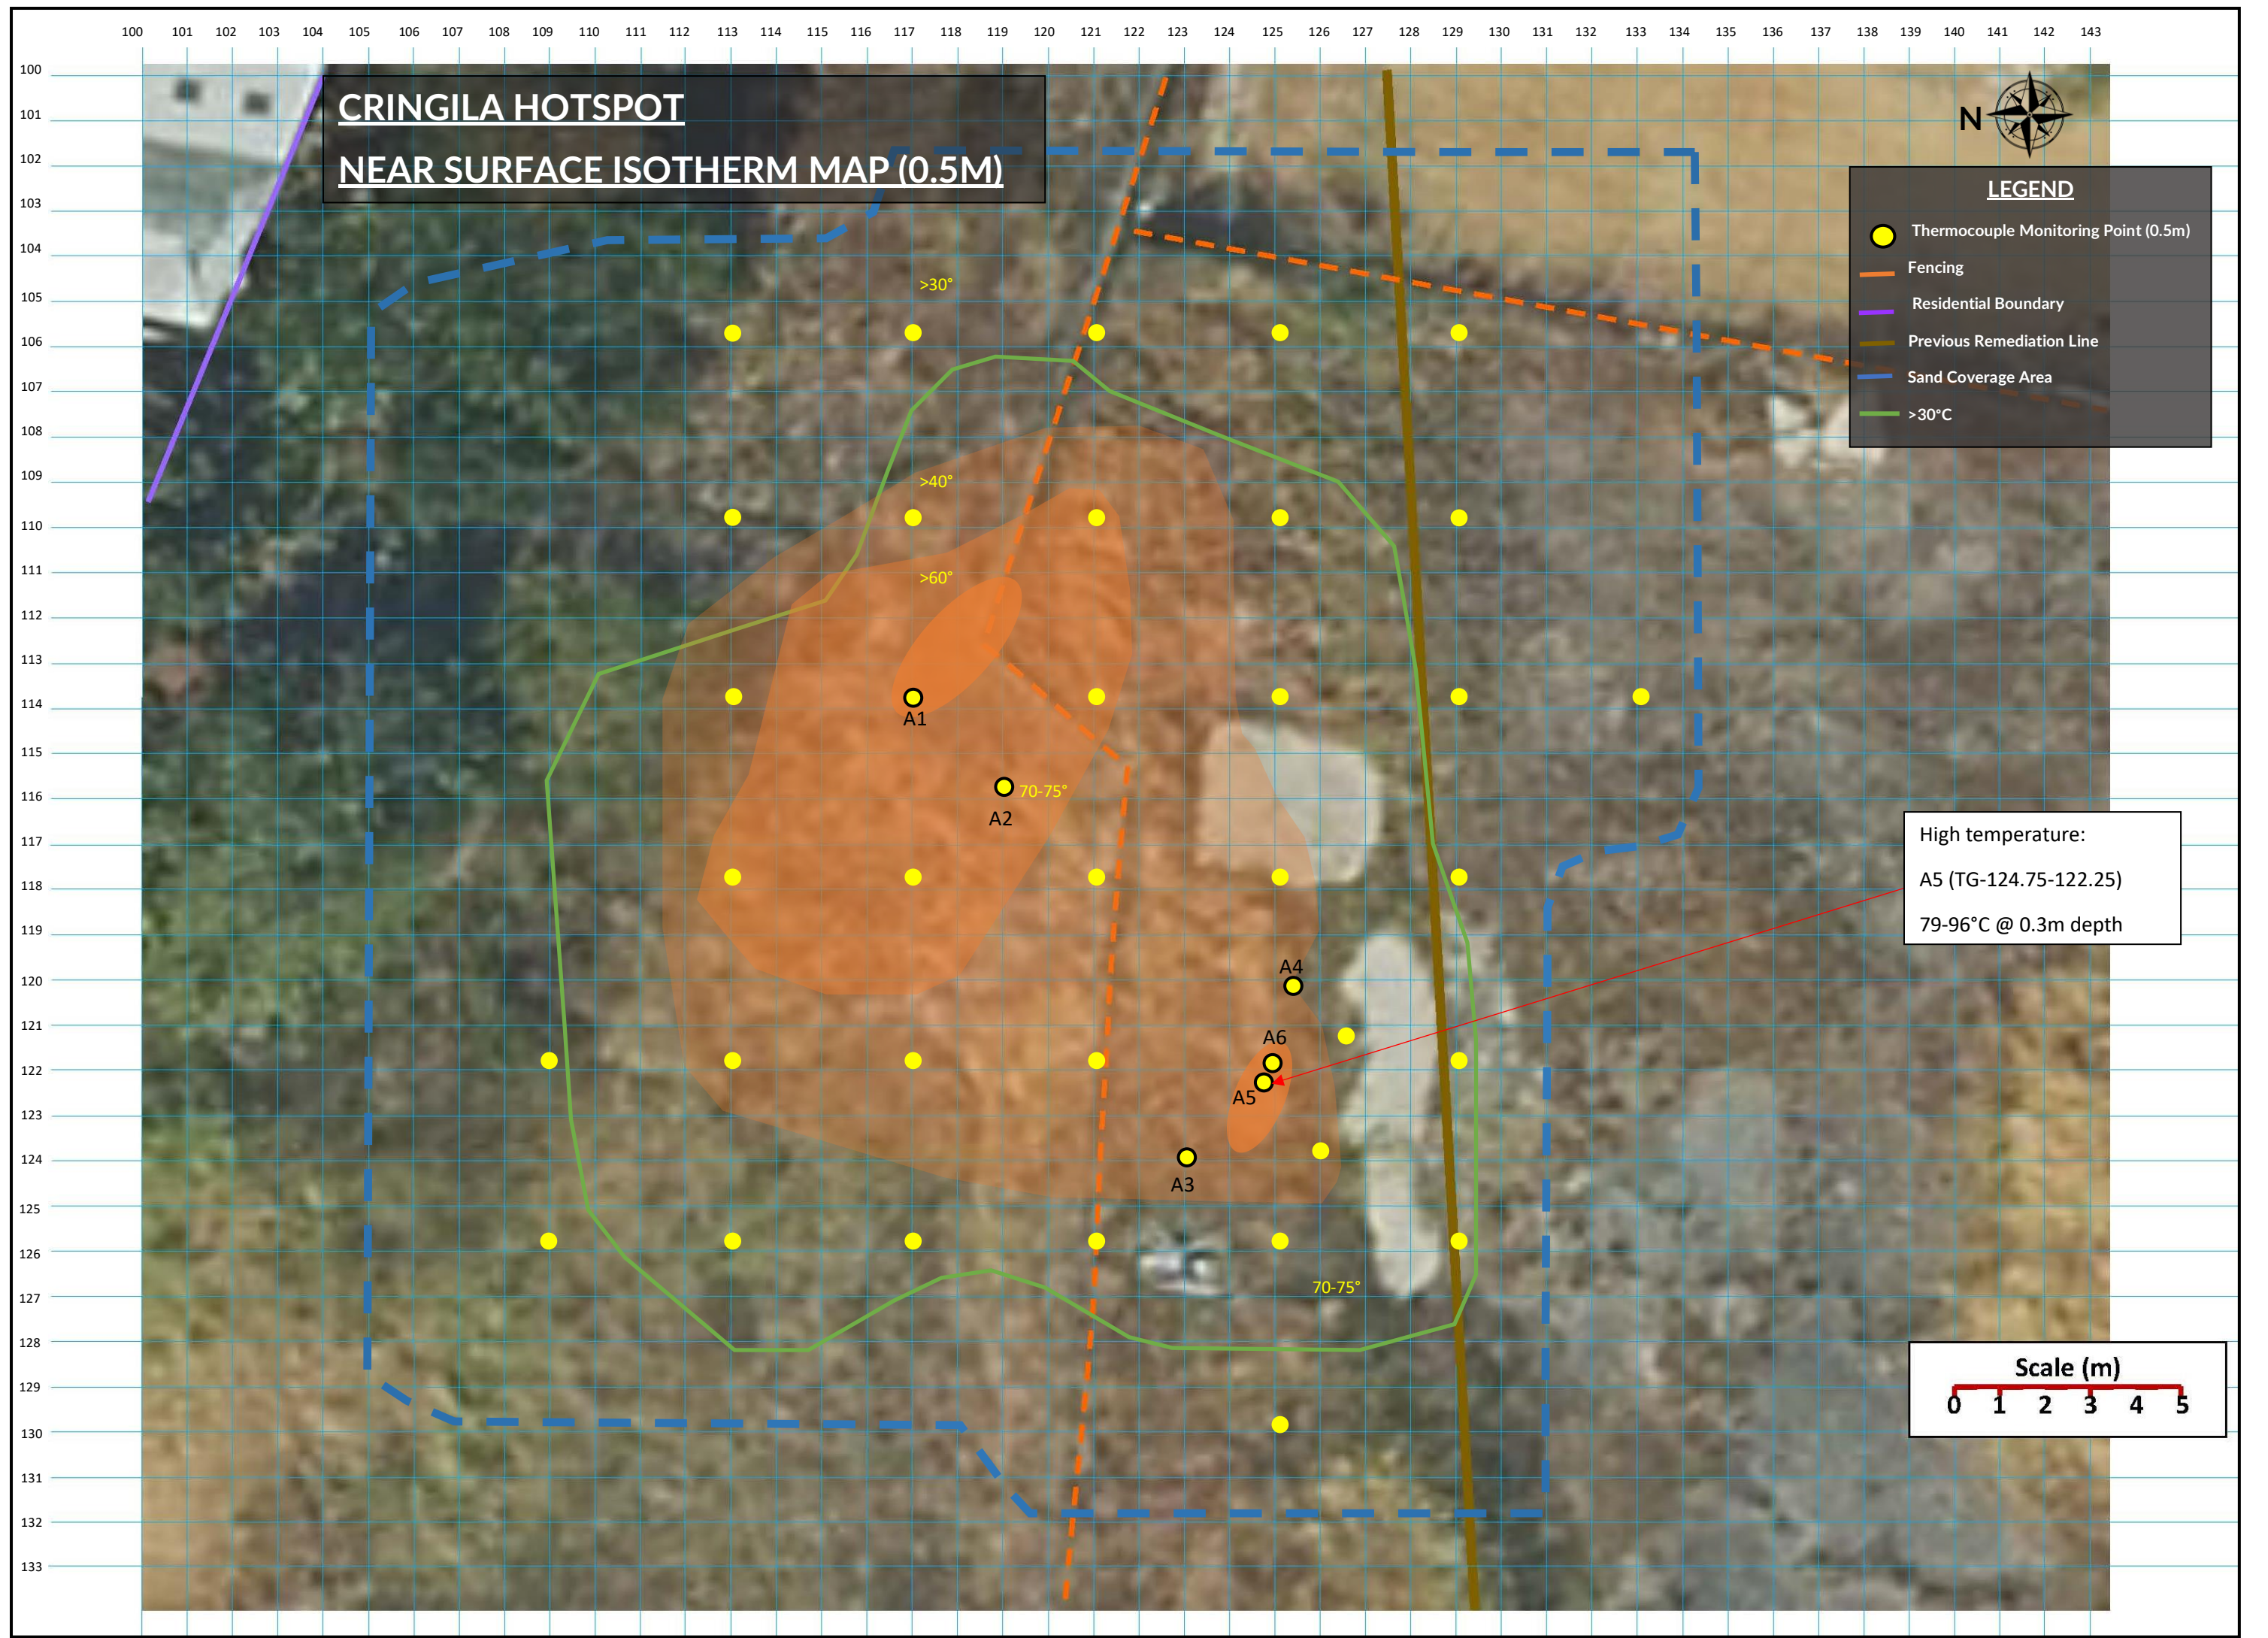
Appendix C: Near Surface Temperature Isotherm Map (0.5m)

The isotherm mapping indicates a maximum temperature below 100°C beneath the small mound west of the concrete cap (monitoring point A5 at 0.3m depth) within the northwest hotspot. The isotherm map shows the general zone of influence for temperatures between 30°C and 75°C at 0.5m, coloured orange. The isotherm map suggests that the hotspot may extend deeper than 0.5m and that the increased temperature in these areas is a result of heat venting to the surface.

It is noted that temperature at the near-surface may be variable across the hotspot due to inconsistencies in the consolidation and compaction of subsurface materials.

CRINGILA HOTSPOT NEAR SURFACE ISOTHERM MAP (0.5M)

High temperature:
A5 (TG-124.75-122.25)
79-96°C @ 0.3m depth
