NEAR SURFACE TEMPERATURE MONITORING CRINGILA PUBLIC SCHOOL - NW HOTSPOT

Weekly Summary Report
28/05/2018 – 01/06/2018

Cringila Public School

C107826: J153825: RC

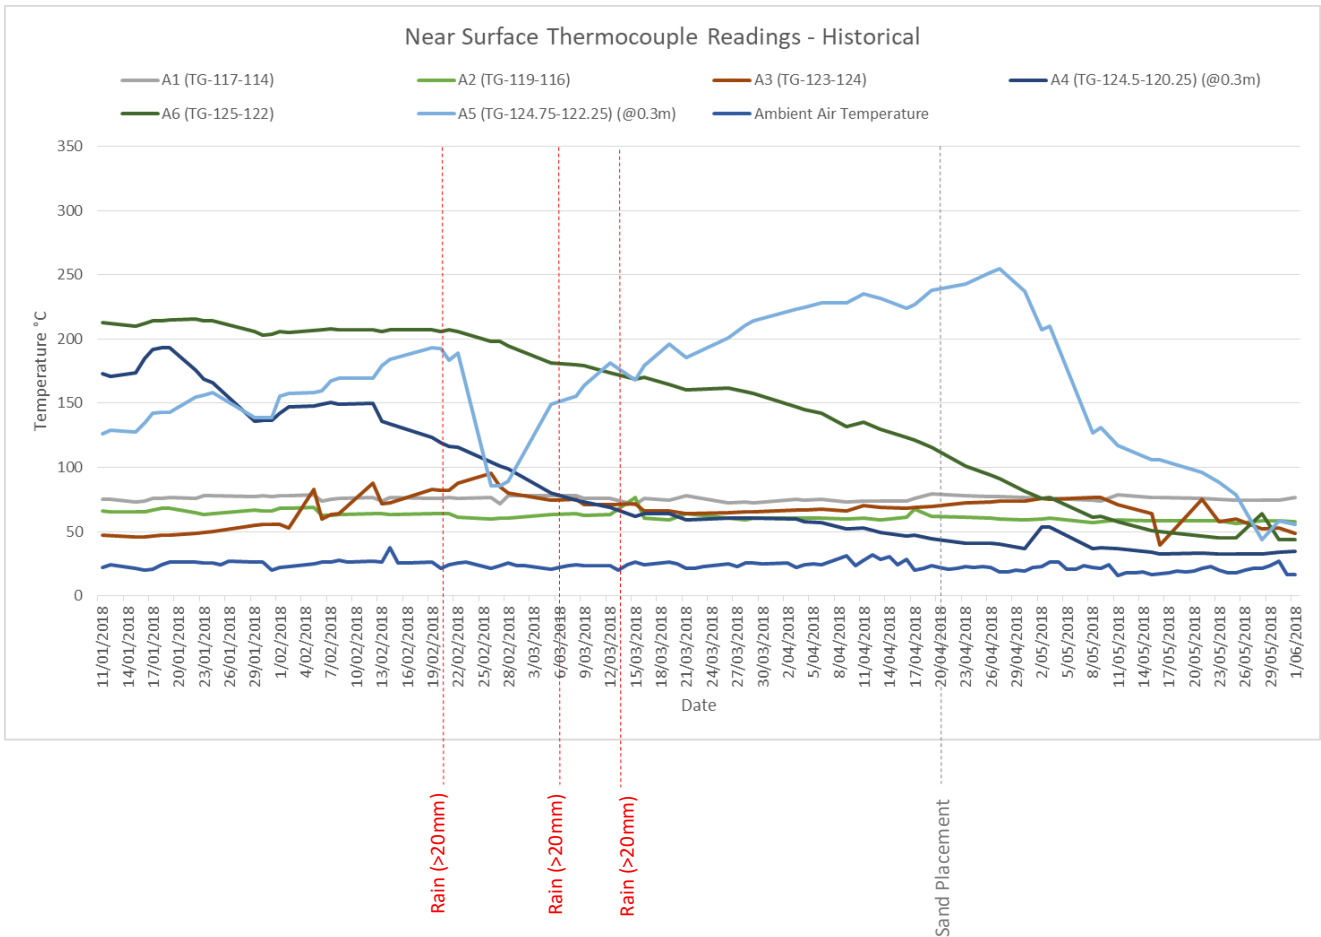
3.3. Near Surface Temperature Graph – Selected Points (Historical)

Near surface temperature measurements for key thermocouple locations, progressive from Thursday 11th January 2018 to present.

The near surface temperature appears to be trending downwards following the placement of sand (approximately 100mm) across the surface of the northwest hotspot grid monitoring area.

Fluctuations in near surface temperature are evident following significant rain events (i.e. over 20mm rain).

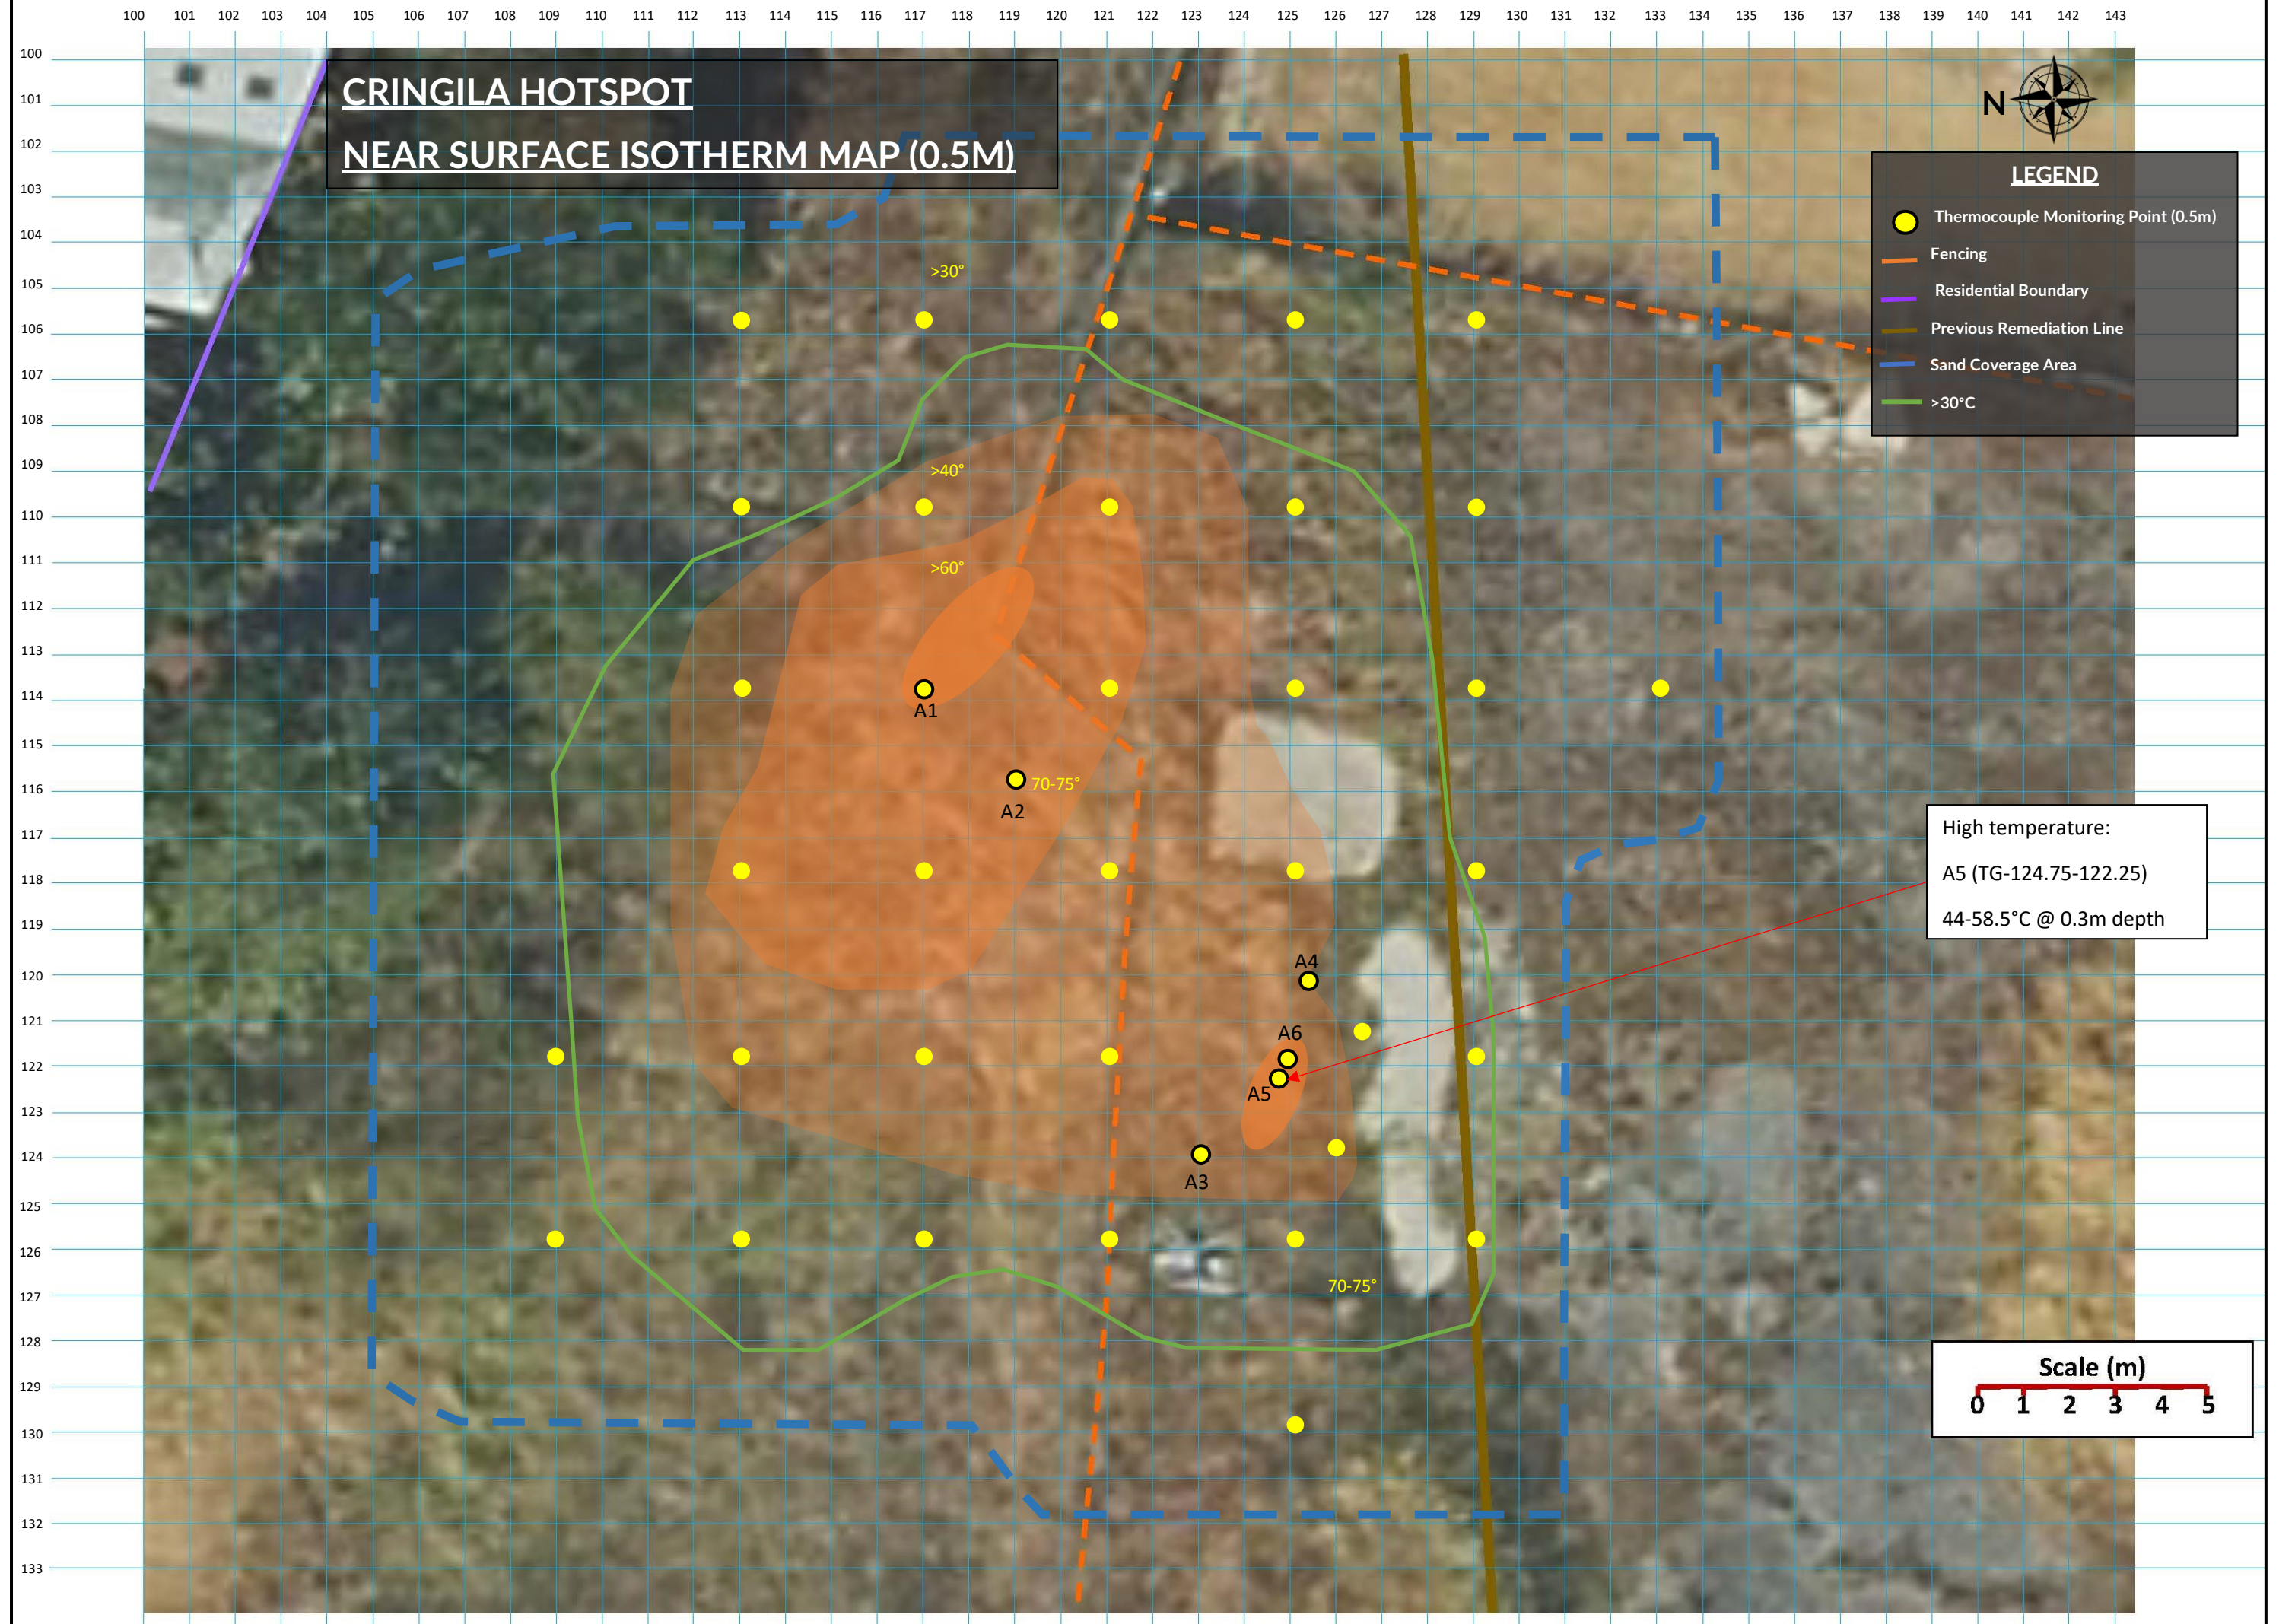
Appendix C: Near Surface Temperature Isotherm Map (0.5m)

The isotherm mapping indicates a maximum temperature below 100°C beneath the small mound west of the concrete cap (monitoring point A5 at 0.3m depth) within the northwest hotspot. The isotherm map shows the general zone of influence for temperatures between 30°C and 75°C at 0.5m, coloured orange. The isotherm map suggests that the hotspot may extend deeper than 0.5m and that the increased temperature in these areas is a result of heat venting to the surface.

It is noted that temperature at the near-surface may be variable across the hotspot due to inconsistencies in the consolidation and compaction of subsurface materials.

CRINGILA HOTSPOT NEAR SURFACE ISOTHERM MAP (0.5M)

High temperature:
A5 (TG-124.75-122.25)
44-58.5°C @ 0.3m depth

It is recommended that weekly site inspections and recording are continued to monitor the surface and near surface temperatures surrounding the hotspot identified at the site.
