NEAR SURFACE TEMPERATURE MONITORING CRINGILA PUBLIC SCHOOL - NW HOTSPOT

Weekly Summary Report
18/06/2018 - 22/06/2018

Cringila Public School

Near Surface Temperature Monitoring

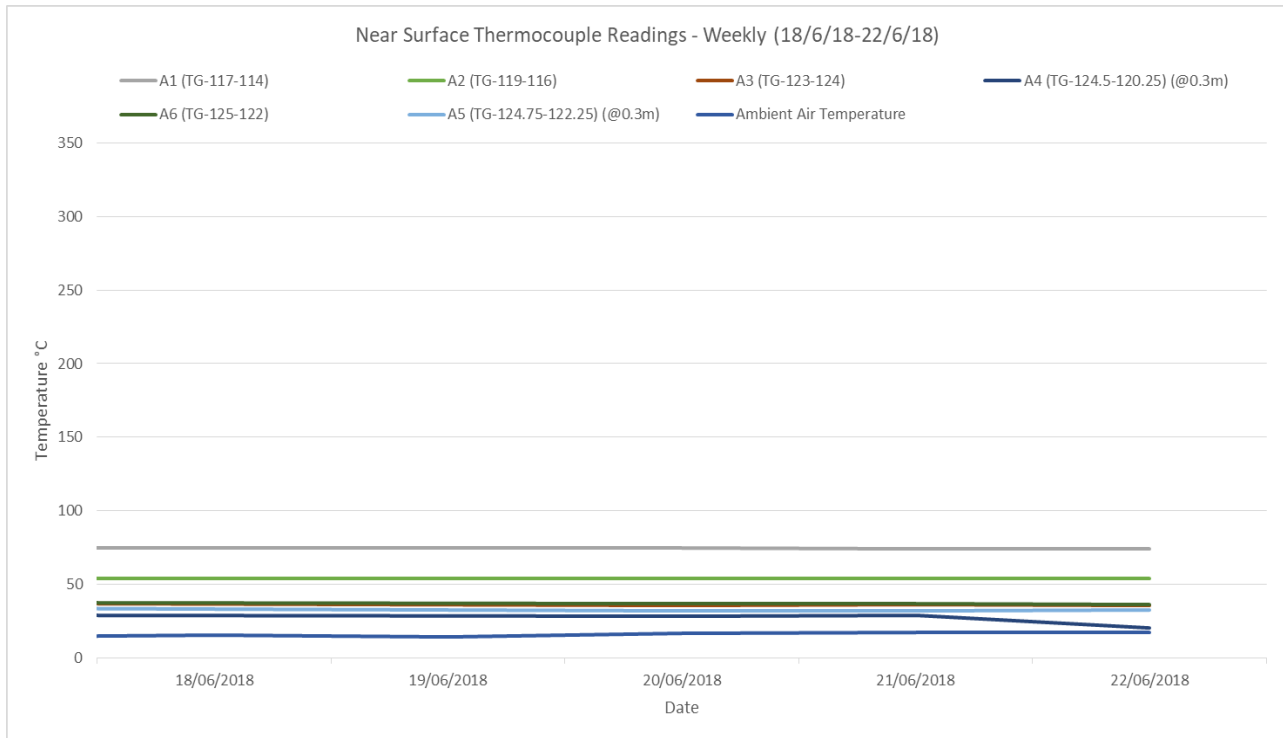
3.4. Near Surface Temperature Graph – Selected Points (Weekly)

Near surface temperature measurements for key thermocouple locations, over monitoring week - 18/6/2018 to 22/6/2018.

The near surface temperature at selected points across the northwest hotspot over the week of monitoring – 18/6/2018 to 22/6/2018, appear to remain consistent.

It is recommended that weekly site inspections and recording are continued to monitor the surface and near surface temperatures surrounding the hotspot identified at the site.

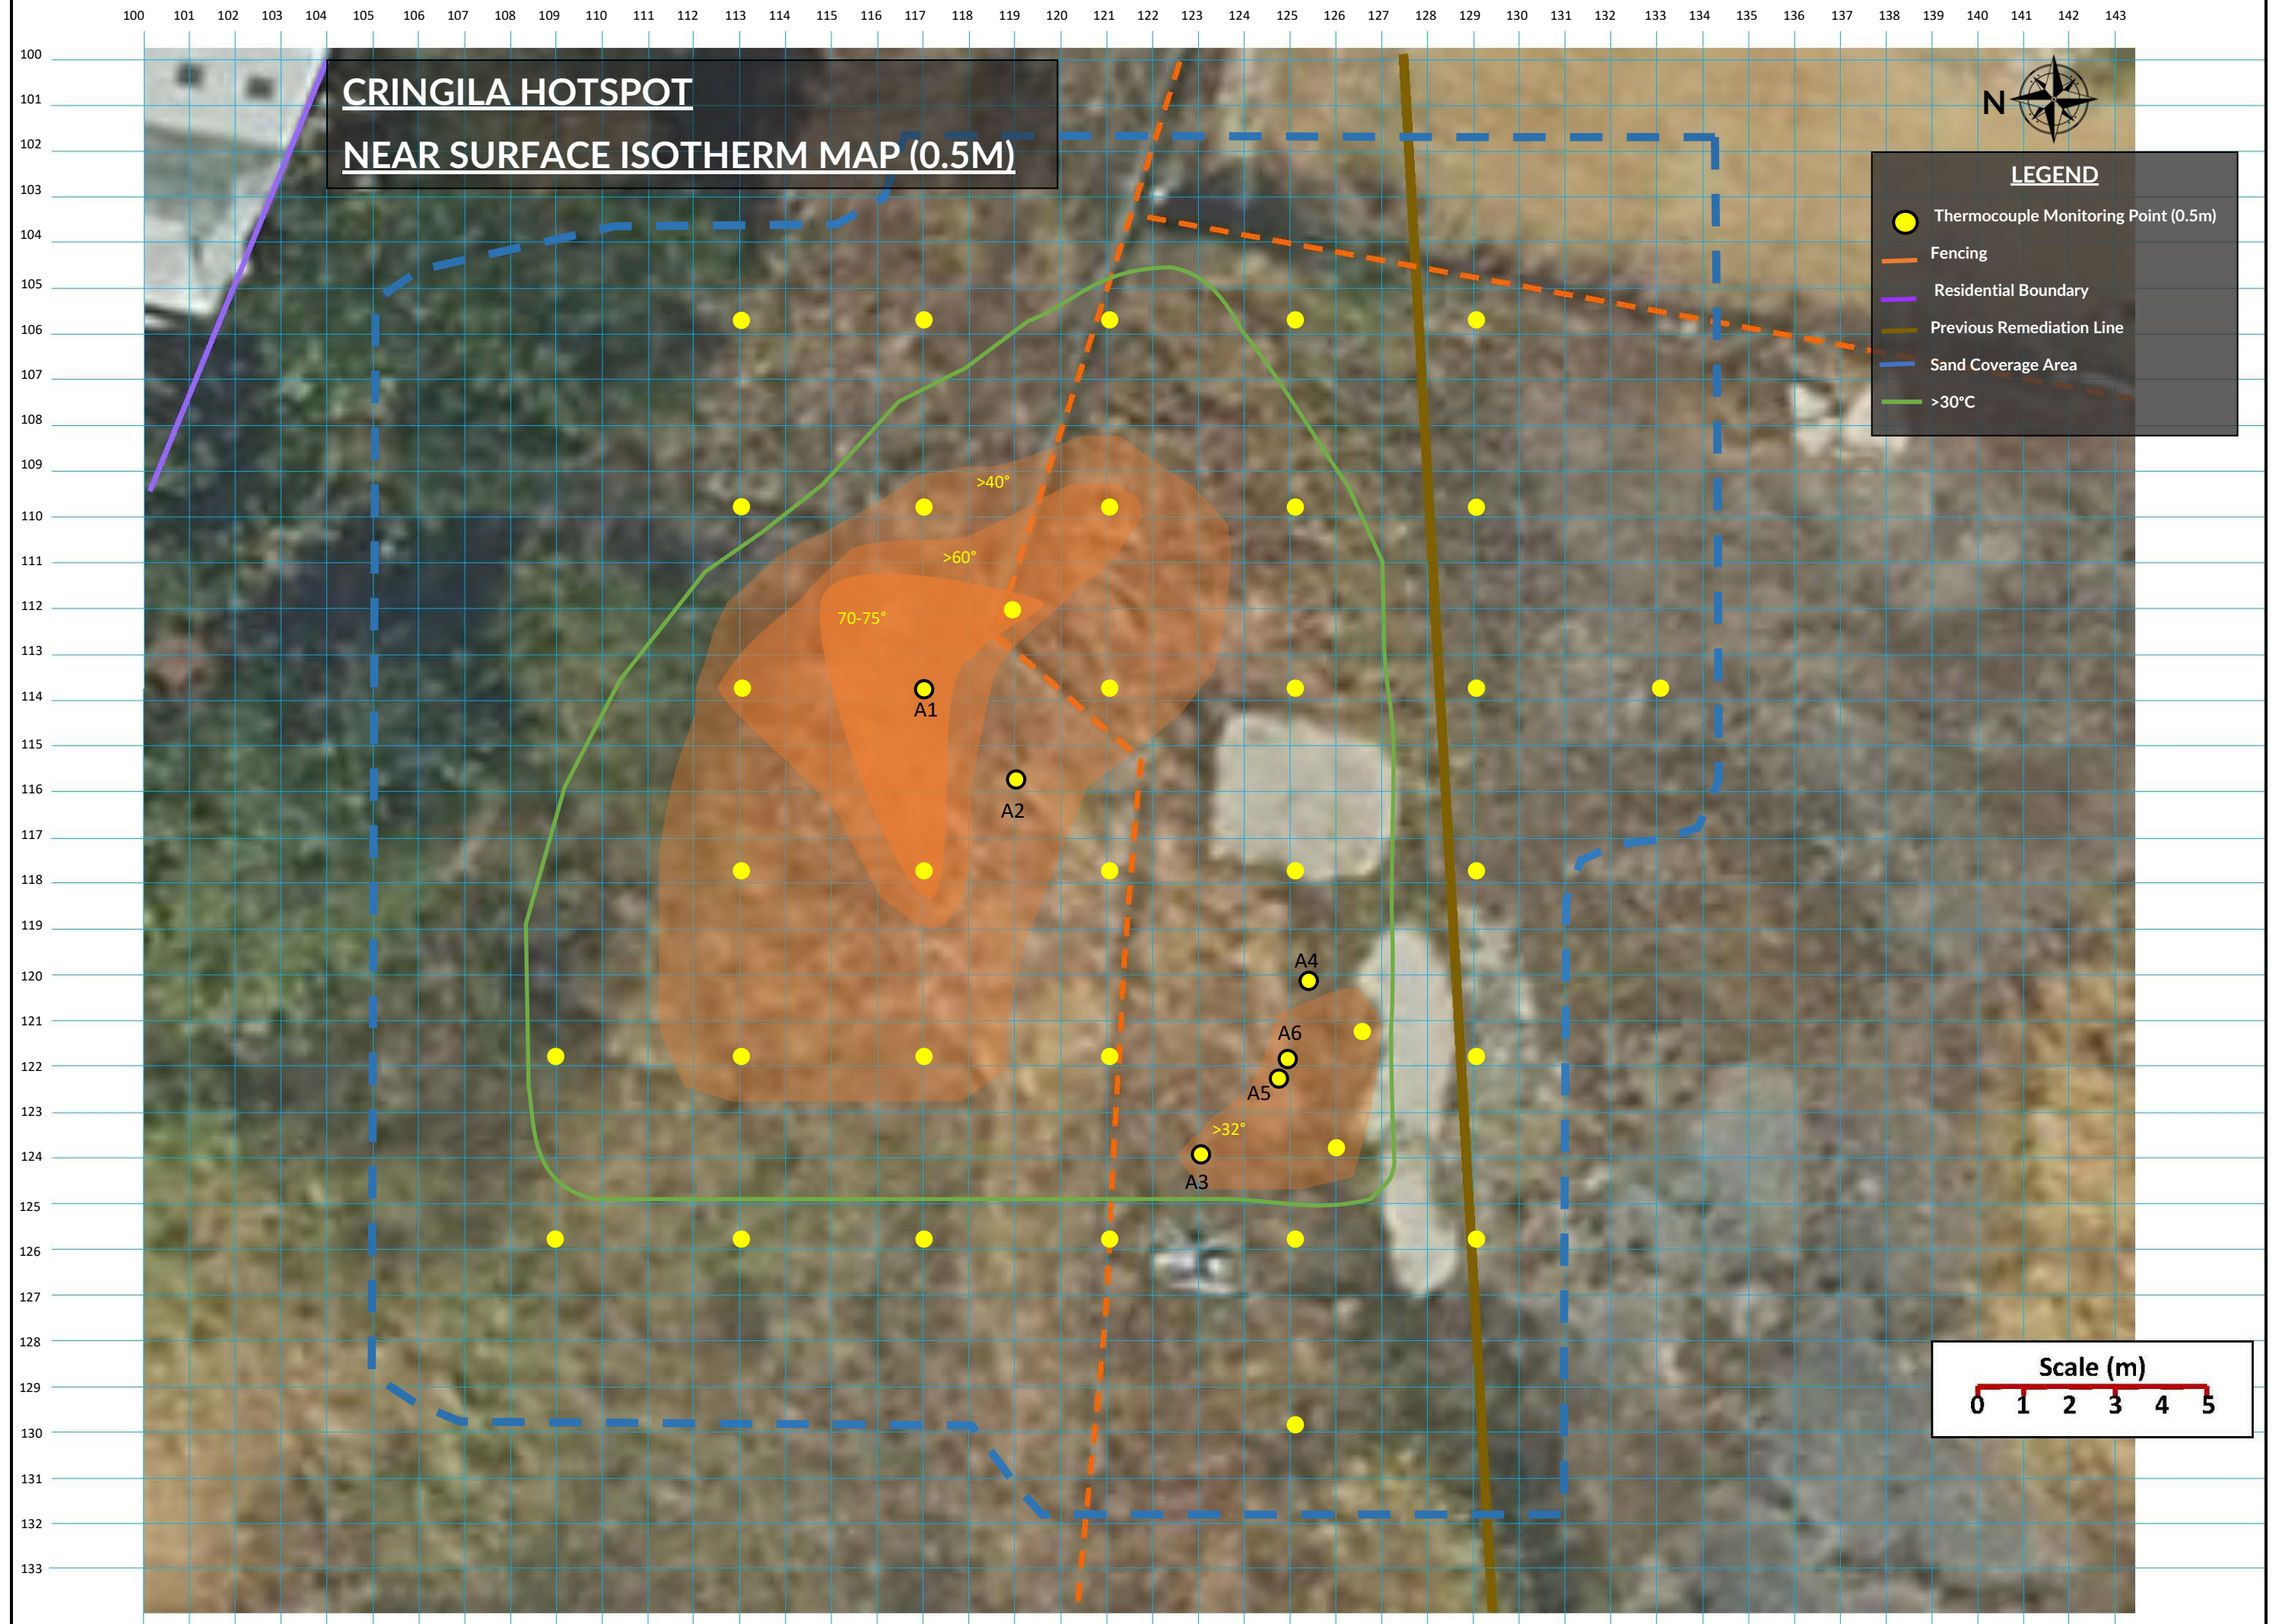
Appendix C: Near Surface Temperature Isotherm Map (0.5m)

The isotherm mapping indicates a maximum temperature below 100°C beneath the small mound west of the concrete cap (monitoring point A5 at 0.3m depth) within the northwest hotspot. The isotherm map shows the general zone of influence for temperatures between 30°C and 75°C at 0.5m, coloured orange. The isotherm map suggests that the hotspot may extend deeper than 0.5m and that the increased temperature in these areas is a result of heat venting to the surface.

It is noted that temperature at the near-surface may be variable across the hotspot due to inconsistencies in the consolidation and compaction of subsurface materials.

CRINGILA HOTSPOT NEAR SURFACE ISOTHERM MAP (0.5M)
