## NEAR SURFACE TEMPERATURE MONITORING CRINGILA PUBLIC SCHOOL - NW HOTSPOT

Weekly Summary Report  
25/06/2018 – 29/06/2018

Cringila Public School

# Near Surface Temperature Monitoring

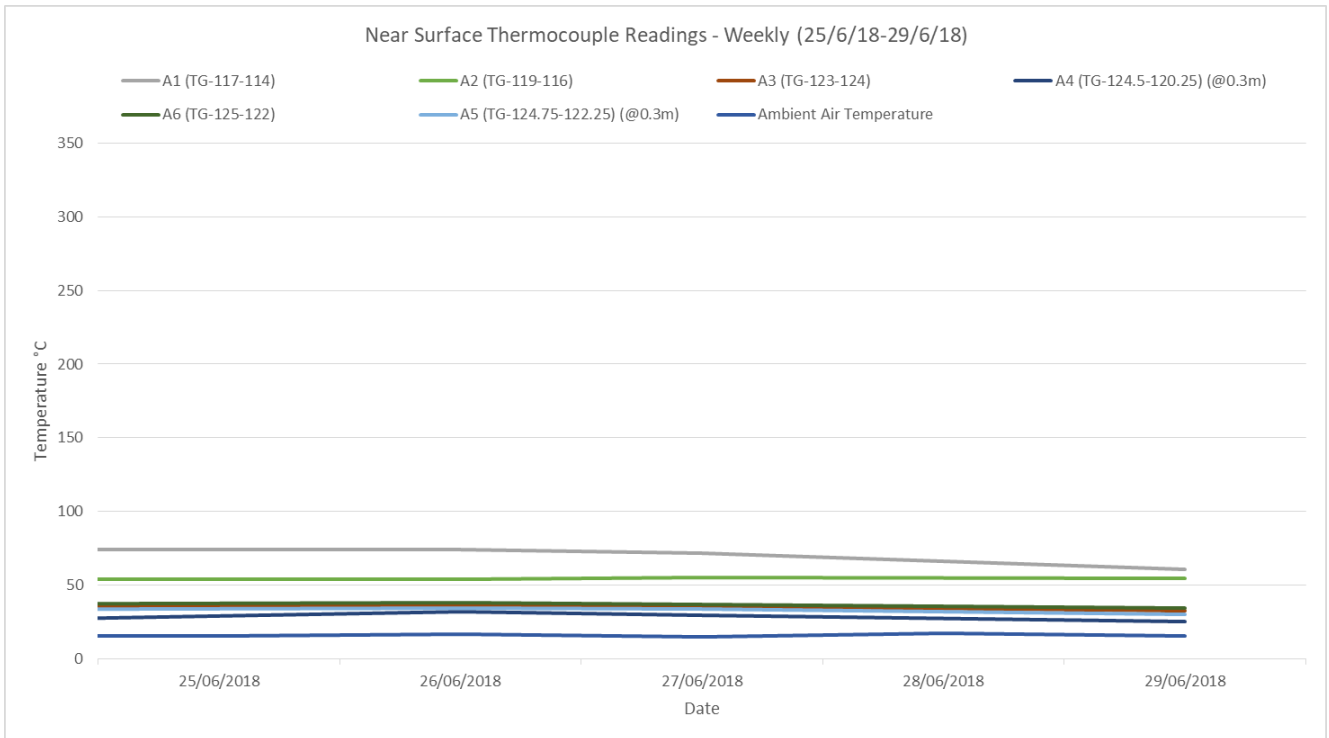
### 3.4. Near Surface Temperature Graph – Selected Points (Weekly)

Near surface temperature measurements for key thermocouple locations, over monitoring week - 25/6/2018 to 29/6/2018.

The near surface temperature at selected points across the northwest hotspot over the week of monitoring – 25/6/2018 to 29/6/2018, appear to remain consistent.

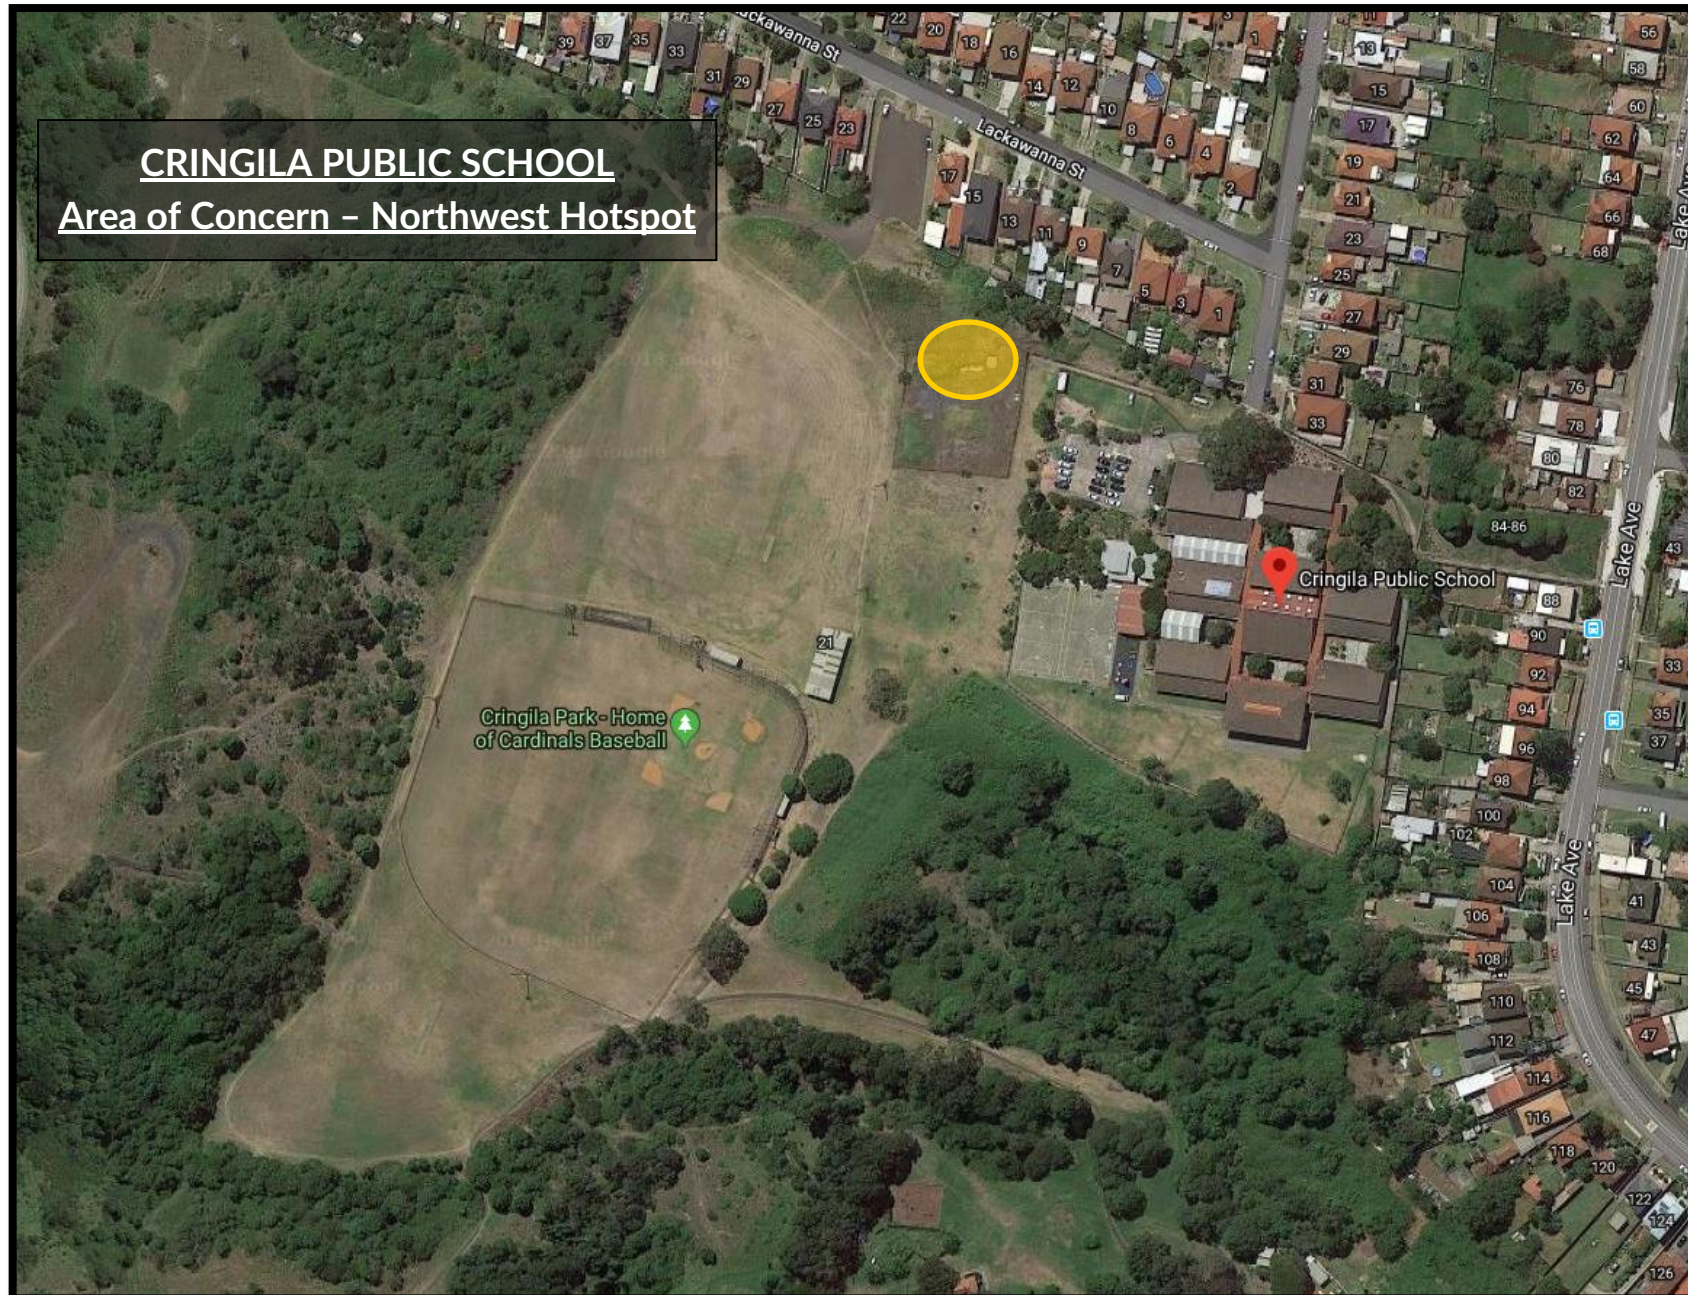
### Appendix A: Area of Concern – Northwest Hotspot Map

**CRINGILA PUBLIC SCHOOL**  
**Area of Concern - Northwest Hotspot**

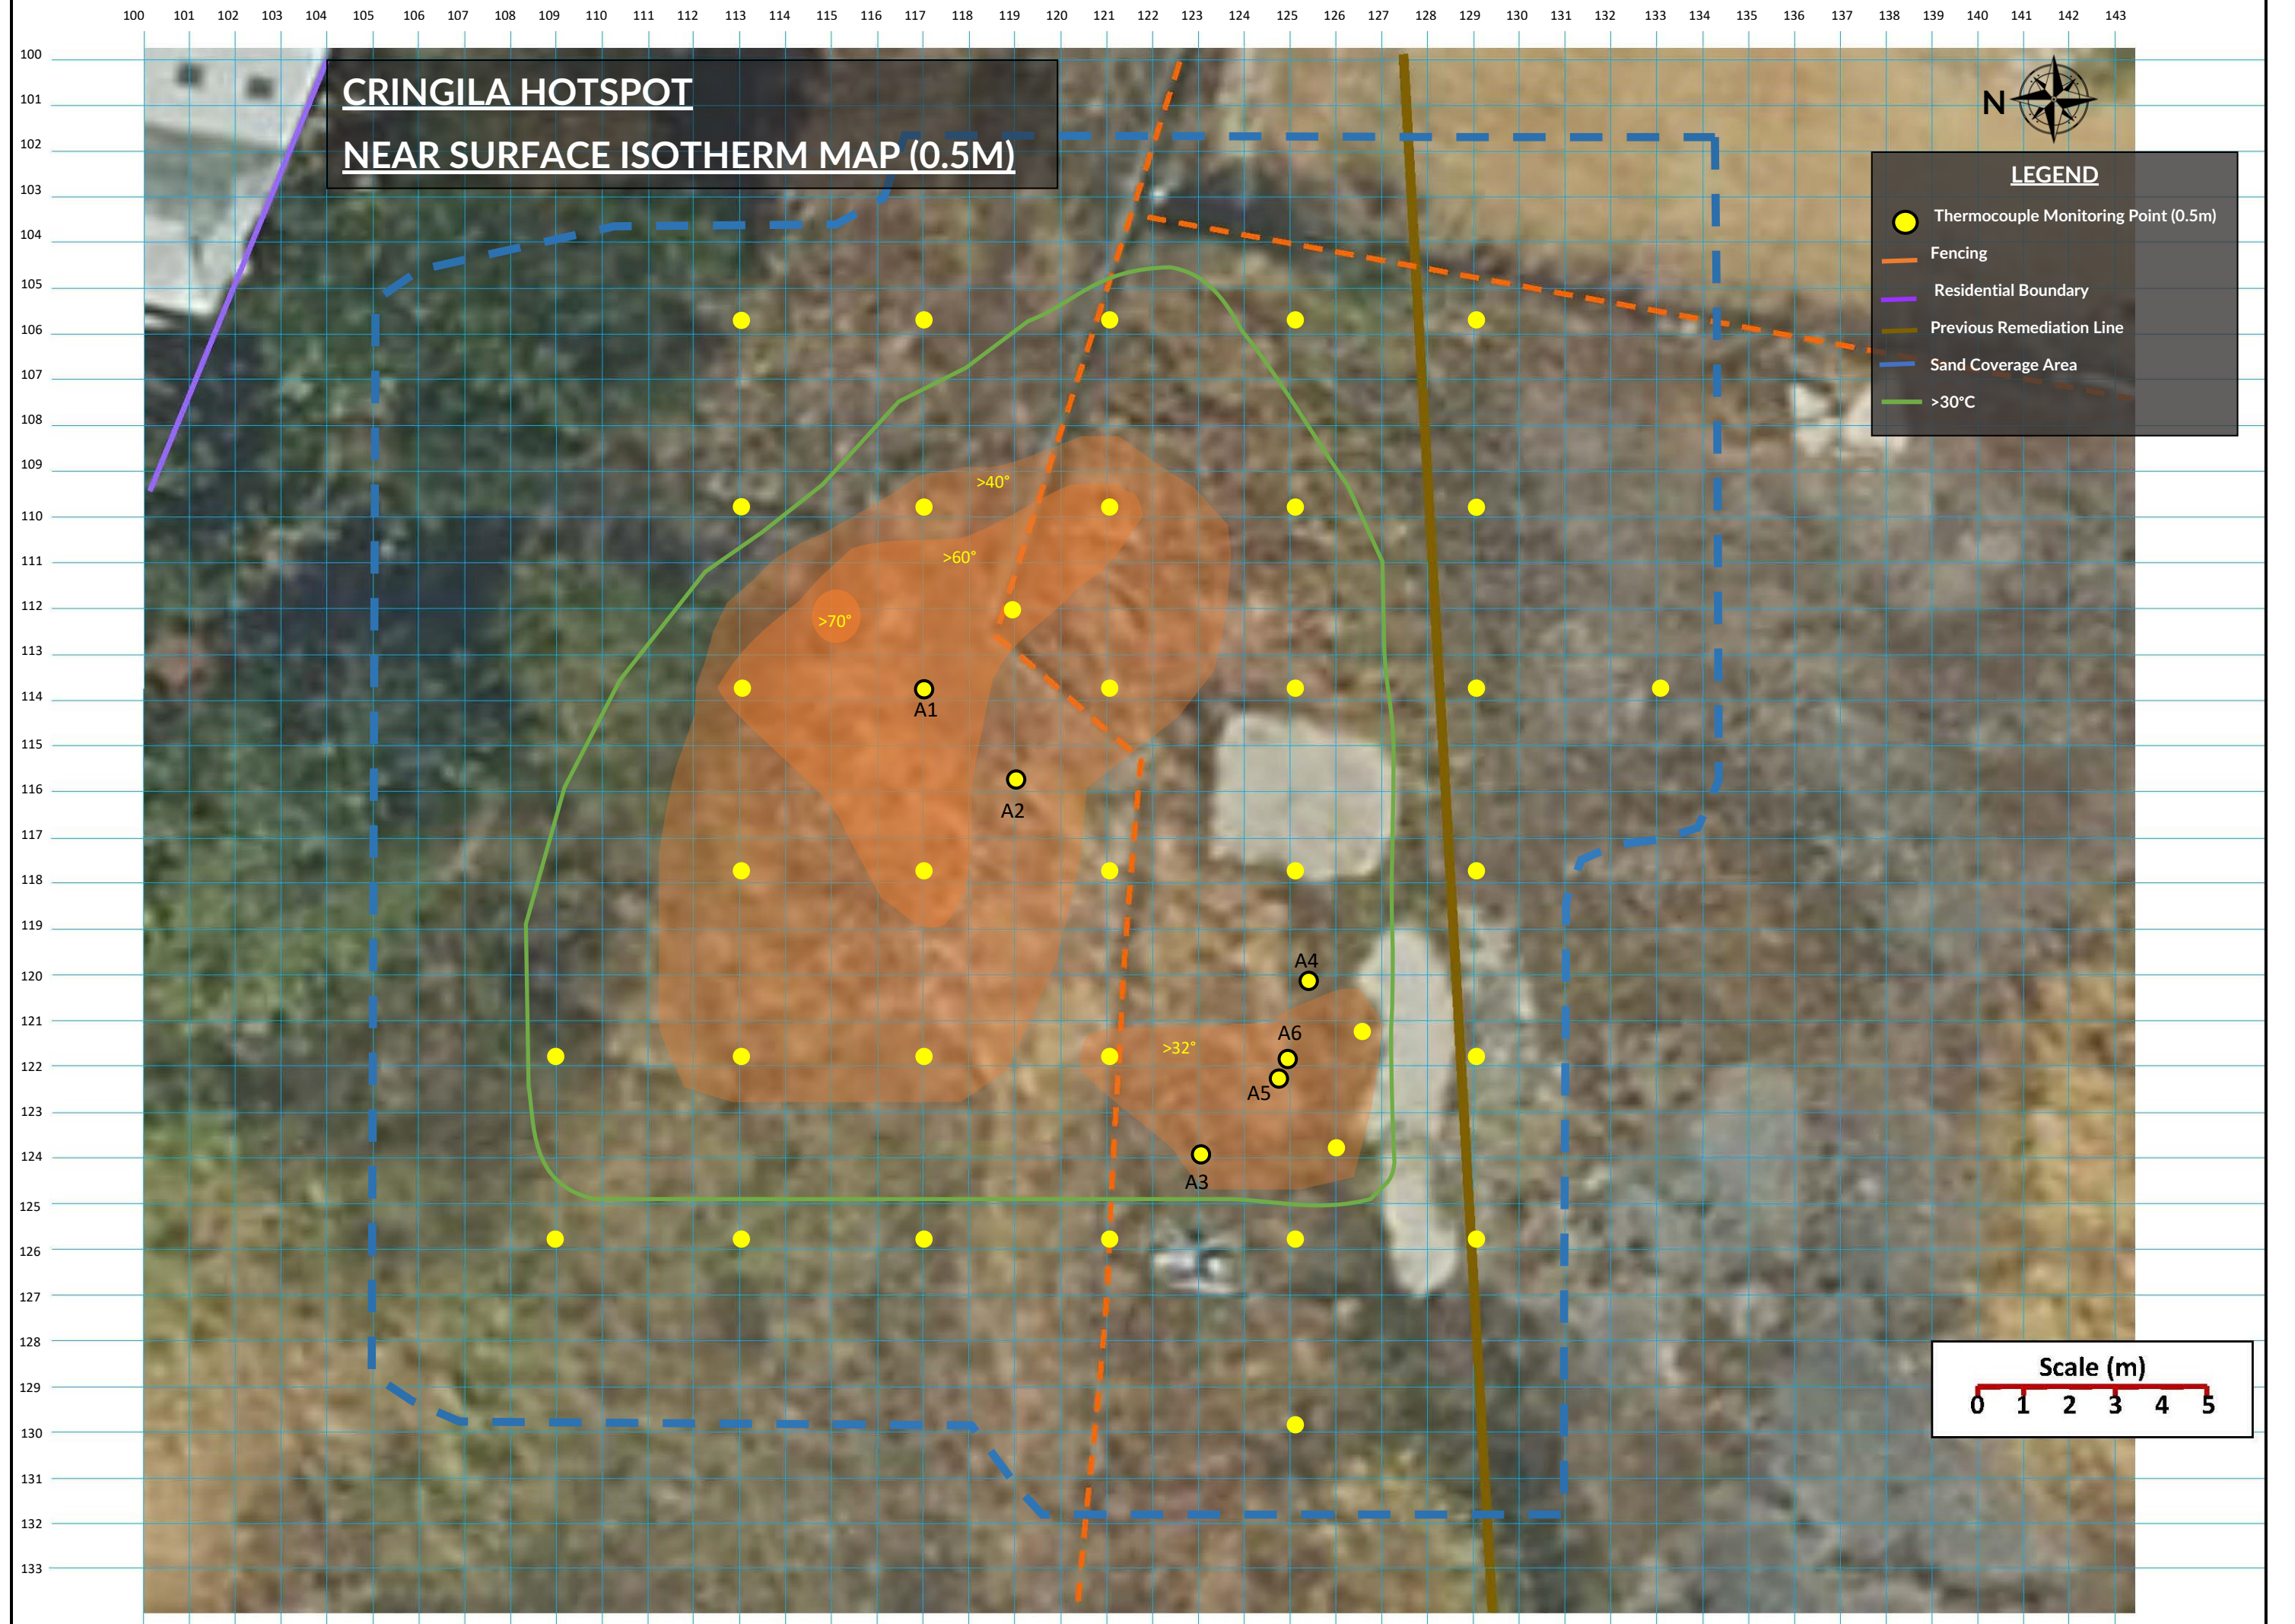
### Appendix C: Near Surface Temperature Isotherm Map (0.5m)

The isotherm mapping indicates a maximum temperature of over 200°C beneath the small mound west of the concrete cap (monitoring point A5 at 0.3m depth) within the northwest hotspot. The isotherm map shows the general zone of influence for temperatures between 30°C and 75°C at 0.5m, coloured orange. The isotherm map suggests that the hotspot may extend deeper than 0.5m and that the increased temperature in these areas is a result of heat venting to the surface.

It is noted that temperature at the near-surface may be variable across the hotspot due to inconsistencies in the consolidation and compaction of subsurface materials.

# CRINGILA HOTSPOT NEAR SURFACE ISOTHERM MAP (0.5M)

It is recommended that weekly site inspections and recording are continued to monitor the surface and near surface temperatures surrounding the hotspot identified at the site.
