NEAR SURFACE TEMPERATURE MONITORING CRINGILA PUBLIC SCHOOL - NW HOTSPOT

Weekly Summary Report
02/07/2018 – 06/07/2018

Cringila Public School

C107826: J153825: EA

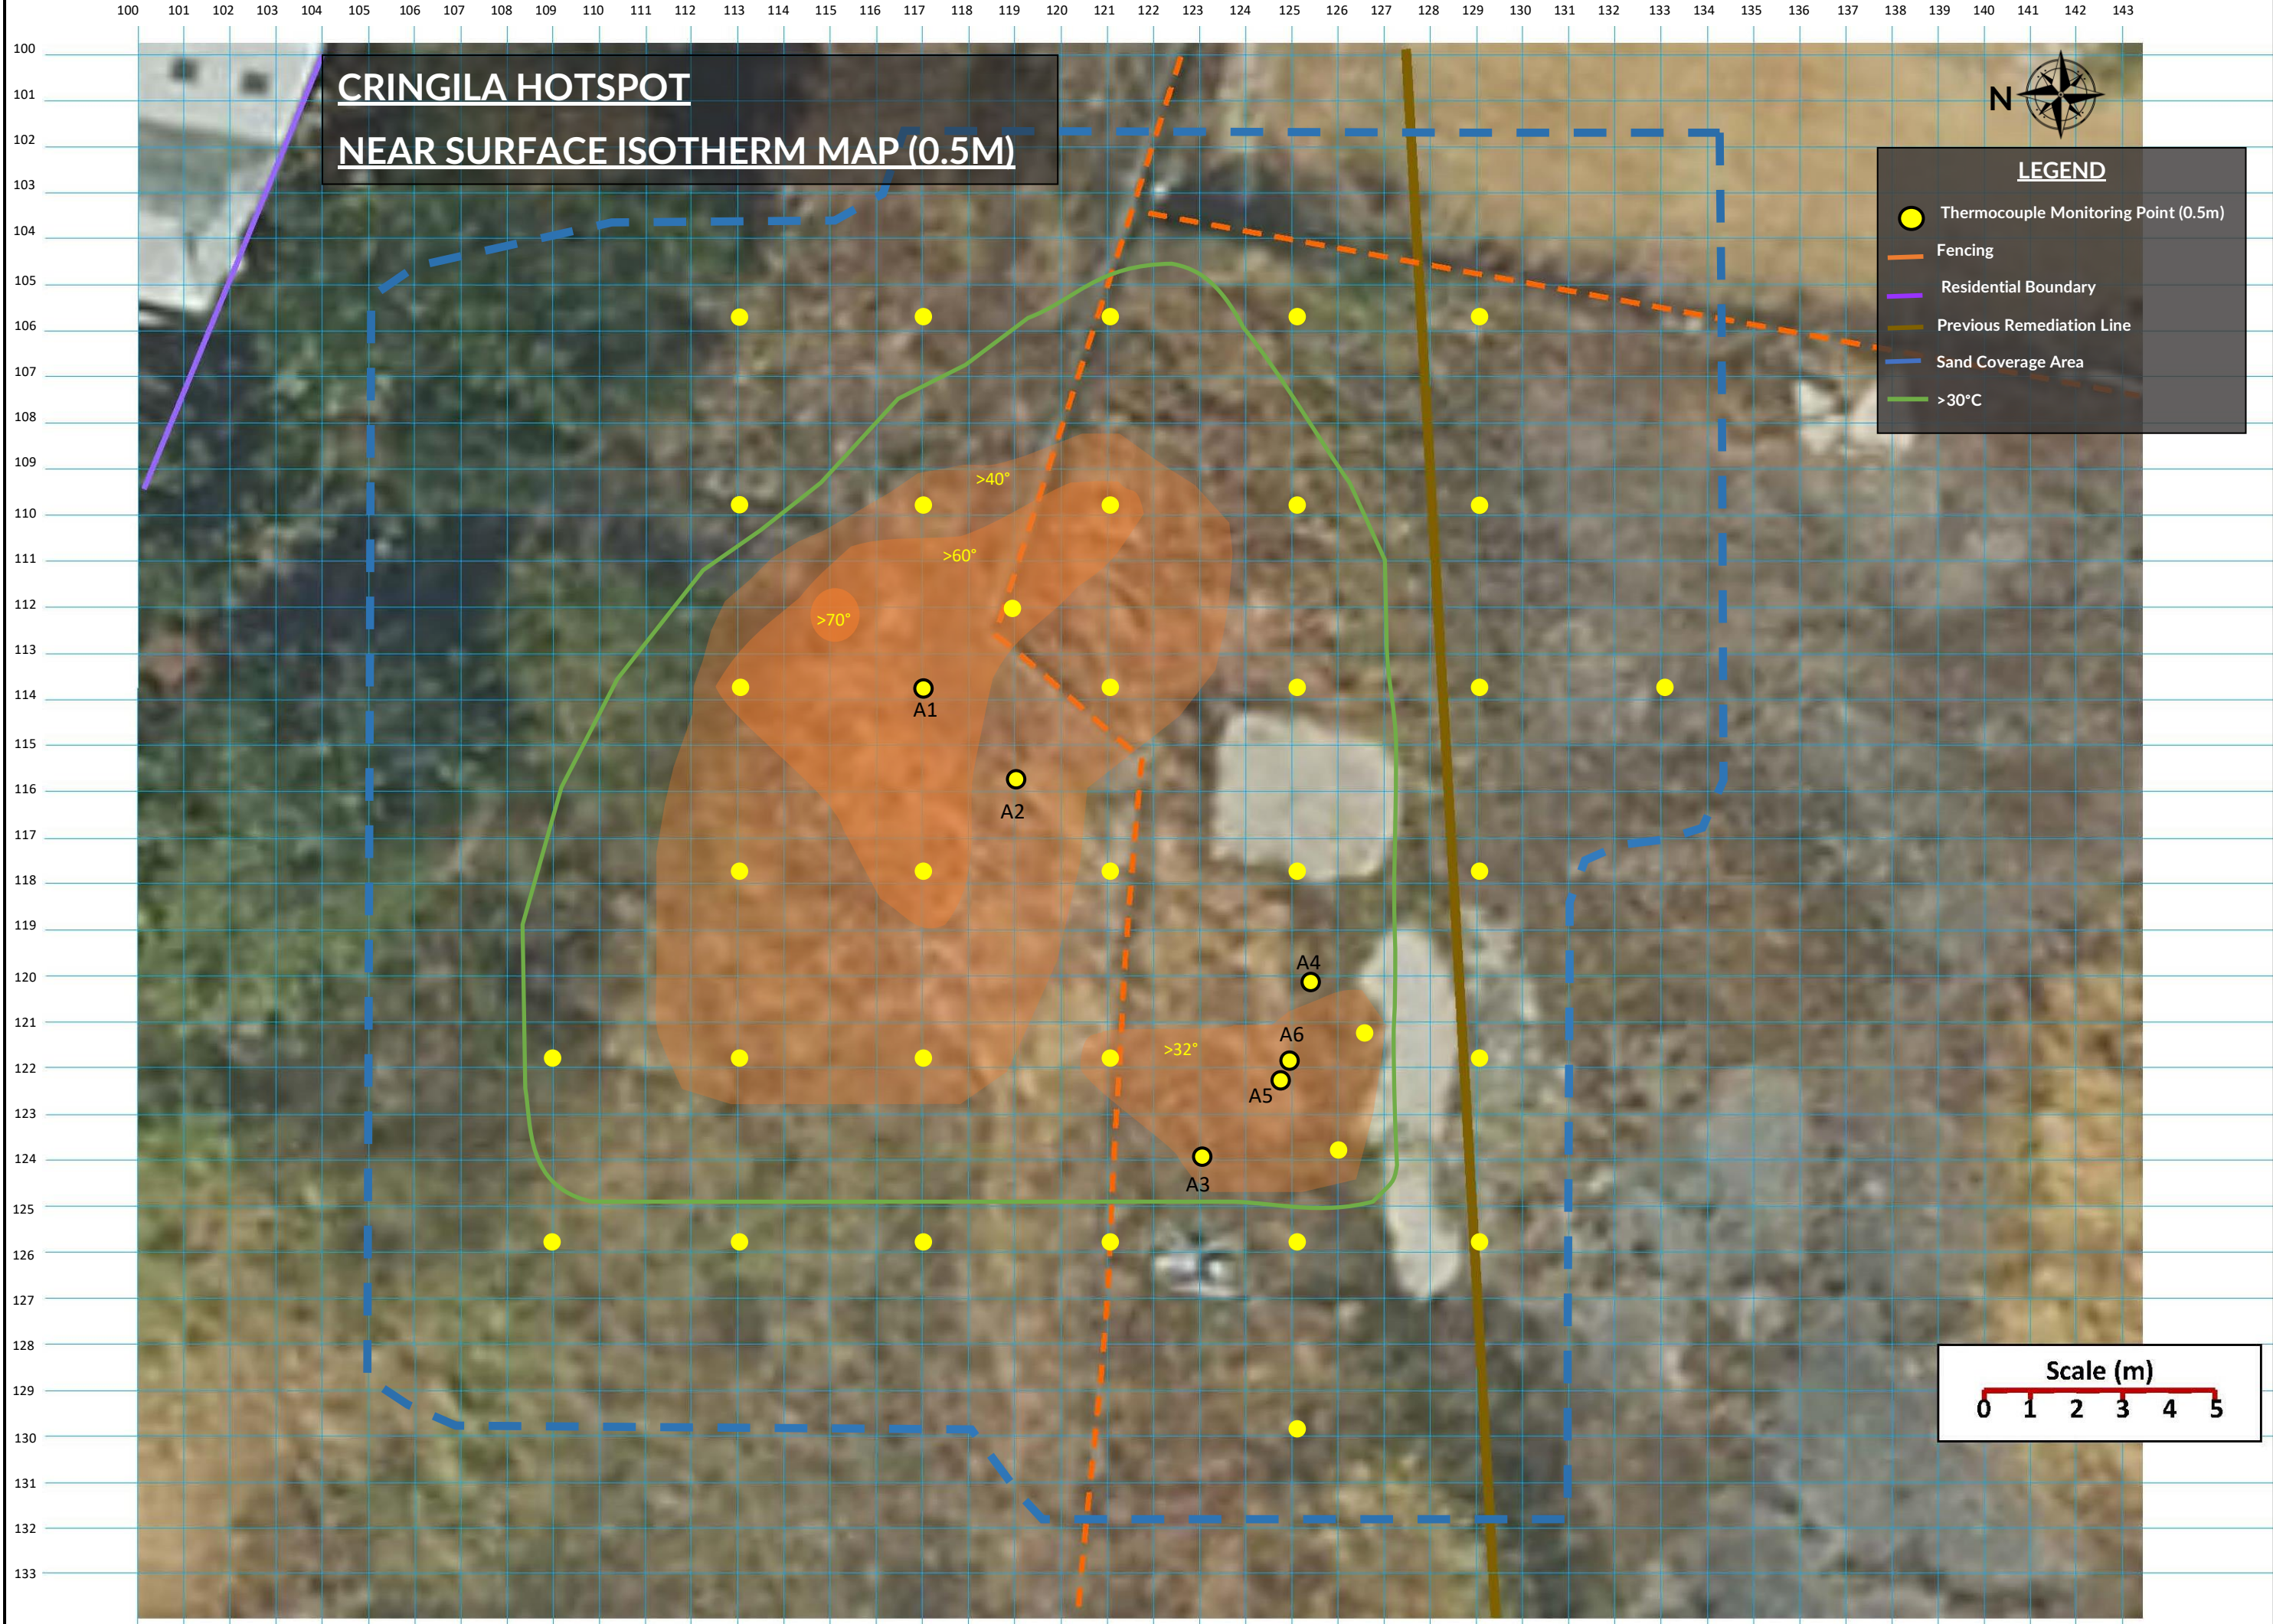
Appendix C: Near Surface Temperature Isotherm Map (0.5m)

The isotherm mapping indicates a maximum temperature of over 200°C beneath the small mound west of the concrete cap (monitoring point A5 at 0.3m depth) within the northwest hotspot. The isotherm map shows the general zone of influence for temperatures between 30°C and 75°C at 0.5m, coloured orange. The isotherm map suggests that the hotspot may extend deeper than 0.5m and that the increased temperature in these areas is a result of heat venting to the surface.

It is noted that temperature at the near-surface may be variable across the hotspot due to inconsistencies in the consolidation and compaction of subsurface materials.

CRINGILA HOTSPOT NEAR SURFACE ISOTHERM MAP (0.5M)

It is recommended that weekly site inspections and recording are continued to monitor the surface and near surface temperatures surrounding the hotspot identified at the site.
