NEAR SURFACE TEMPERATURE MONITORING CRINGILA PUBLIC SCHOOL - NW HOTSPOT

Weekly Summary Report
09/07/2018 – 13/07/2018

Cringila Public School

C107826: J153825: EA

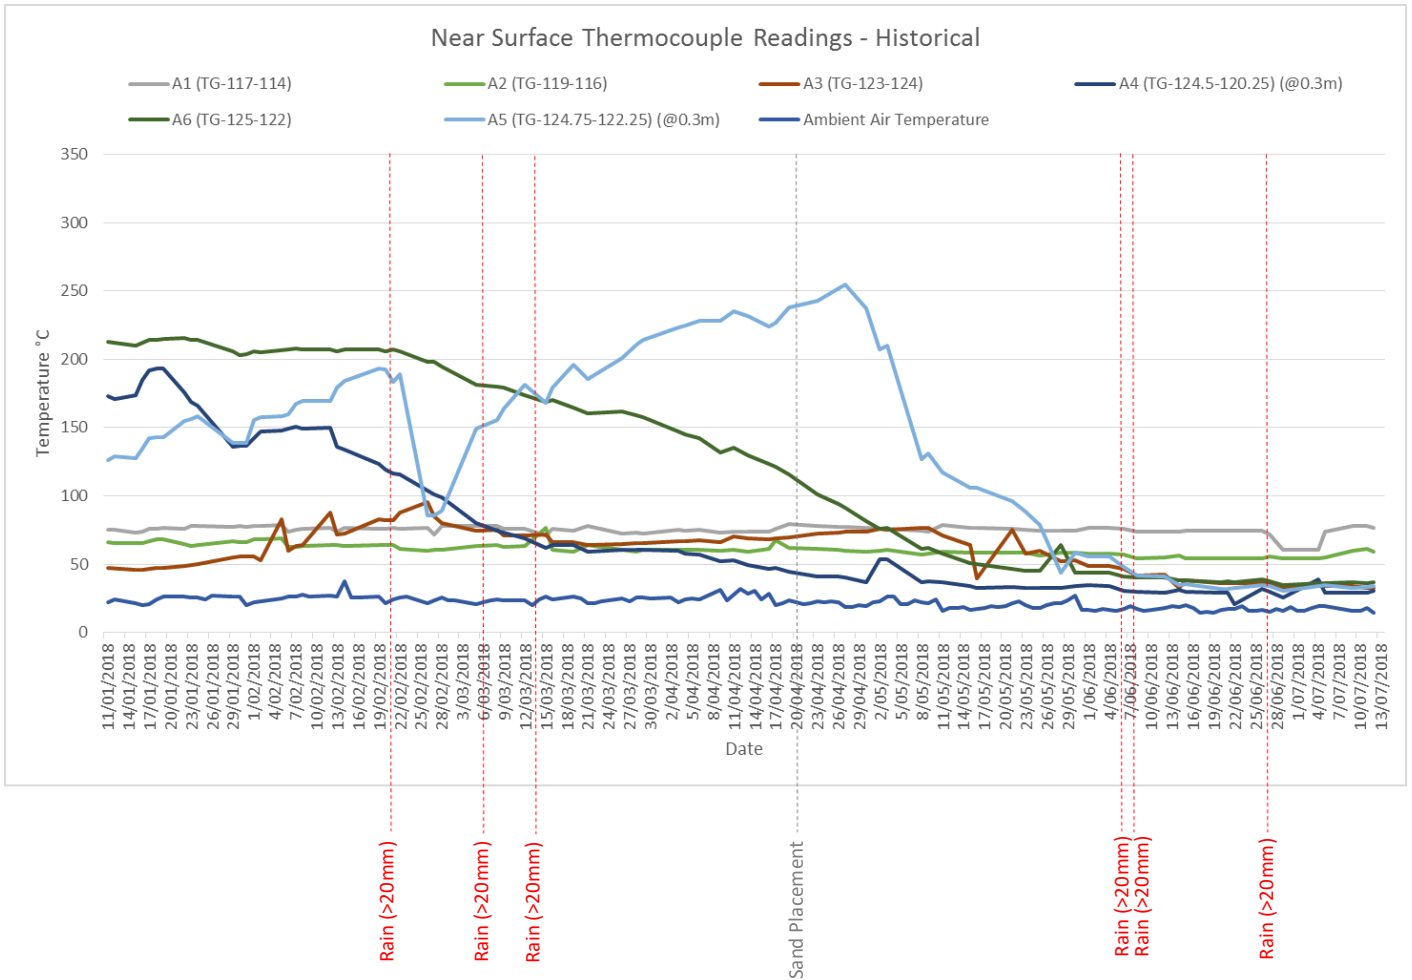
3.3. Near Surface Temperature Graph – Selected Points (Historical)

Near surface temperature measurements for key thermocouple locations, progressive from Thursday 11th January 2018 to present.

The near surface temperature appears to be trending downwards following the placement of sand (approximately 100mm) across the surface of the northwest hotspot grid monitoring area.

Fluctuations in near surface temperature are evident following significant rain events (i.e. over 20mm rain).
