## NEAR SURFACE TEMPERATURE MONITORING CRINGILA PUBLIC SCHOOL - NW HOTSPOT

Weekly Summary Report  
16/07/2018 – 20/07/2018

Cringila Public School

C107826: J153825: EA

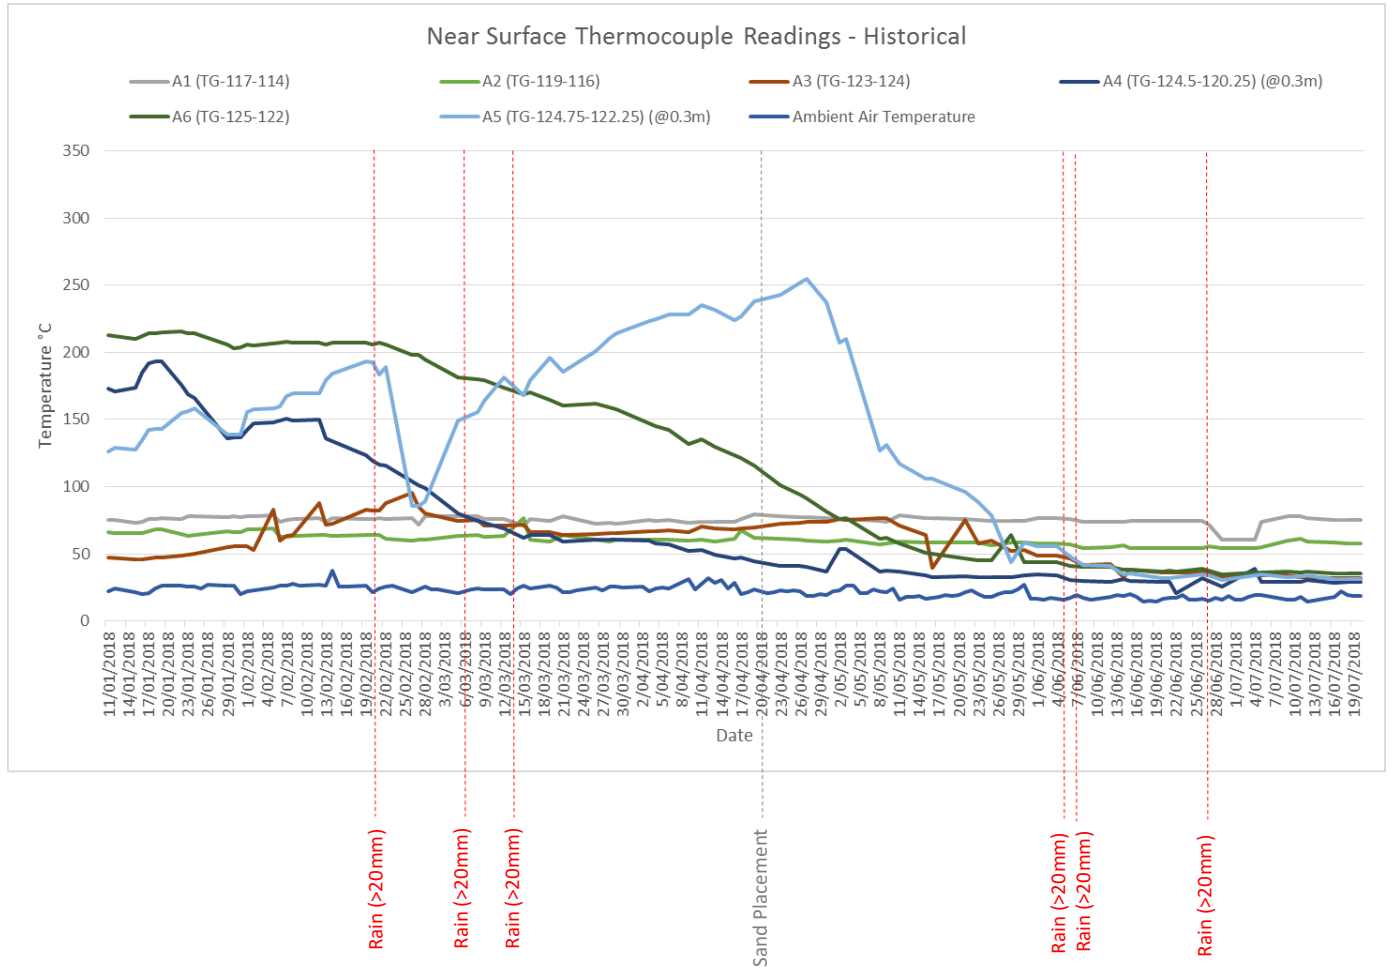
### 3.3. Near Surface Temperature Graph – Selected Points (Historical)

Near surface temperature measurements for key thermocouple locations, progressive from Thursday 11<sup>th</sup> January 2018 to present.

The near surface temperature appears to be trending downwards following the placement of sand (approximately 100mm) across the surface of the northwest hotspot grid monitoring area.

Fluctuations in near surface temperature are evident following significant rain events (i.e. over 20mm rain).

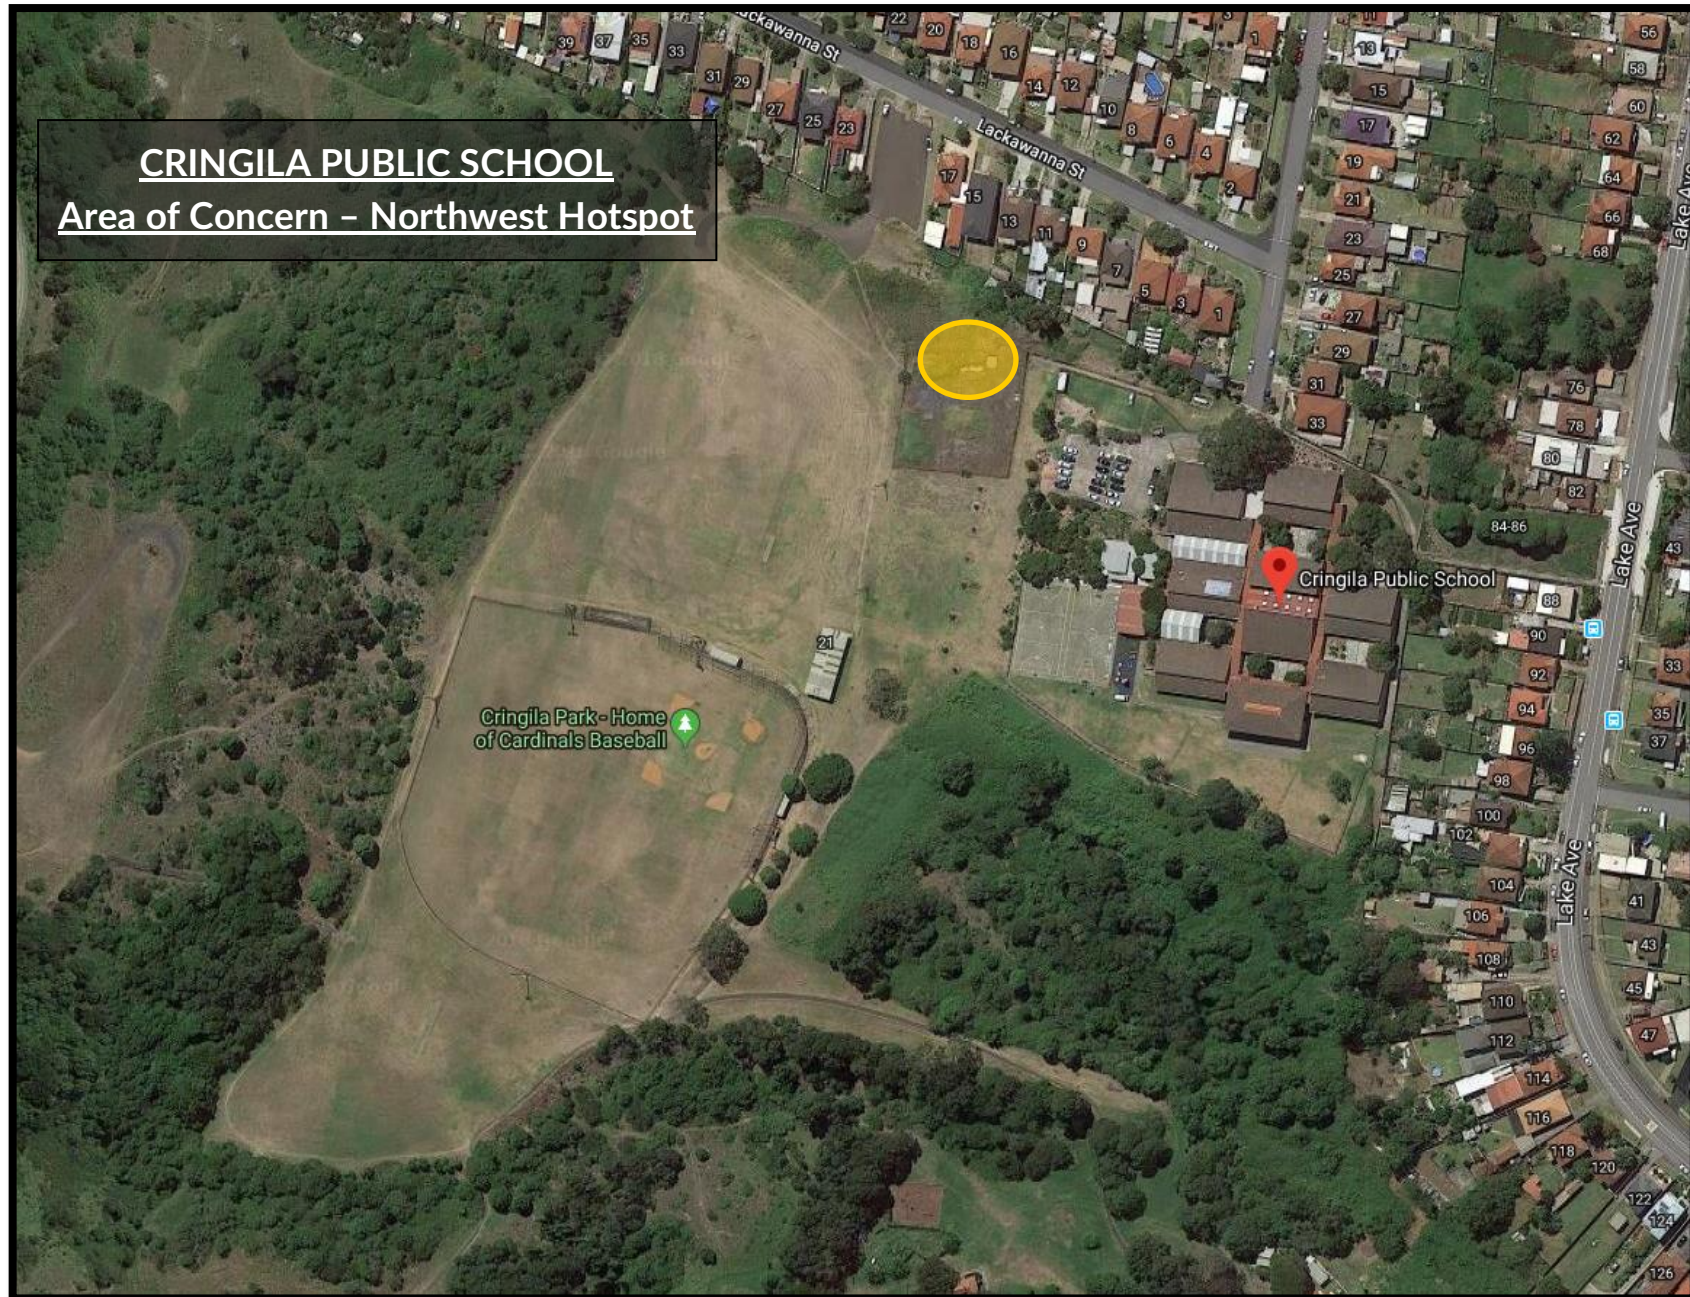
### Appendix A: Area of Concern – Northwest Hotspot Map

**CRINGILA PUBLIC SCHOOL**  
**Area of Concern - Northwest Hotspot**

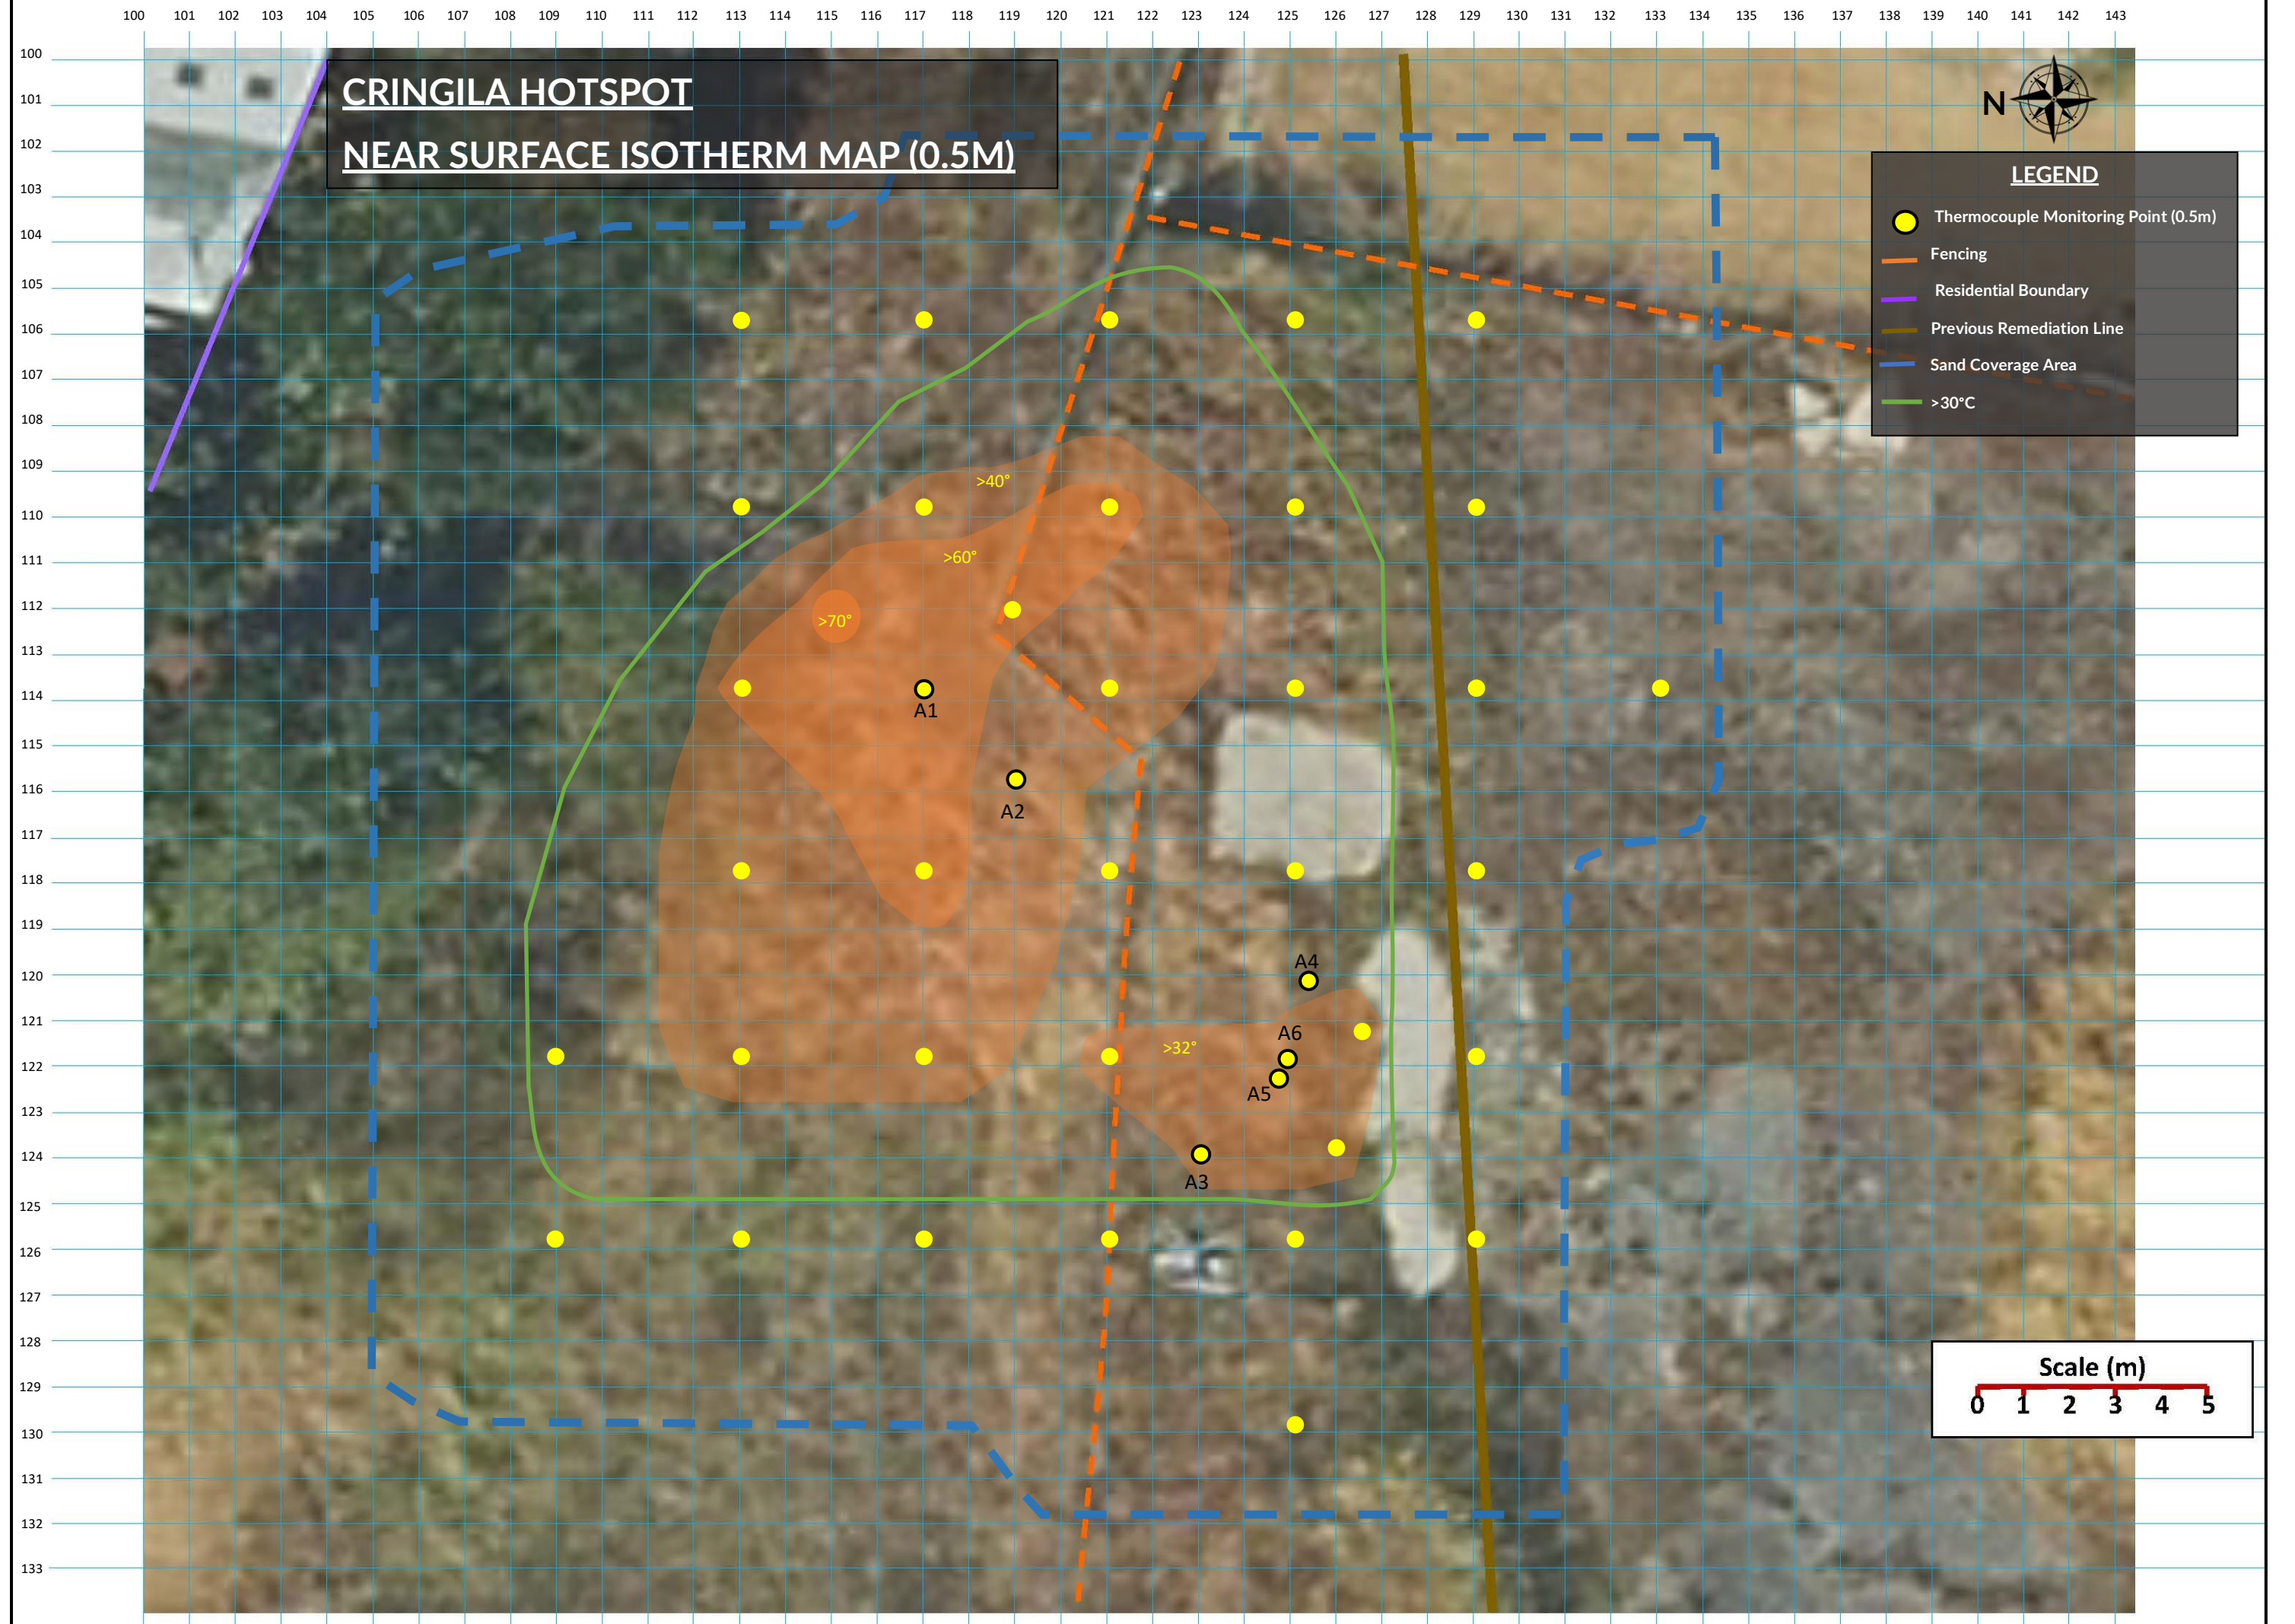
### Appendix C: Near Surface Temperature Isotherm Map (0.5m)

The isotherm mapping indicates a maximum temperature of over 200°C beneath the small mound west of the concrete cap (monitoring point A5 at 0.3m depth) within the northwest hotspot. The isotherm map shows the general zone of influence for temperatures between 30°C and 75°C at 0.5m, coloured orange. The isotherm map suggests that the hotspot may extend deeper than 0.5m and that the increased temperature in these areas is a result of heat venting to the surface.

It is noted that temperature at the near-surface may be variable across the hotspot due to inconsistencies in the consolidation and compaction of subsurface materials.

# CRINGILA HOTSPOT NEAR SURFACE ISOTHERM MAP (0.5M)

It is recommended that weekly site inspections and recording are continued to monitor the surface and near surface temperatures surrounding the hotspot identified at the site.
