NEAR SURFACE TEMPERATURE MONITORING CRINGILA PUBLIC SCHOOL - NW HOTSPOT

Weekly Summary Report
30/07/2018 – 03/08/2018

Cringila Public School

C107826: J153825: RC

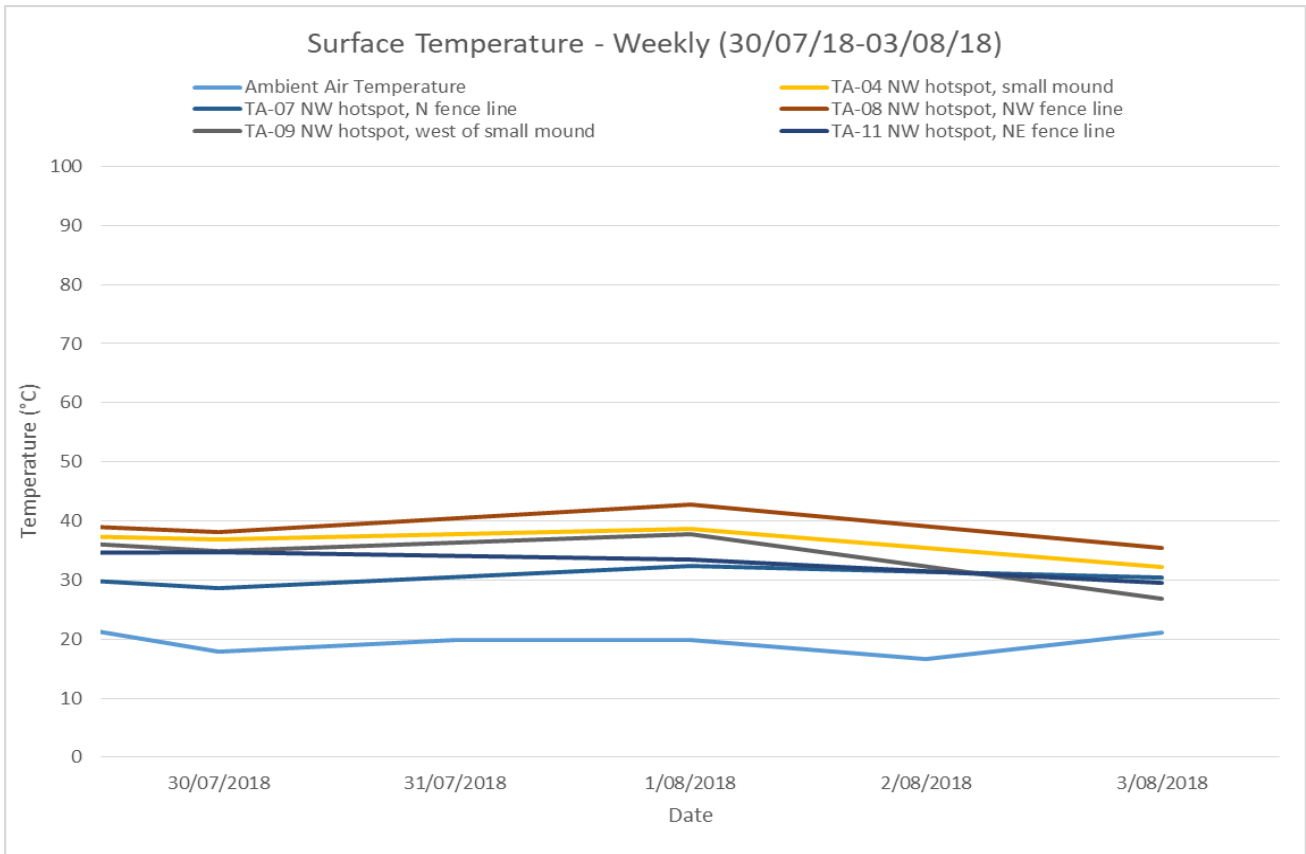
3.2. Surface Temperature Graph – Selected Points (Weekly)

Surface temperature measurements for key locations, over monitoring week – 30/07/2018 to 03/08/2018.

The surface temperature at selected points across the northwest hotspot over the week of monitoring – 30/07/2018 to 03/08/2018, appear to remain consistent.

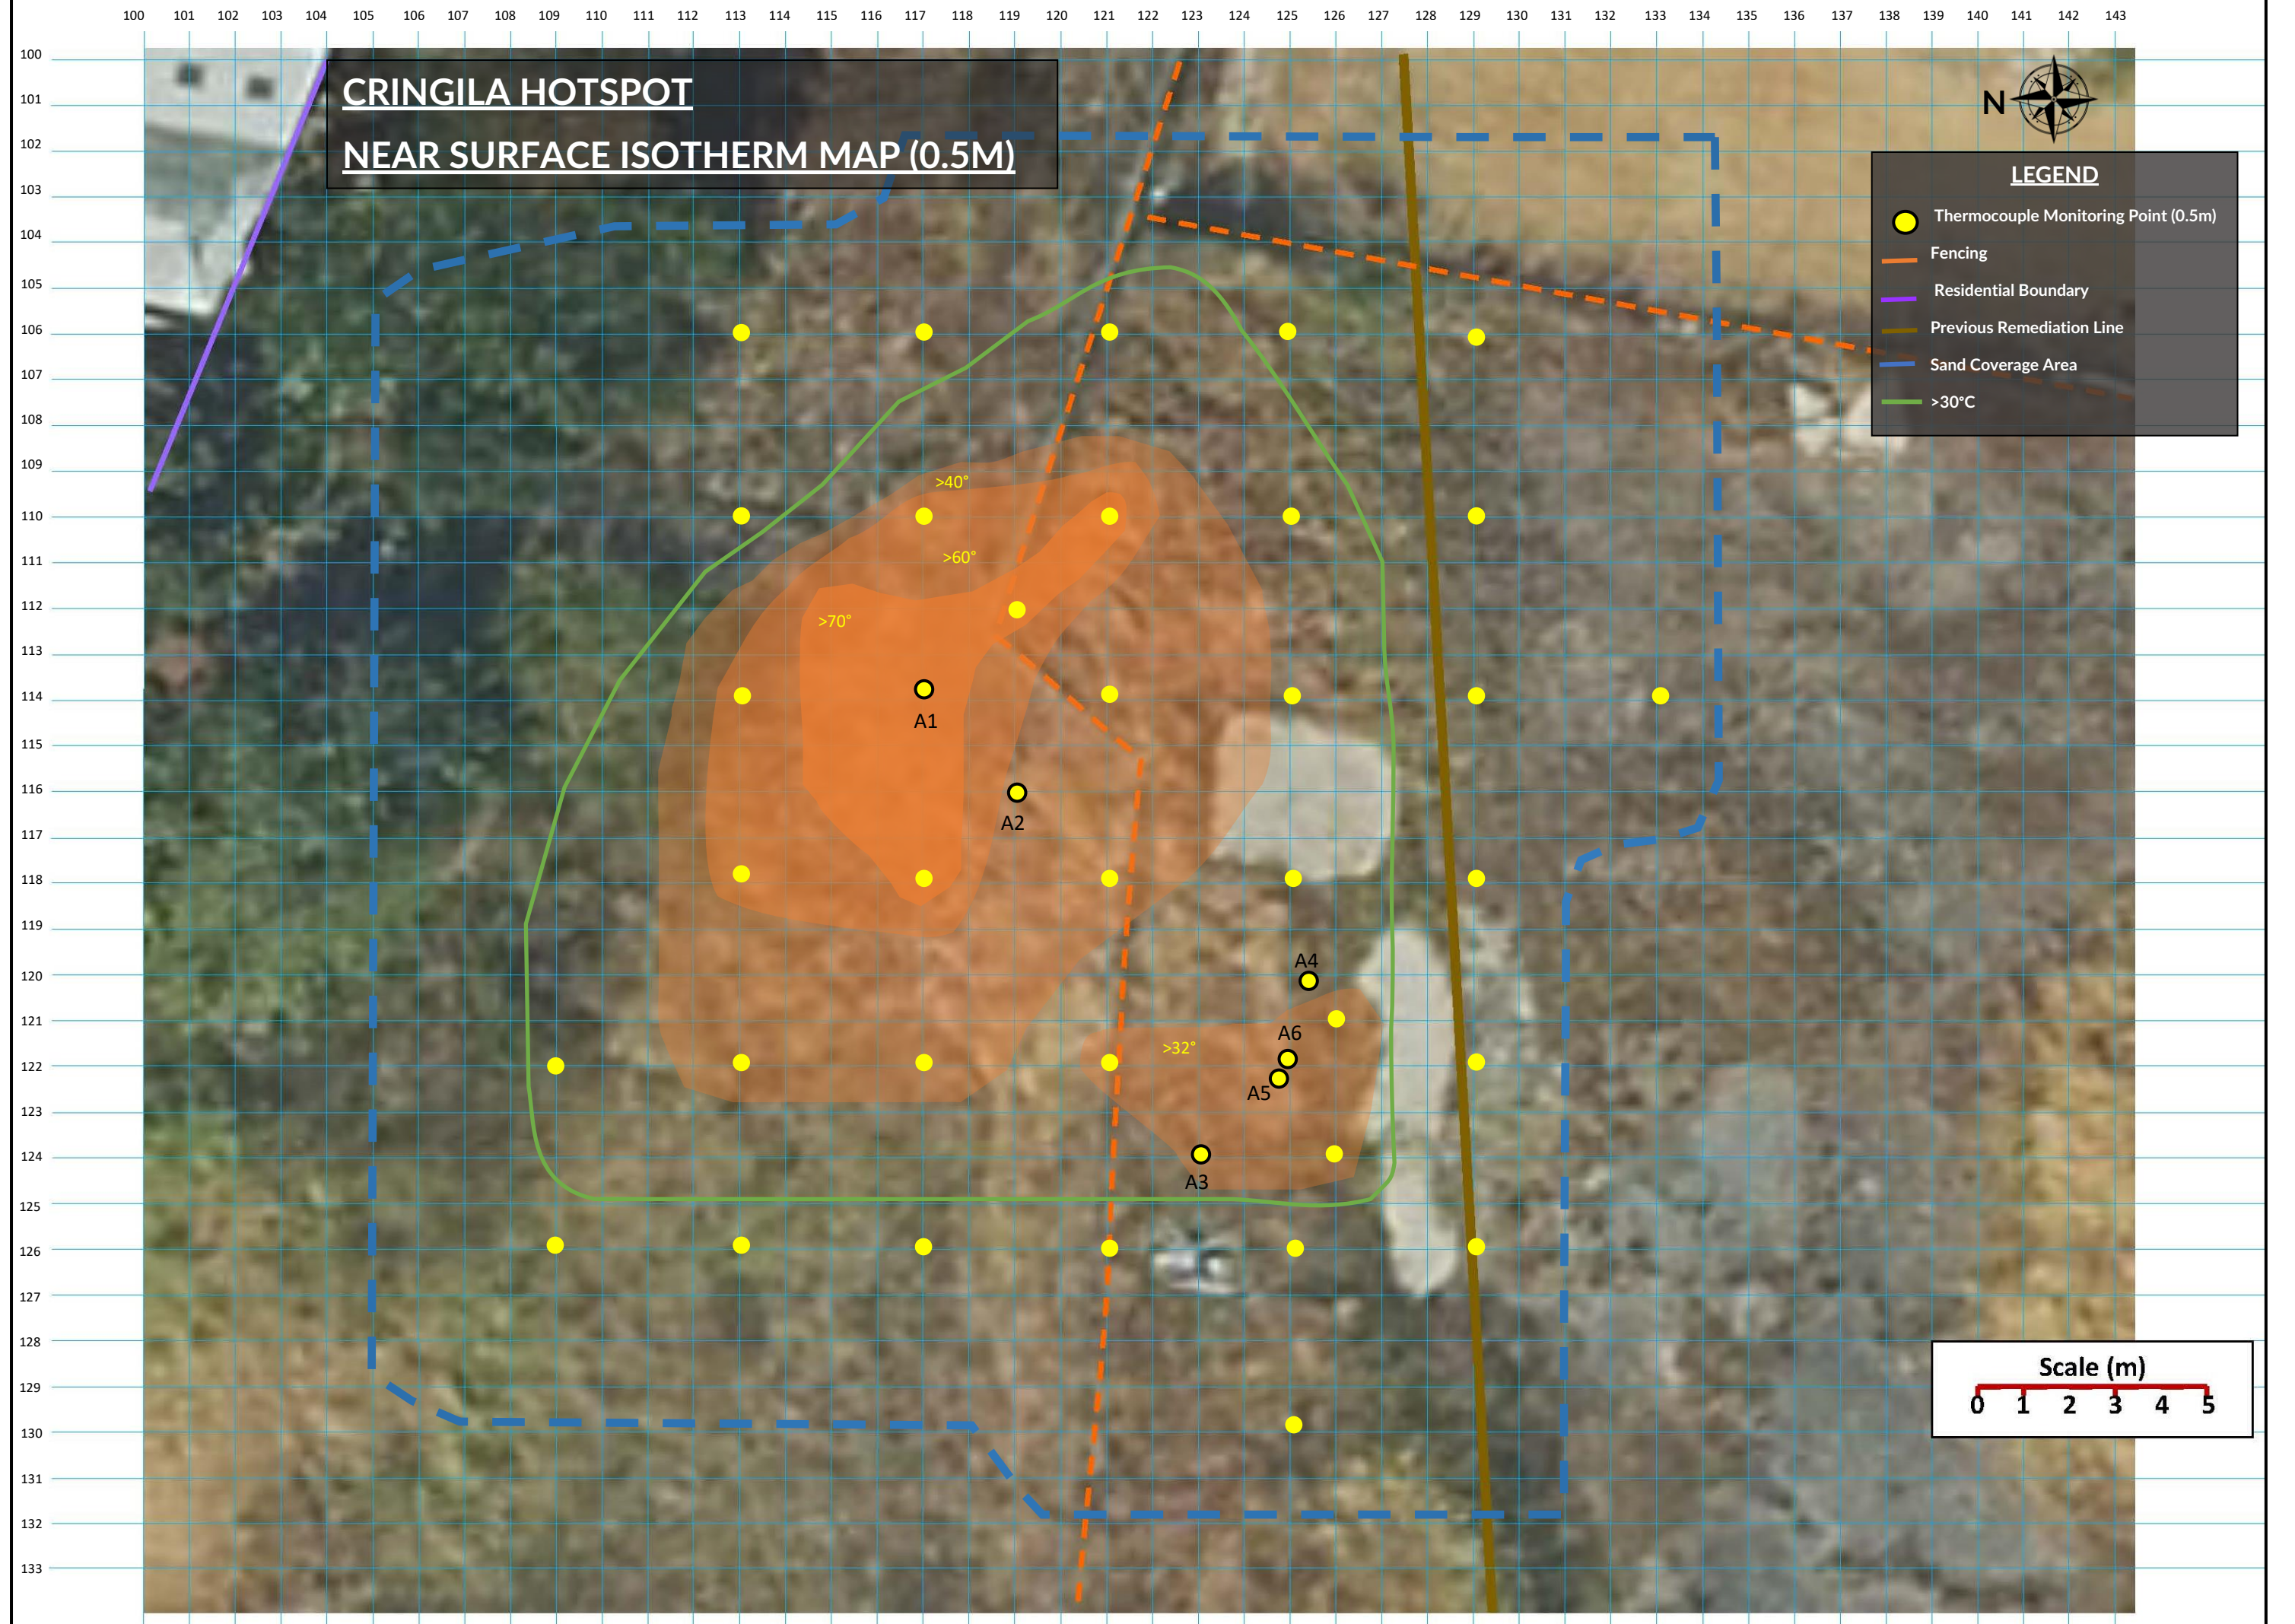
CRINGILA HOTSPOT NEAR SURFACE ISOTHERM MAP (0.5M)

The isotherm map shows the general zone of influence for temperatures between 30°C and 75°C at 0.5m, coloured orange. The isotherm map suggests that the hotspot may extend deeper than 0.5m and that the increased temperature in these areas is a result of heat venting to the surface.

It is noted that temperature at the near-surface may be variable across the hotspot due to inconsistencies in the consolidation and compaction of subsurface materials.

It is recommended that weekly site inspections and recording are continued to monitor the surface and near surface temperatures surrounding the hotspot identified at the site.
