## NEAR SURFACE TEMPERATURE MONITORING CRINGILA PUBLIC SCHOOL - NW HOTSPOT

Weekly Summary Report  
06/08/2018 – 10/08/2018

Cringila Public School

August 2018  
C107826: J153825: RC

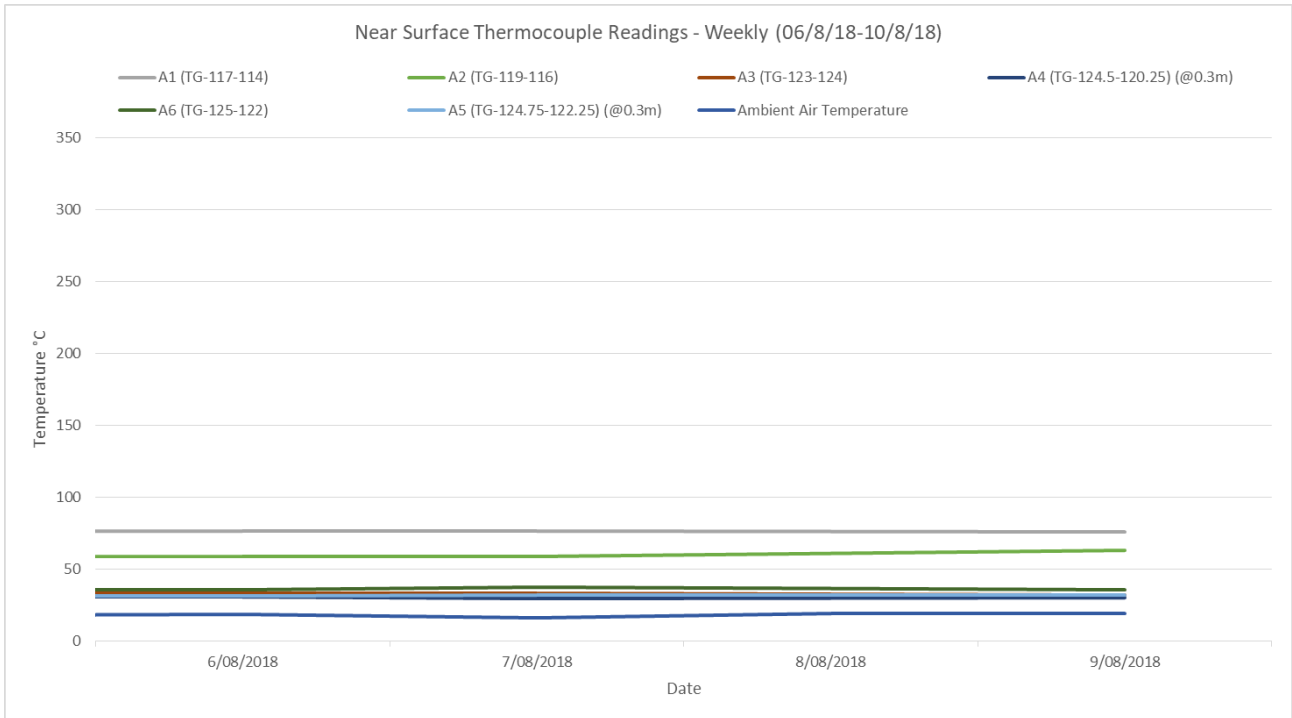
### 3.4. Near Surface Temperature Graph – Selected Points (Weekly)

Near surface temperature measurements for key thermocouple locations, over monitoring week - 06/08/2018 to 10/08/2018.

The near surface temperature at selected points across the northwest hotspot over the week of monitoring – 06/08/2018 to 10/08/2018, appear to remain consistent.

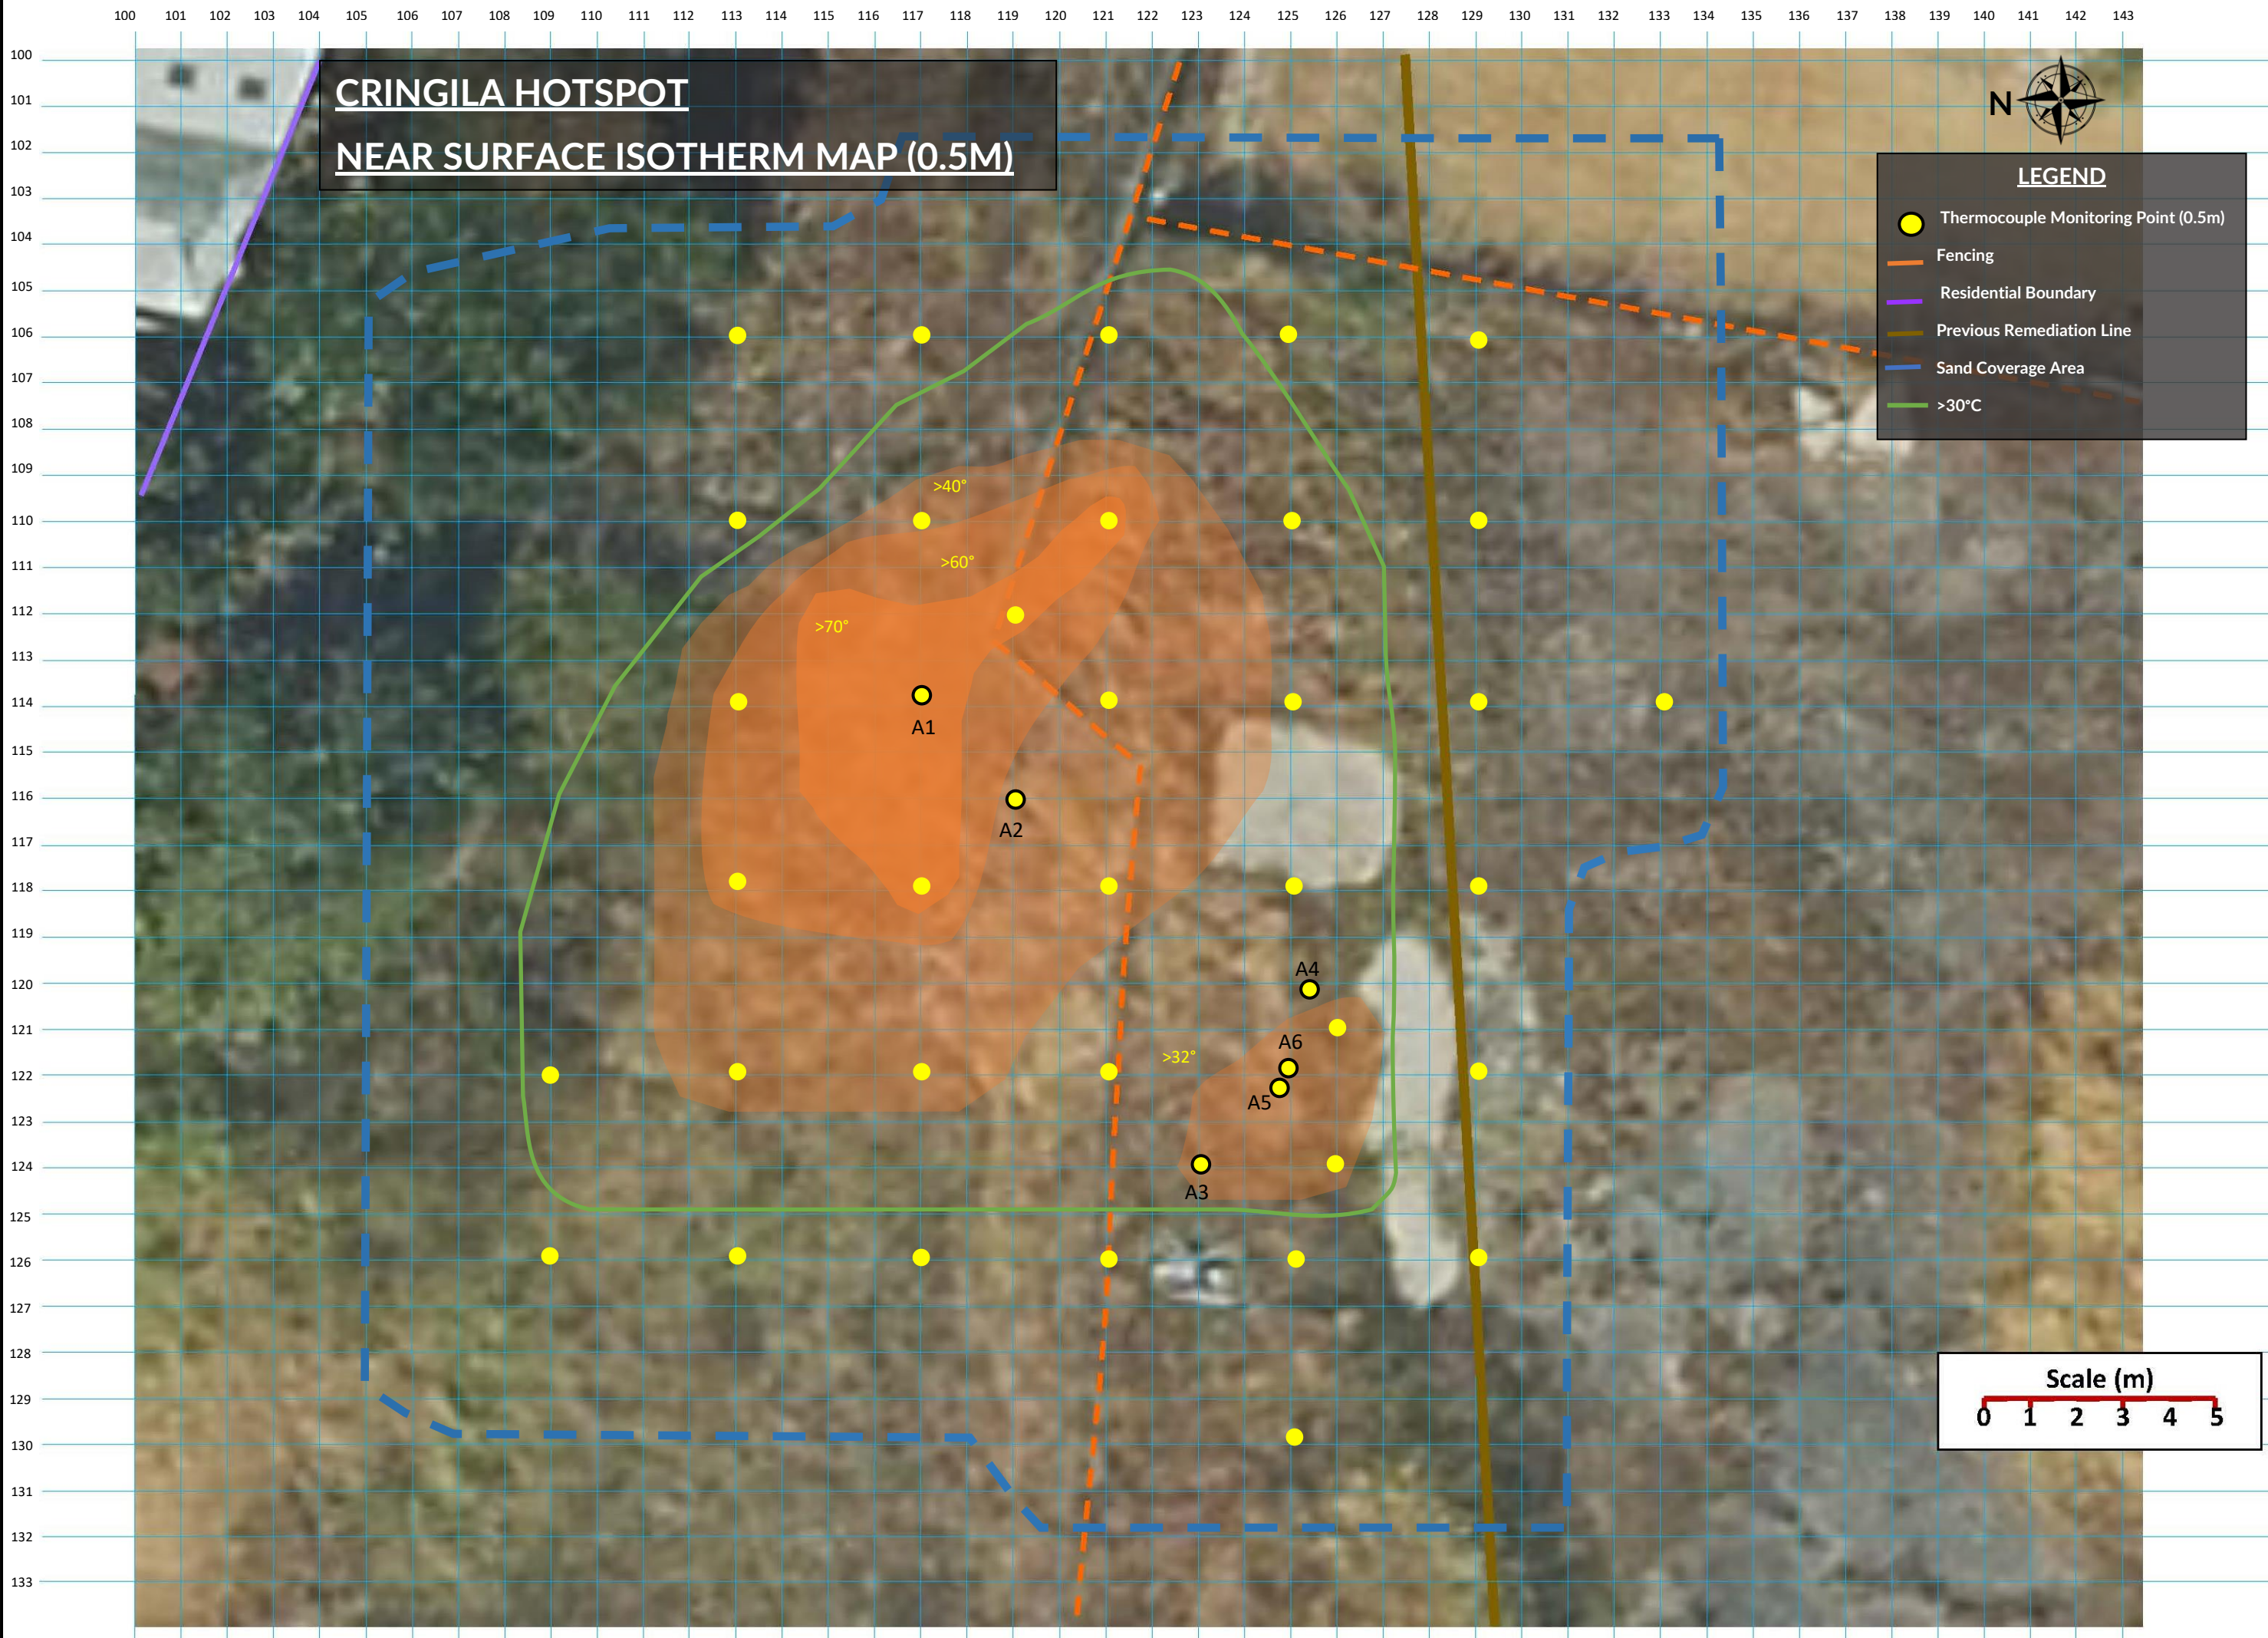
### Appendix C: Near Surface Temperature Isotherm Map (0.5m)

The isotherm map shows the general zone of influence for temperatures between 30°C and 75°C at 0.5m, coloured orange. The isotherm map suggests that the hotspot may extend deeper than 0.5m and that the increased temperature in these areas is a result of heat venting to the surface.

It is noted that temperature at the near-surface may be variable across the hotspot due to inconsistencies in the consolidation and compaction of subsurface materials.

# CRINGILA HOTSPOT NEAR SURFACE ISOTHERM MAP (0.5M)

It is recommended that weekly site inspections and recording are continued to monitor the surface and near surface temperatures surrounding the hotspot identified at the site.
