NEAR SURFACE TEMPERATURE MONITORING CRINGILA PUBLIC SCHOOL - NW HOTSPOT

Weekly Summary Report
13/08/2018 – 17/08/2018

Cringila Public School

35 Sheffield Street
Cringila NSW 2502

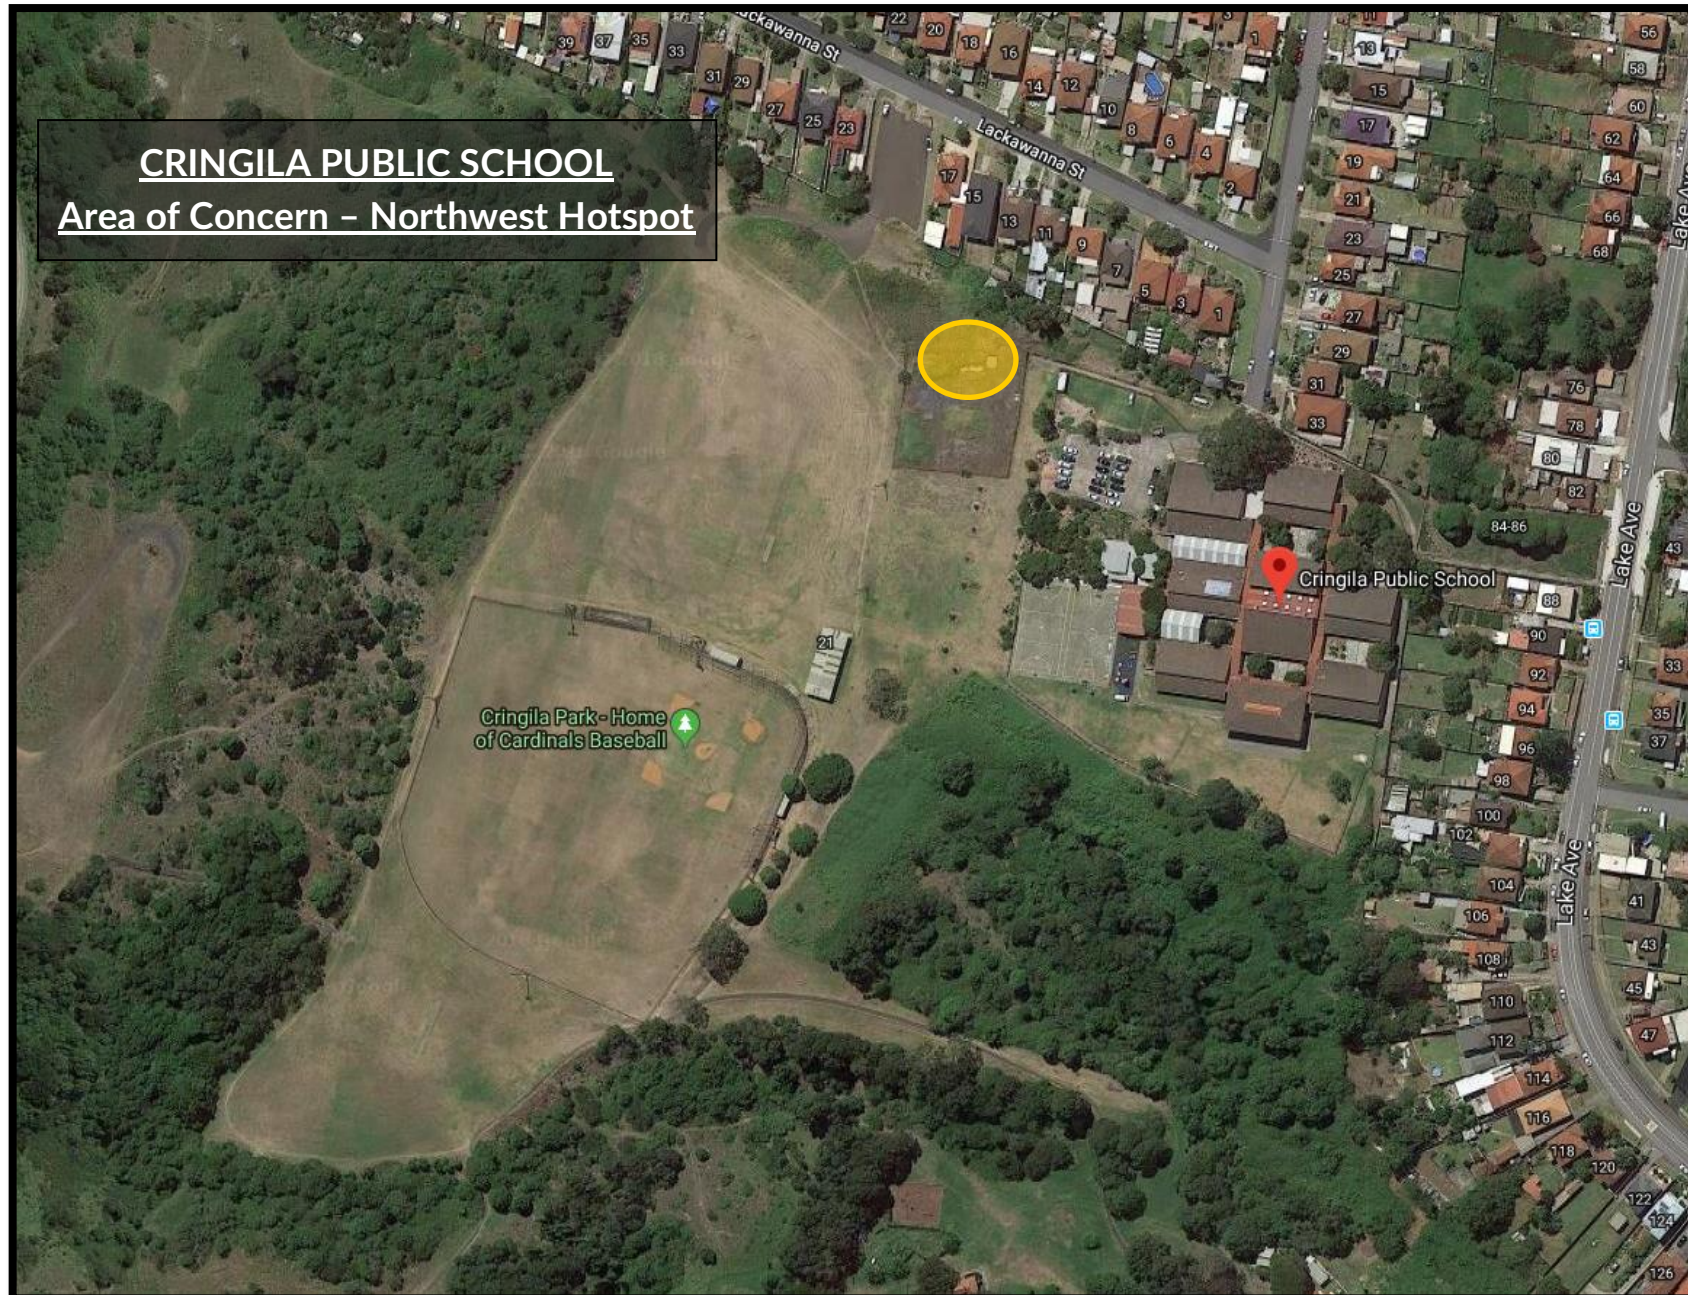
Appendix A: Area of Concern – Northwest Hotspot Map

CRINGILA PUBLIC SCHOOL
Area of Concern - Northwest Hotspot

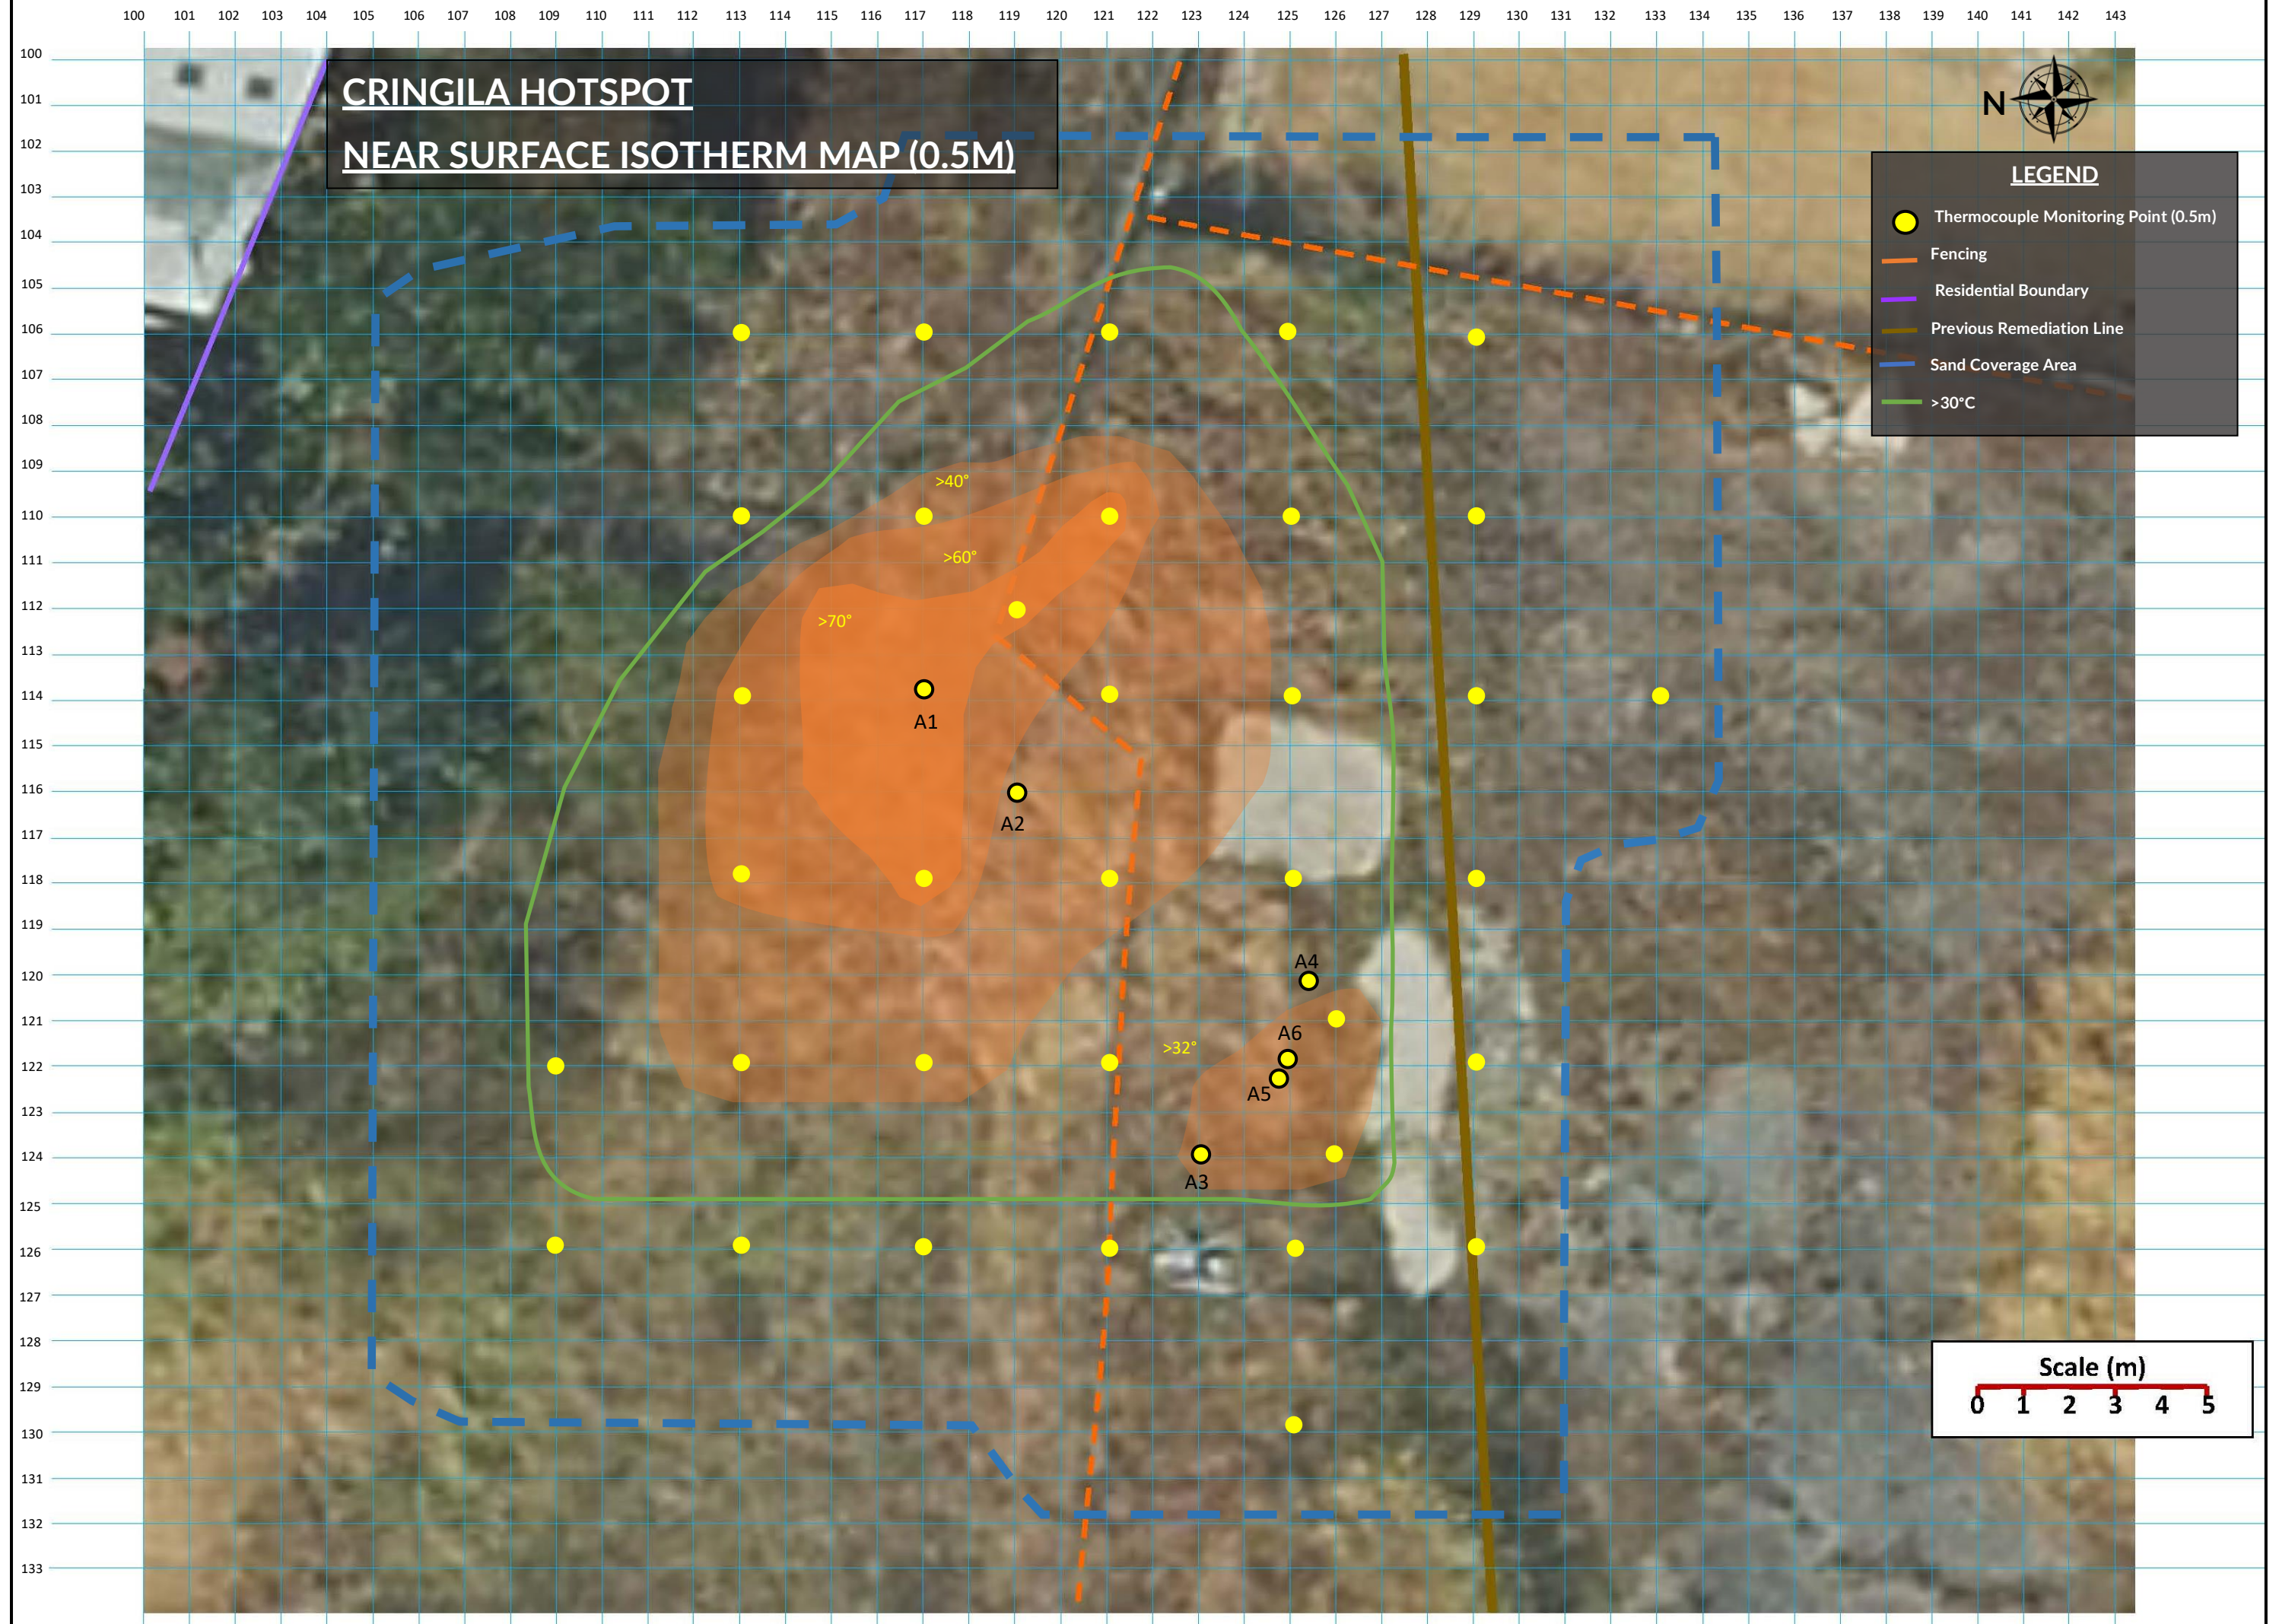
Appendix C: Near Surface Temperature Isotherm Map (0.5m)

The isotherm map shows the general zone of influence for temperatures between 30°C and 75°C at 0.5m, coloured orange. The isotherm map suggests that the hotspot may extend deeper than 0.5m and that the increased temperature in these areas is a result of heat venting to the surface.

It is noted that temperature at the near-surface may be variable across the hotspot due to inconsistencies in the consolidation and compaction of subsurface materials.

CRINGILA HOTSPOT NEAR SURFACE ISOTHERM MAP (0.5M)

It is recommended that weekly site inspections and recording are continued to monitor the surface and near surface temperatures surrounding the hotspot identified at the site.
