## NEAR SURFACE TEMPERATURE MONITORING CRINGILA PUBLIC SCHOOL - NW HOTSPOT

Weekly Summary Report  
03/09/2018 – 07/09/2018

Cringila Public School

35 Sheffield Street  
Cringila NSW 2502

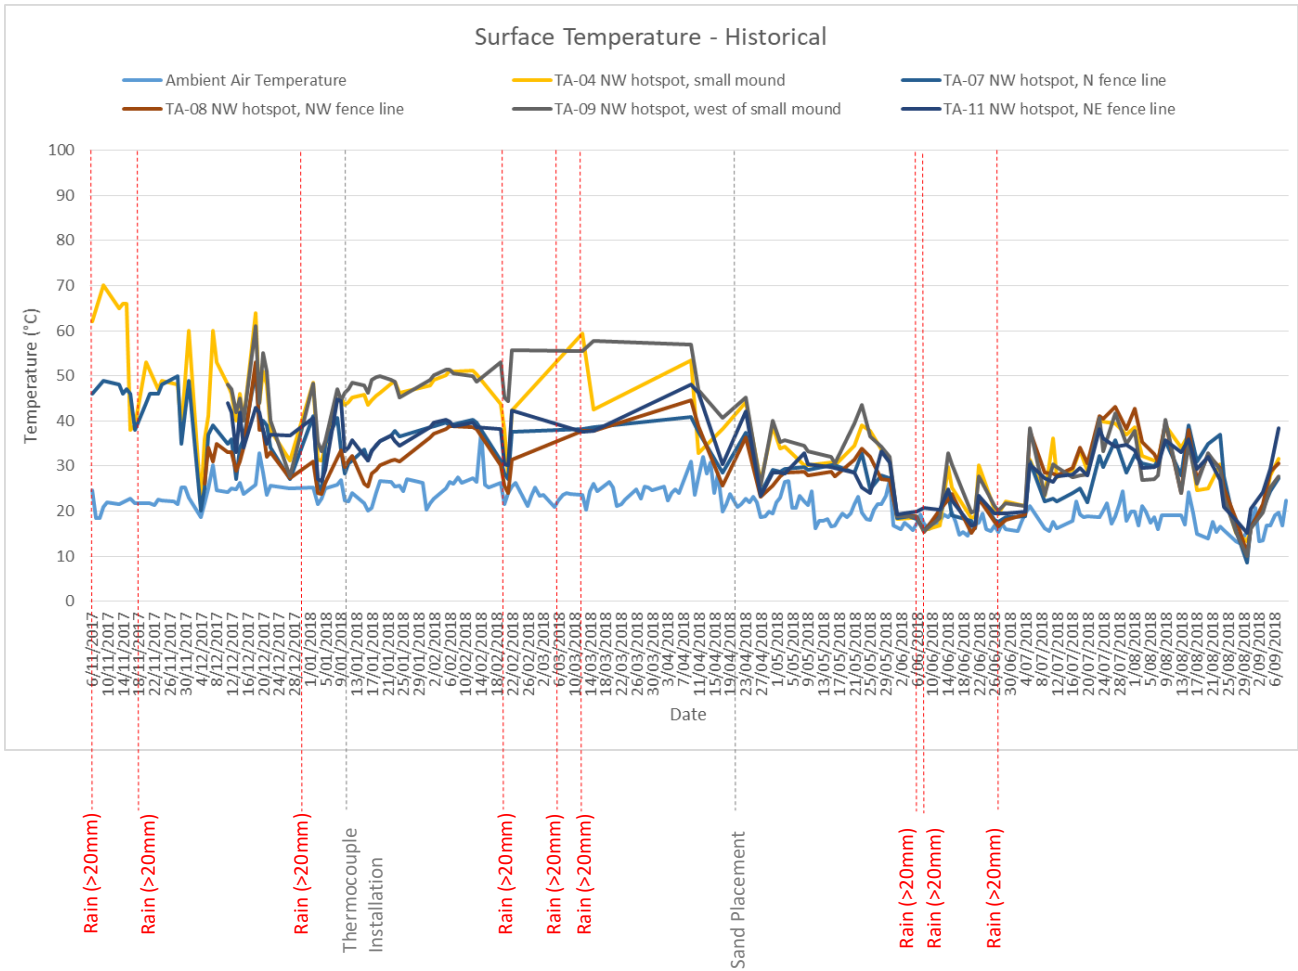
### 3.1. Surface Temperature Graph – Selected Points (Historical)

Surface temperature measurements for key locations, progressive from Monday 6<sup>th</sup> November 2017 to present.

The surface temperature appears to have decreased and stabilised following the placement of sand (approximately 100mm) across the surface of the northwest hotspot grid monitoring area.

Fluctuations in surface temperature are evident following significant rain events (i.e. over 20mm). Surface temperature also appears to correlate with the ambient air temperature and the range of direct sunlight throughout the day.

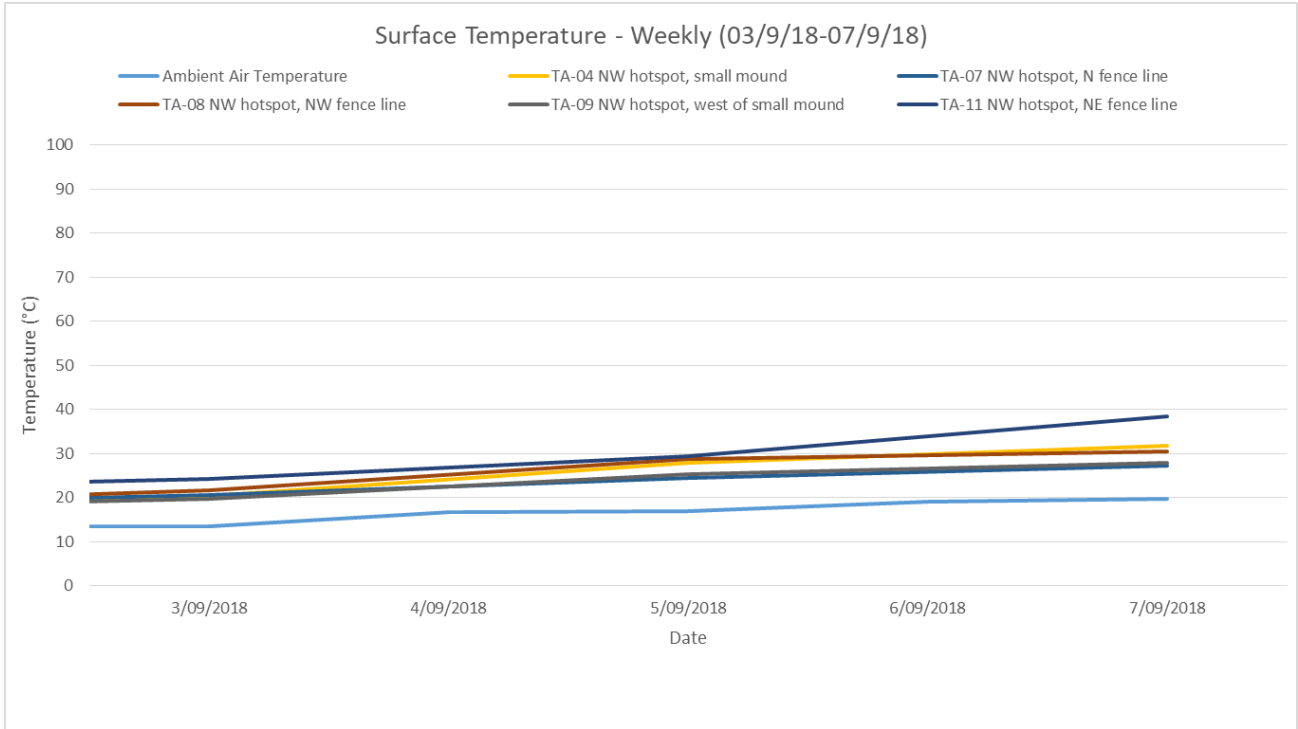
### 3.2. Surface Temperature Graph – Selected Points (Weekly)

Surface temperature measurements for key locations, over monitoring week – 03/09/2018 to 07/09/2018.

The surface temperature at selected points across the northwest hotspot over the week of monitoring – 03/09/2018 to 07/09/2018, appear to remain consistent.

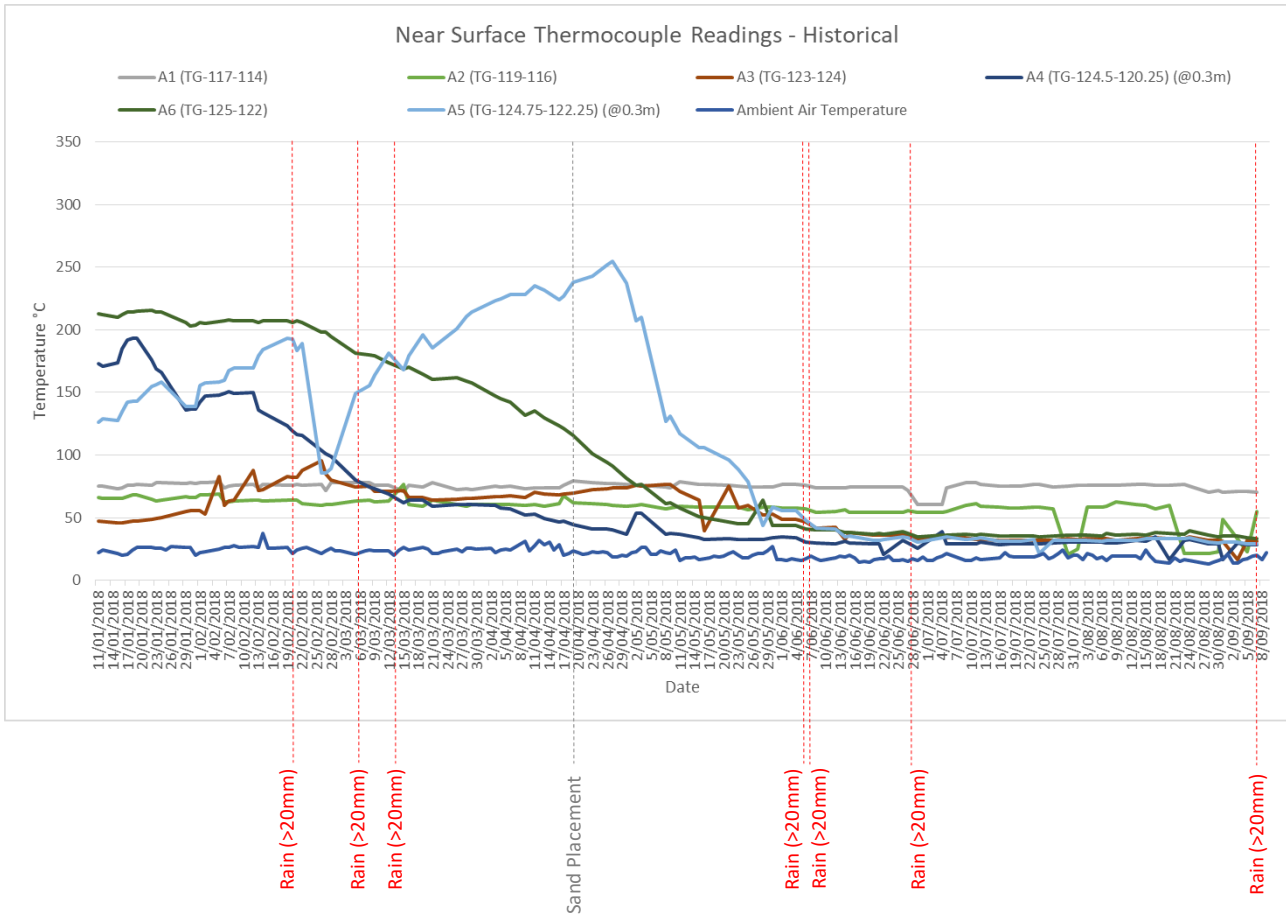
### 3.3. Near Surface Temperature Graph – Selected Points (Historical)

Near surface temperature measurements for key thermocouple locations, progressive from Thursday 11<sup>th</sup> January 2018 to present.

The near surface temperature appears to be trending downwards following the placement of sand (approximately 100mm) across the surface of the northwest hotspot grid monitoring area.

Fluctuations in near surface temperature are evident following significant rain events (i.e. over 20mm rain).

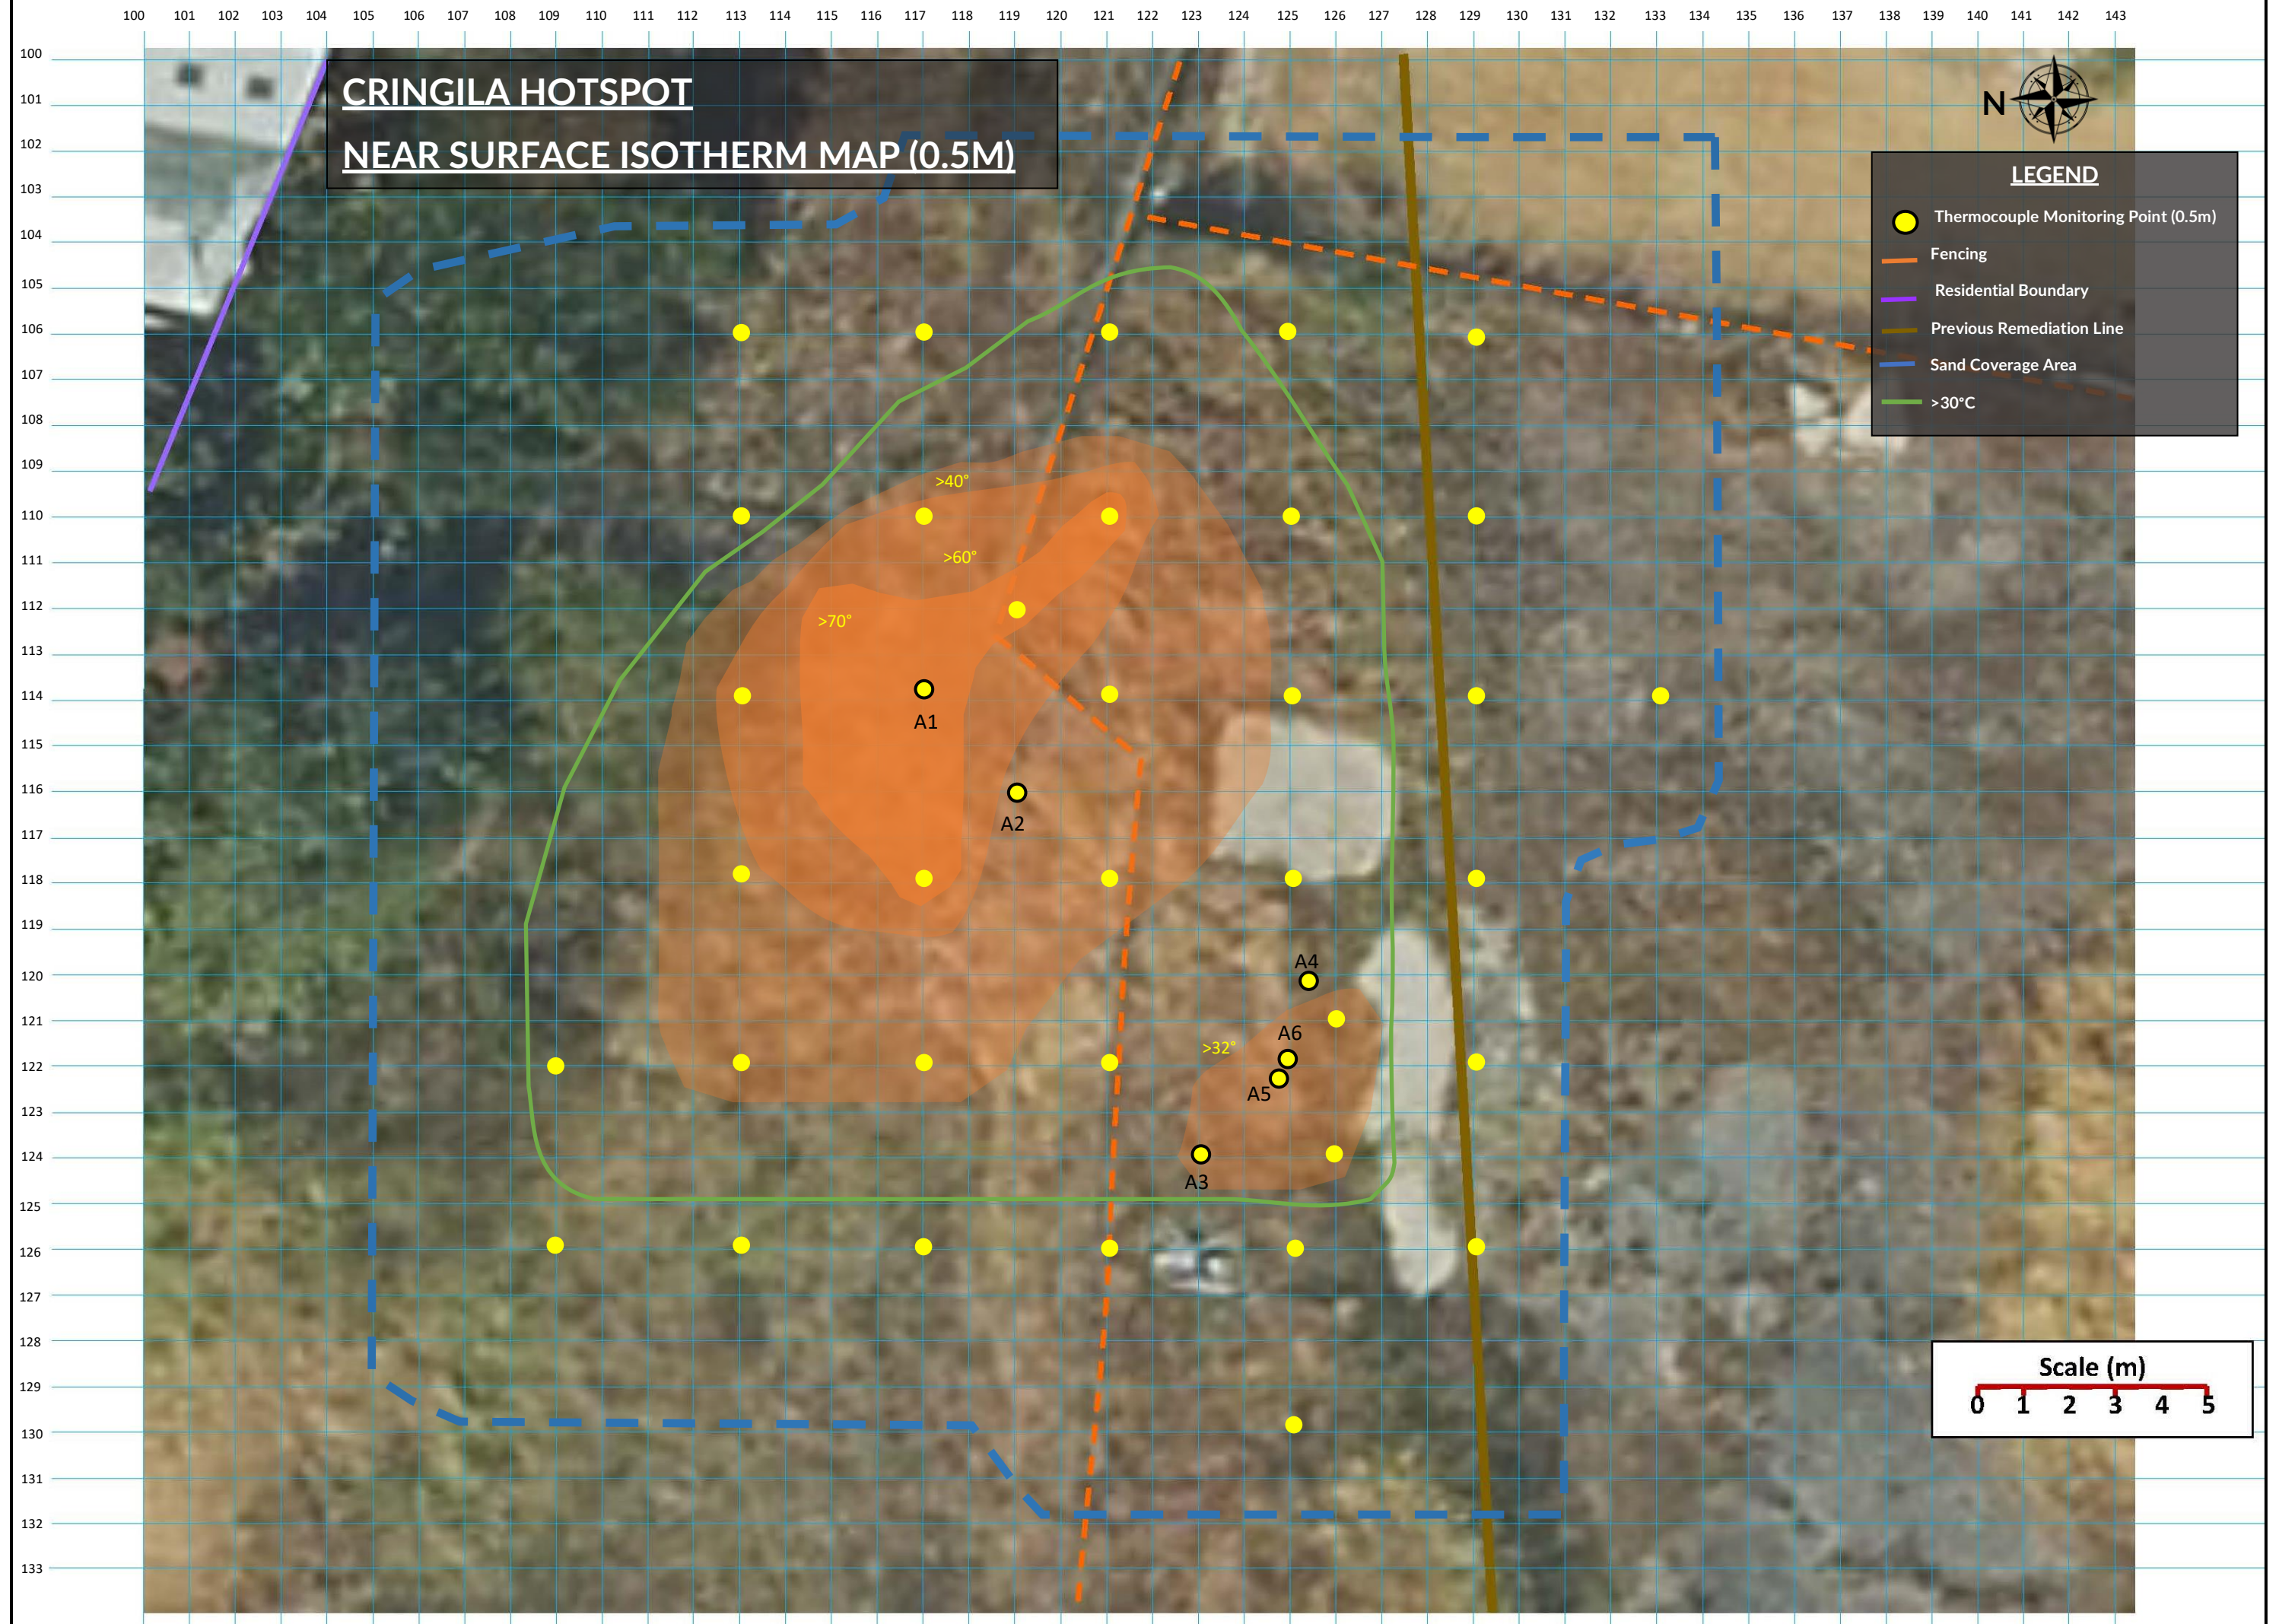
### Appendix C: Near Surface Temperature Isotherm Map (0.5m)

The isotherm map shows the general zone of influence for temperatures between 30°C and 75°C at 0.5m, coloured orange. The isotherm map suggests that the hotspot may extend deeper than 0.5m and that the increased temperature in these areas is a result of heat venting to the surface.

It is noted that temperature at the near-surface may be variable across the hotspot due to inconsistencies in the consolidation and compaction of subsurface materials.

# CRINGILA HOTSPOT NEAR SURFACE ISOTHERM MAP (0.5M)

It is recommended that weekly site inspections and recording are continued to monitor the surface and near surface temperatures surrounding the hotspot identified at the site.
