## NEAR SURFACE TEMPERATURE MONITORING CRINGILA PUBLIC SCHOOL - NW HOTSPOT

Weekly Summary Report  
10/09/2018 - 14/09/2018

Cringila Public School

September 2018  
C107826: J153825: RC

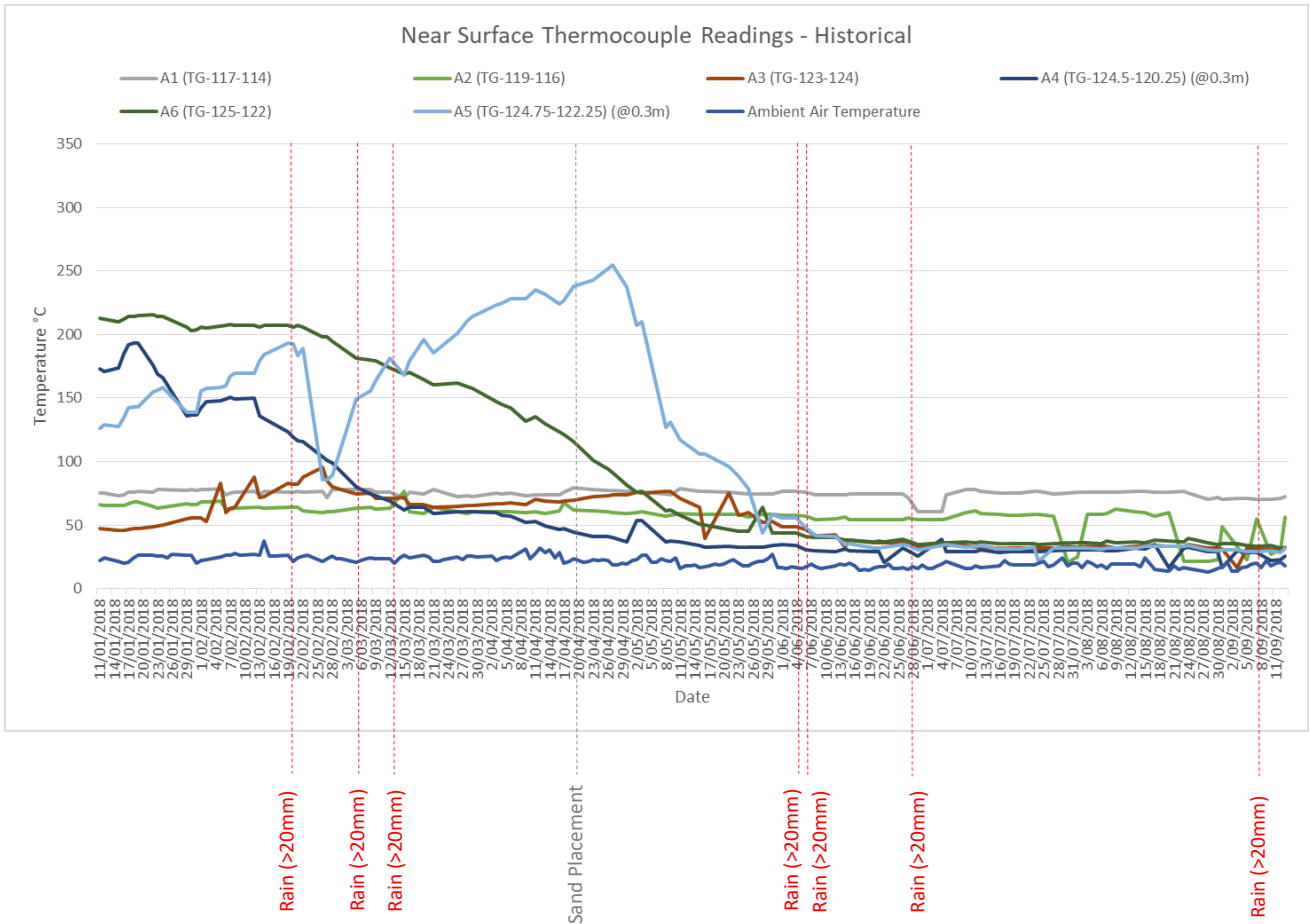
### 3.3. Near Surface Temperature Graph – Selected Points (Historical)

Near surface temperature measurements for key thermocouple locations, progressive from Thursday 11<sup>th</sup> January 2018 to present.

The near surface temperature appears to be trending downwards following the placement of sand (approximately 100mm) across the surface of the northwest hotspot grid monitoring area.

Fluctuations in near surface temperature are evident following significant rain events (i.e. over 20mm rain).

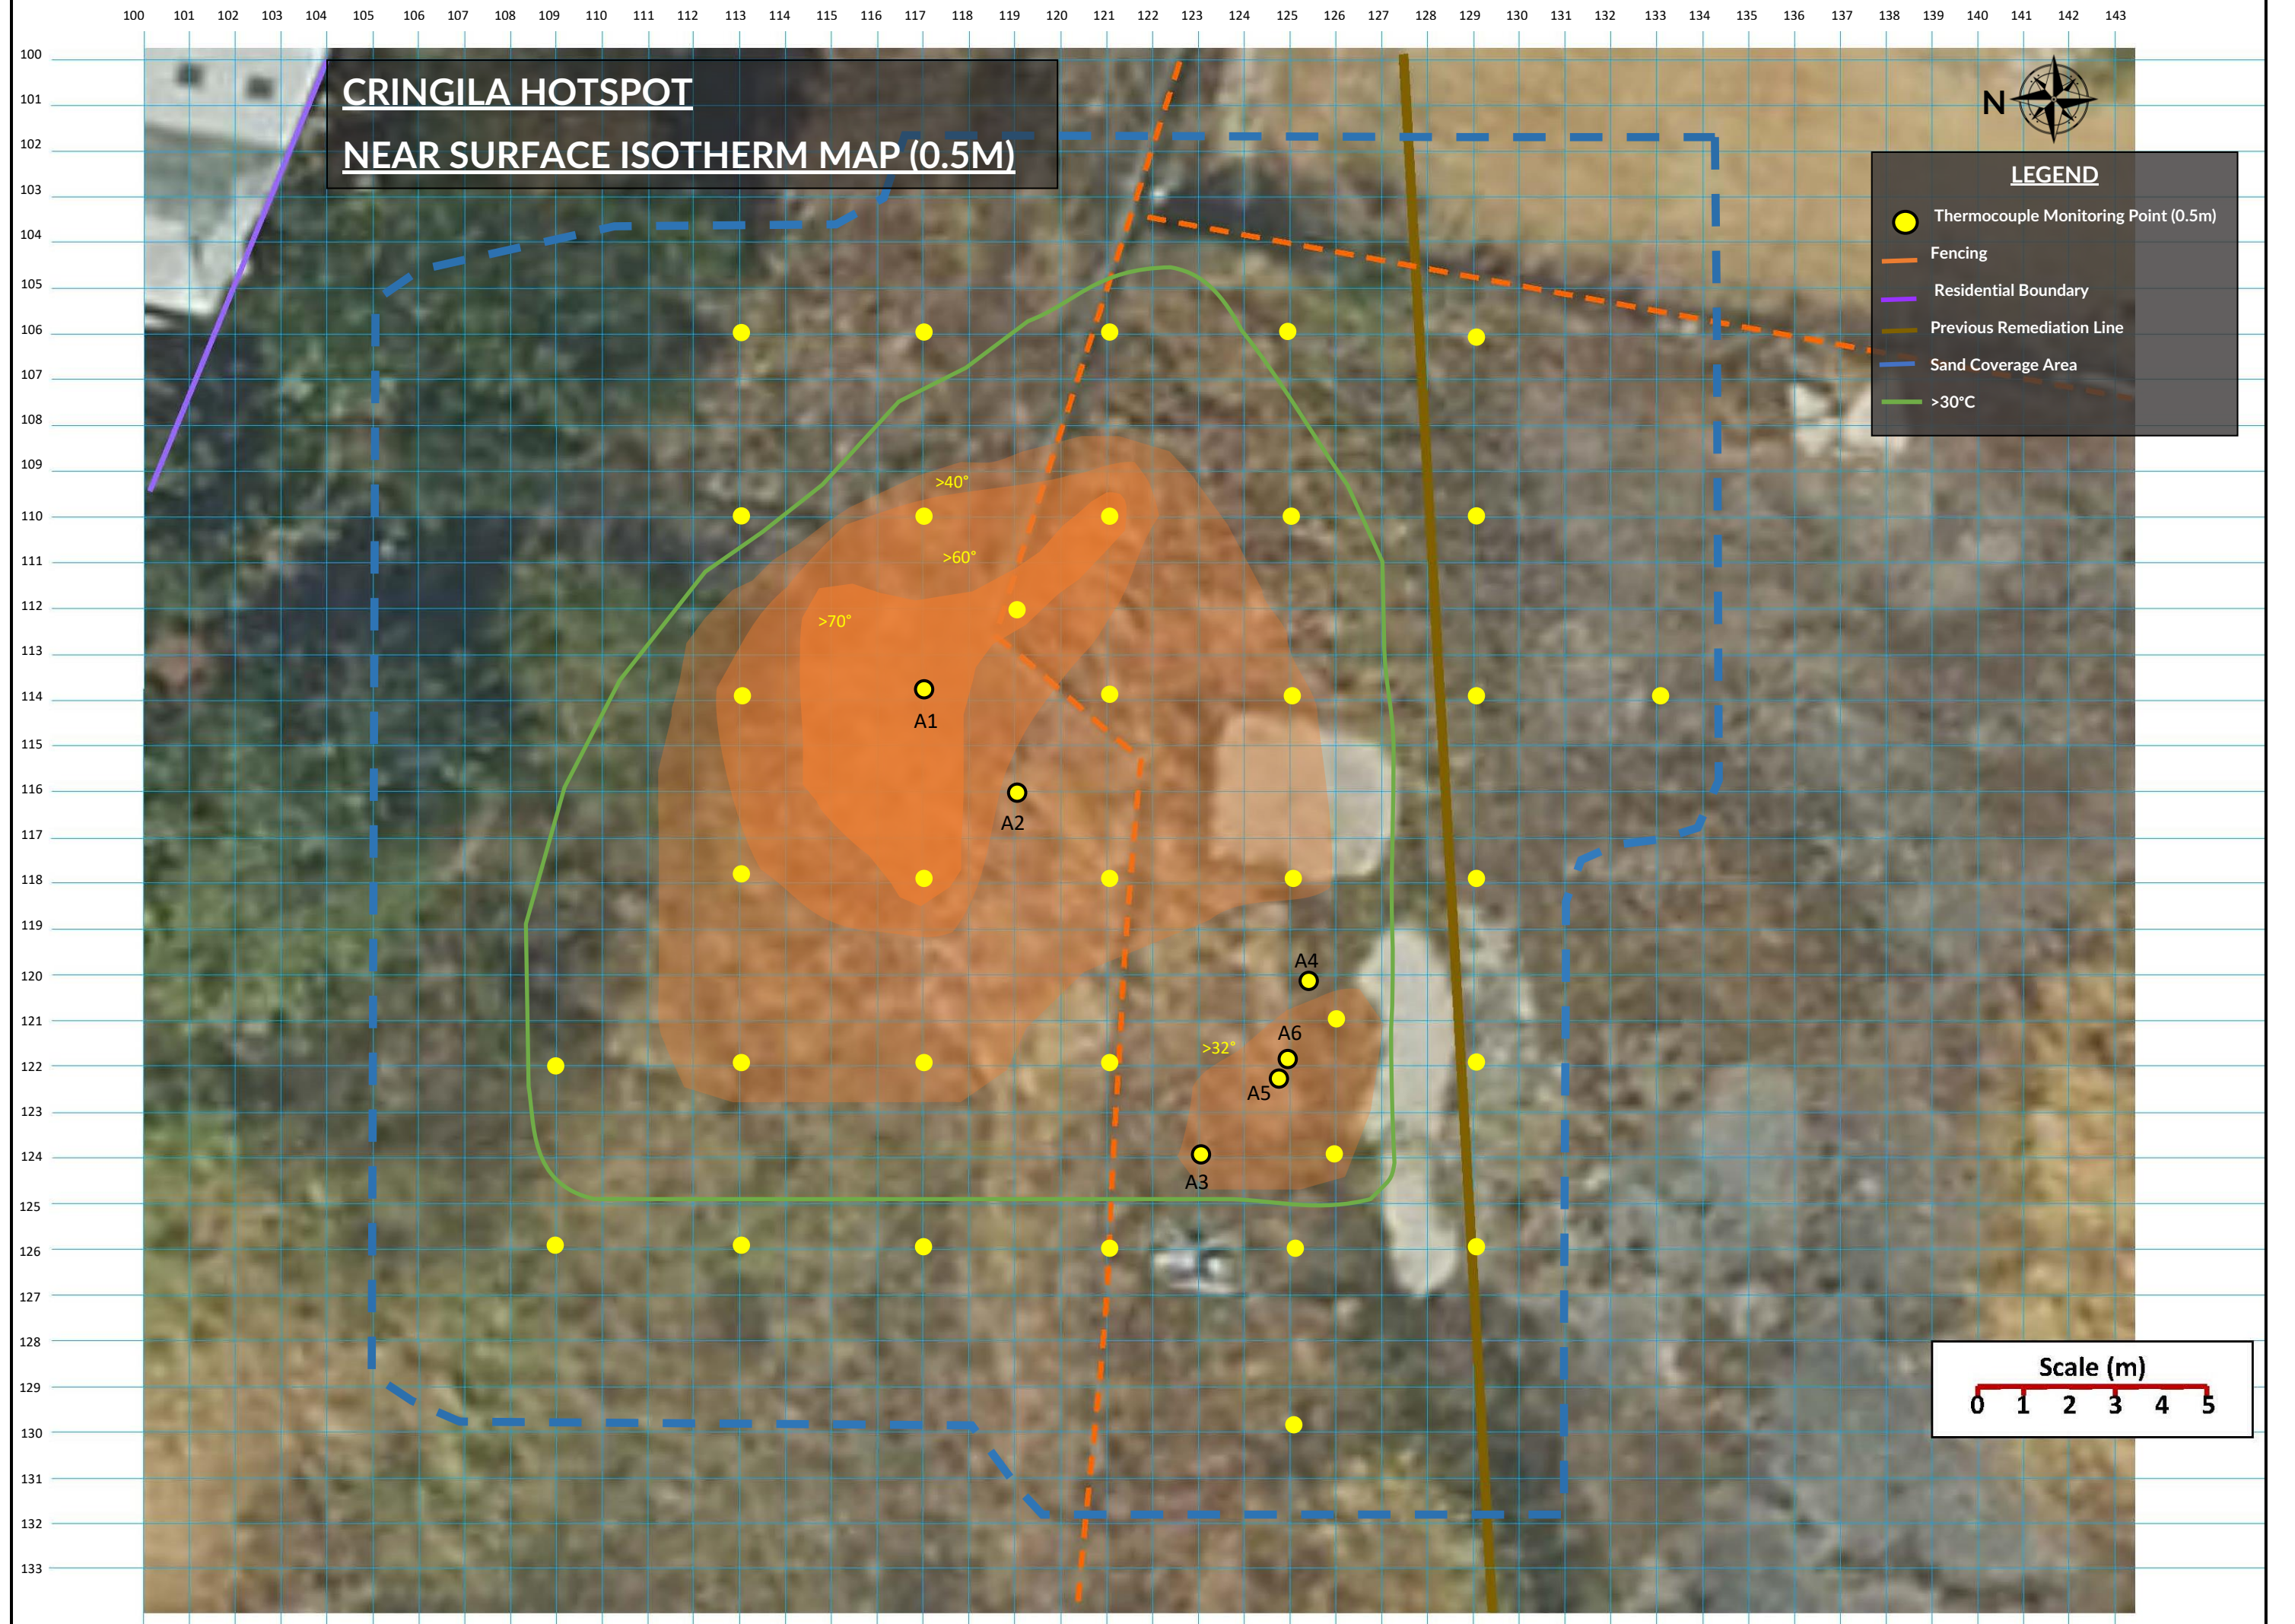
### Appendix C: Near Surface Temperature Isotherm Map (0.5m)

The isotherm map shows the general zone of influence for temperatures between 30°C and 75°C at 0.5m, coloured orange. The isotherm map suggests that the hotspot may extend deeper than 0.5m and that the increased temperature in these areas is a result of heat venting to the surface.

It is noted that temperature at the near-surface may be variable across the hotspot due to inconsistencies in the consolidation and compaction of subsurface materials.

# CRINGILA HOTSPOT NEAR SURFACE ISOTHERM MAP (0.5M)

It is recommended that weekly site inspections and recording are continued to monitor the surface and near surface temperatures surrounding the hotspot identified at the site.
