NEAR SURFACE TEMPERATURE MONITORING CRINGILA PUBLIC SCHOOL - NW HOTSPOT

Weekly Summary Report
17/09/2018 – 21/09/2018

Cringila Public School

September 2018
C107826: J153825: RC

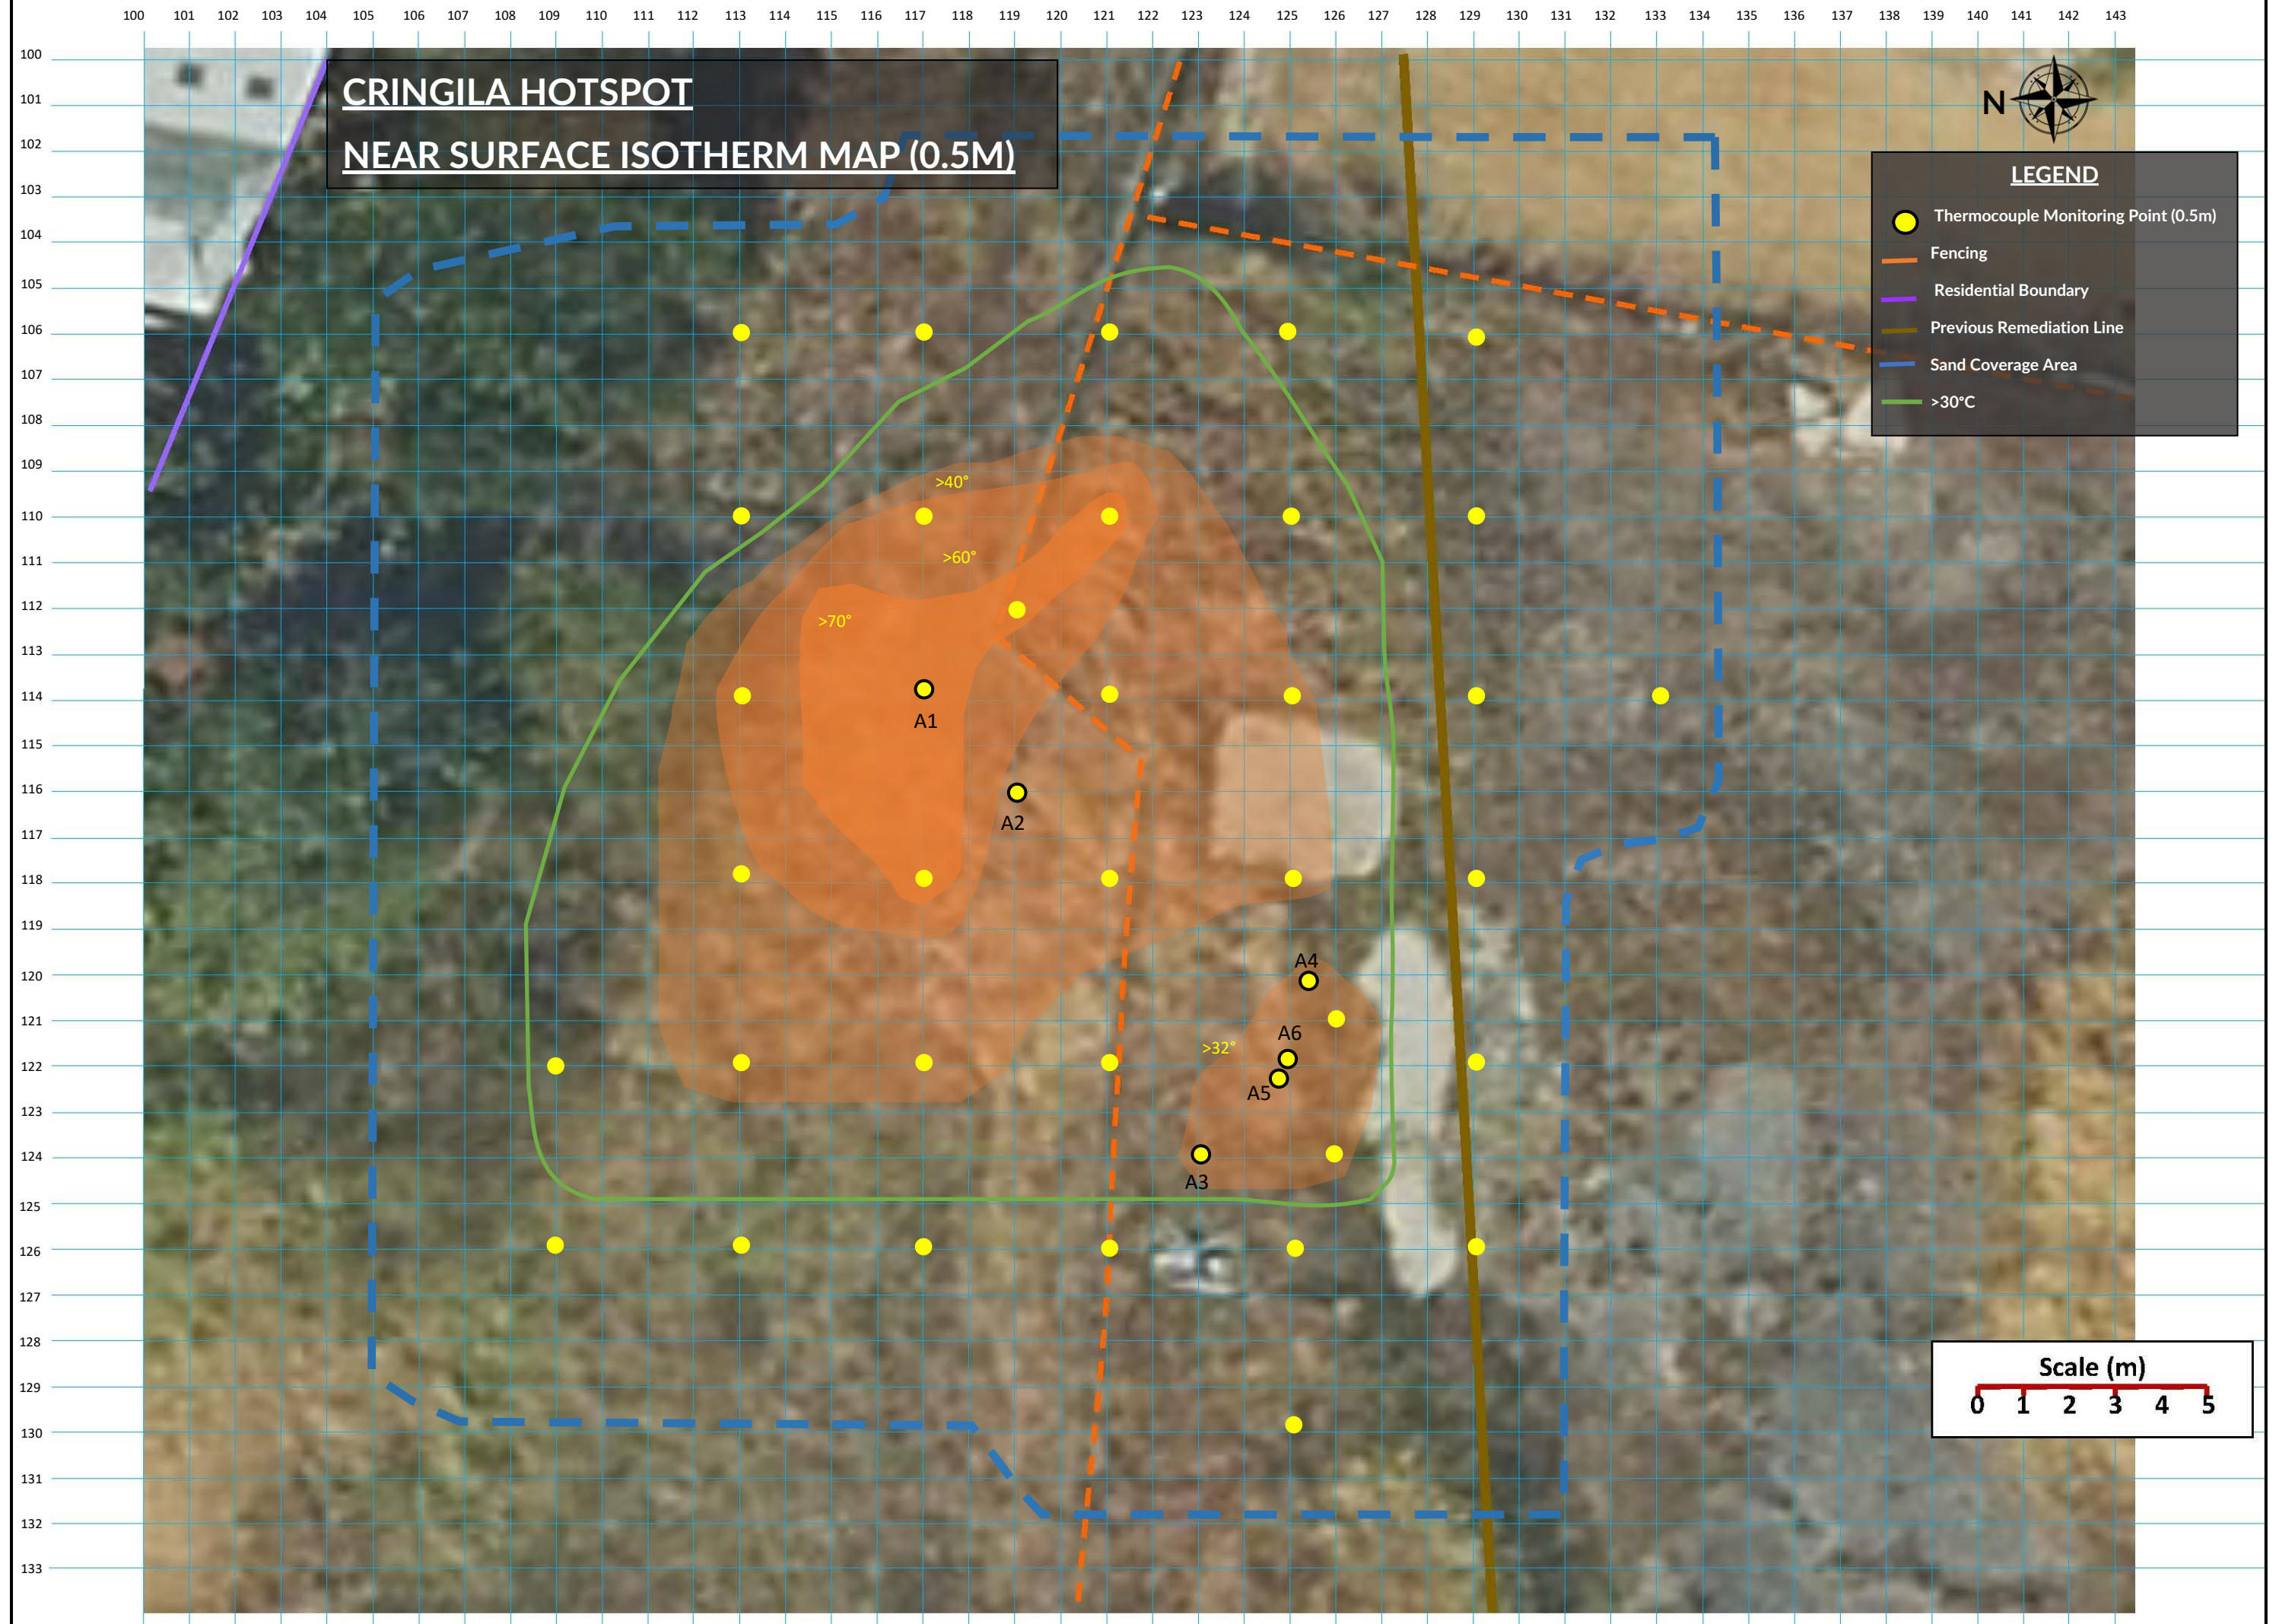
Appendix C: Near Surface Temperature Isotherm Map (0.5m)

The isotherm map shows the general zone of influence for temperatures between 30°C and 78°C at 0.5m, coloured orange. The isotherm map suggests that the hotspot may extend deeper than 0.5m and that the increased temperature in these areas is a result of heat venting to the surface.

It is noted that temperature at the near-surface may be variable across the hotspot due to inconsistencies in the consolidation and compaction of subsurface materials.

CRINGILA HOTSPOT NEAR SURFACE ISOTHERM MAP (0.5M)

It is recommended that weekly site inspections and recording are continued to monitor the surface and near surface temperatures surrounding the hotspot identified at the site.
