NEAR SURFACE TEMPERATURE MONITORING CRINGILA PUBLIC SCHOOL - NW HOTSPOT

Weekly Summary Report
24/09/2018 – 28/09/2018

Cringila Public School

October 2018
C107826: J153825: RC

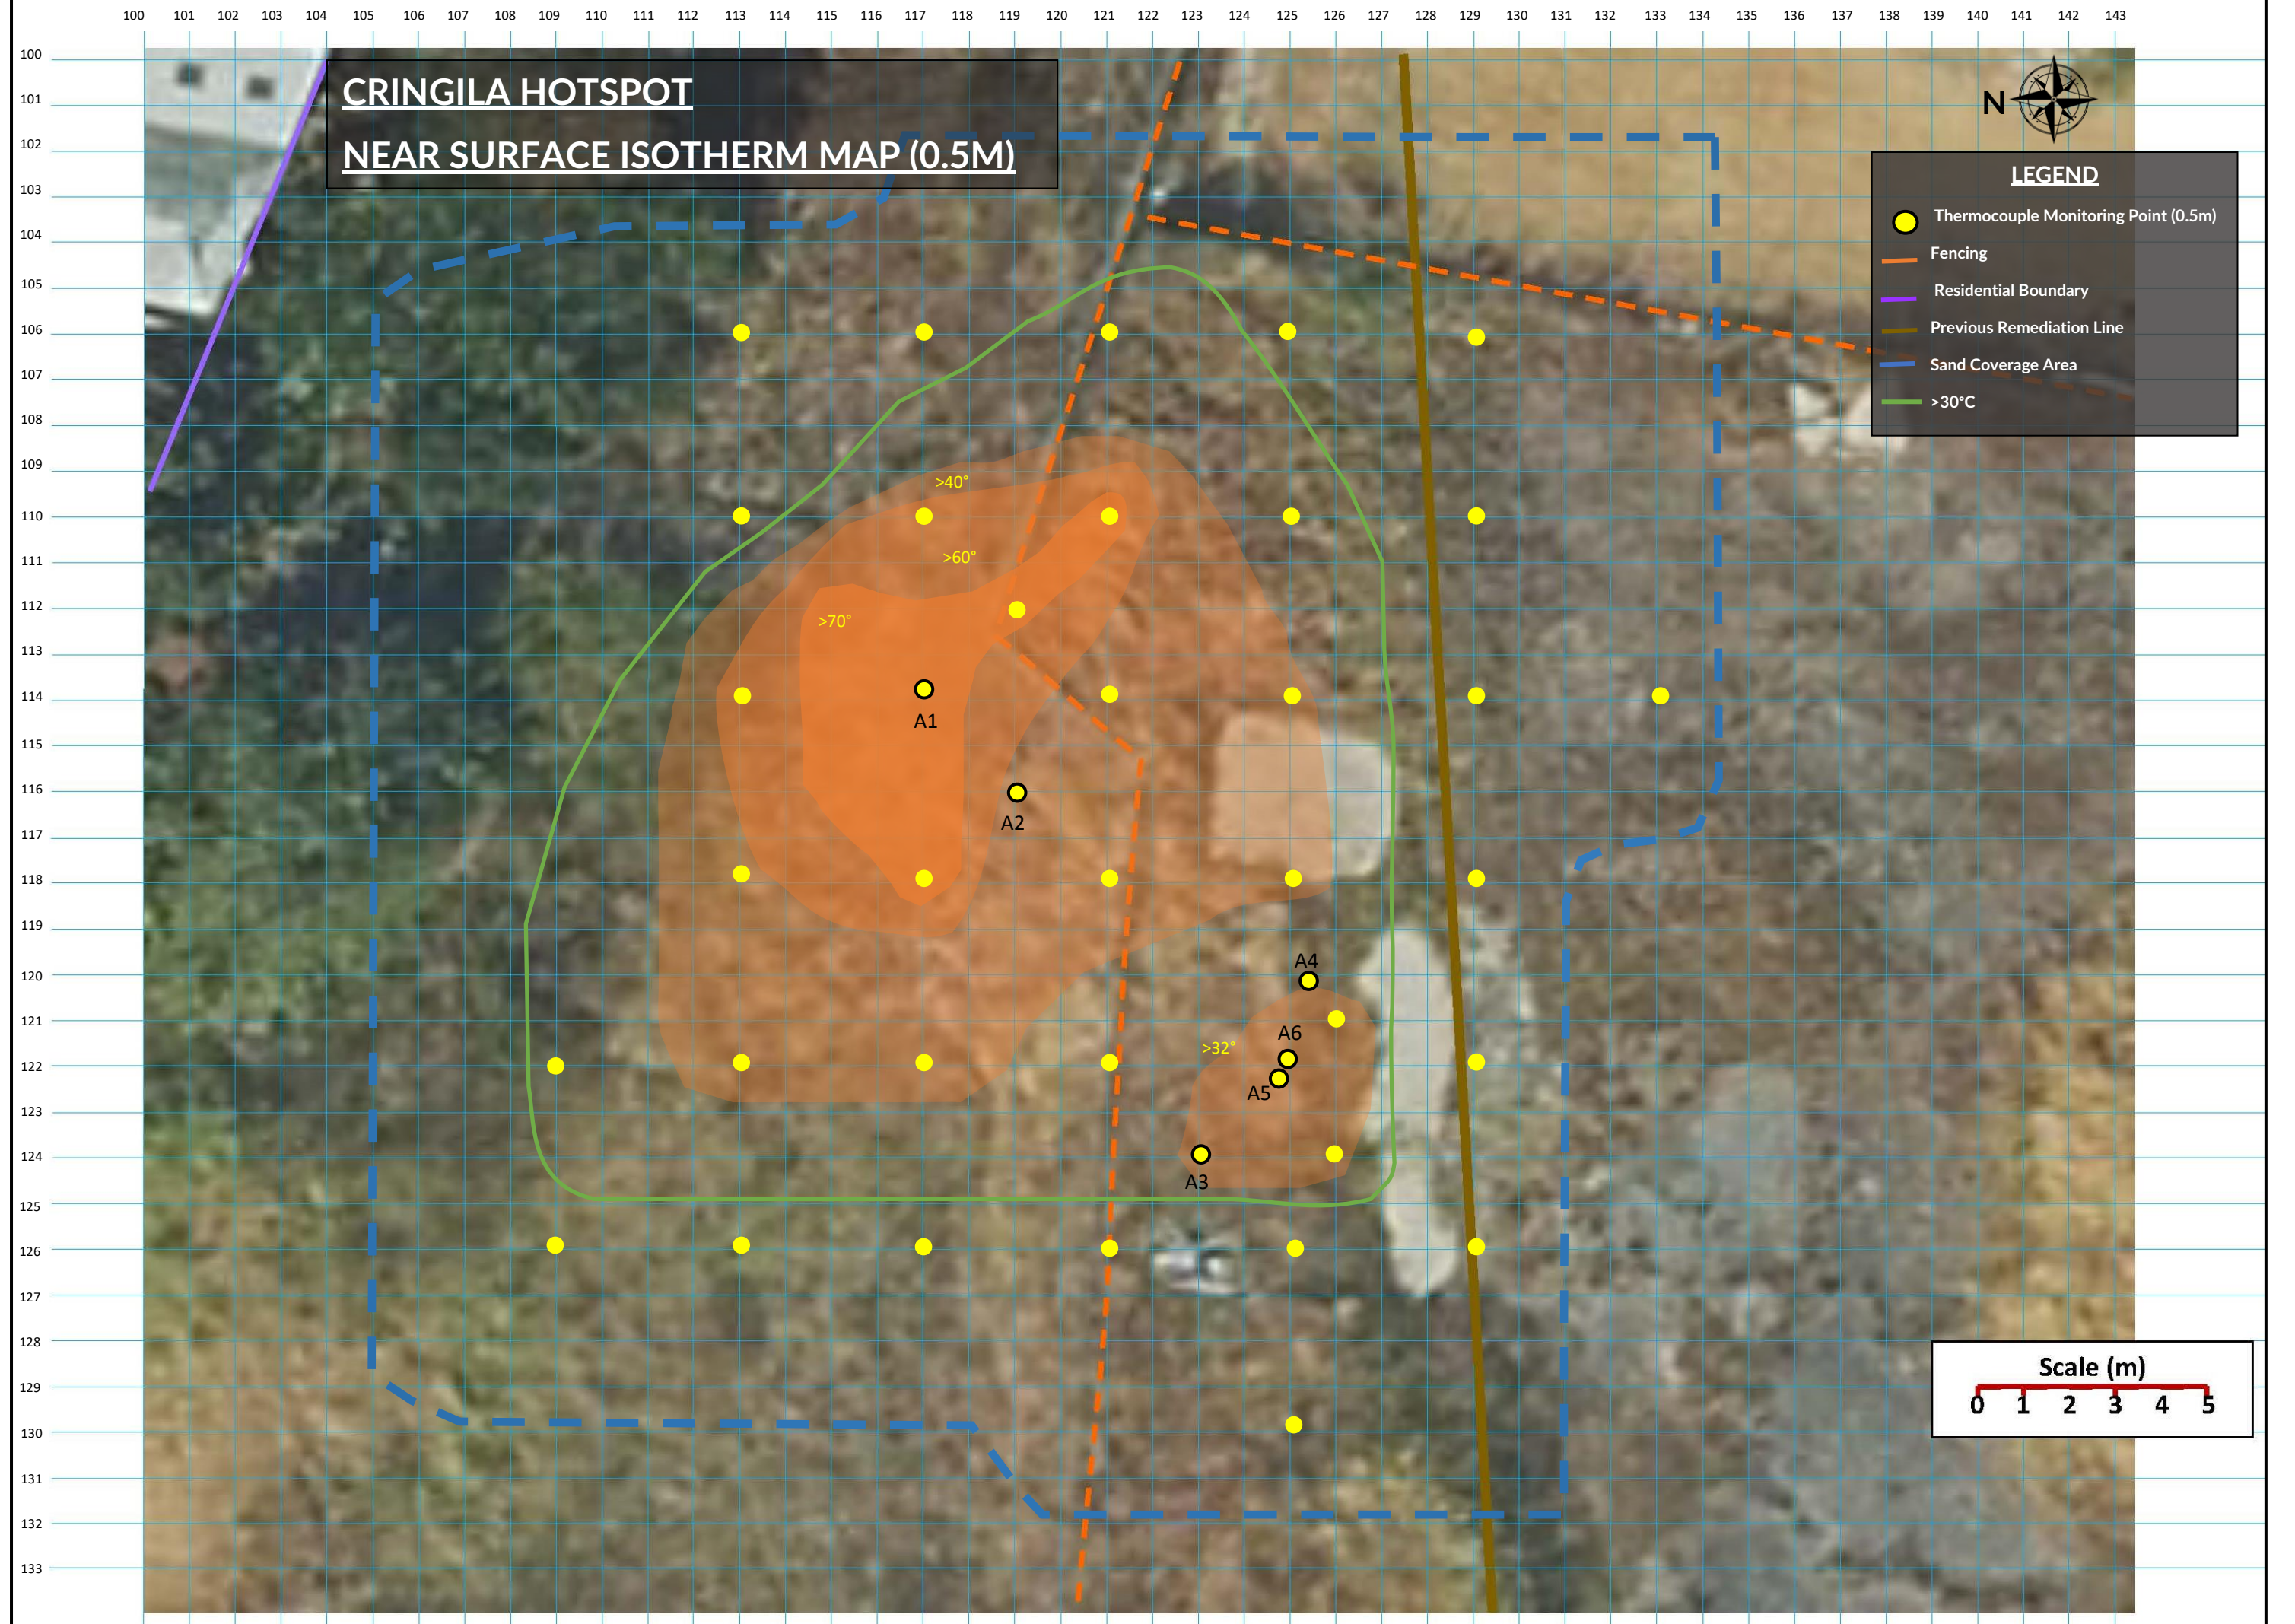
CRINGILA HOTSPOT NEAR SURFACE ISOTHERM MAP (0.5M)

The isotherm map shows the general zone of influence for temperatures between 30°C and 78°C at 0.5m, coloured orange. The isotherm map suggests that the hotspot may extend deeper than 0.5m and that the increased temperature in these areas is a result of heat venting to the surface.

It is noted that temperature at the near-surface may be variable across the hotspot due to inconsistencies in the consolidation and compaction of subsurface materials.

It is recommended that weekly site inspections and recording are continued to monitor the surface and near surface temperatures surrounding the hotspot identified at the site.
