NEAR SURFACE TEMPERATURE MONITORING CRINGILA PUBLIC SCHOOL - NW HOTSPOT

Weekly Summary Report
01/10/2018 - 05/10/2018

Cringila Public School

October 2018
C107826: J153825: RC

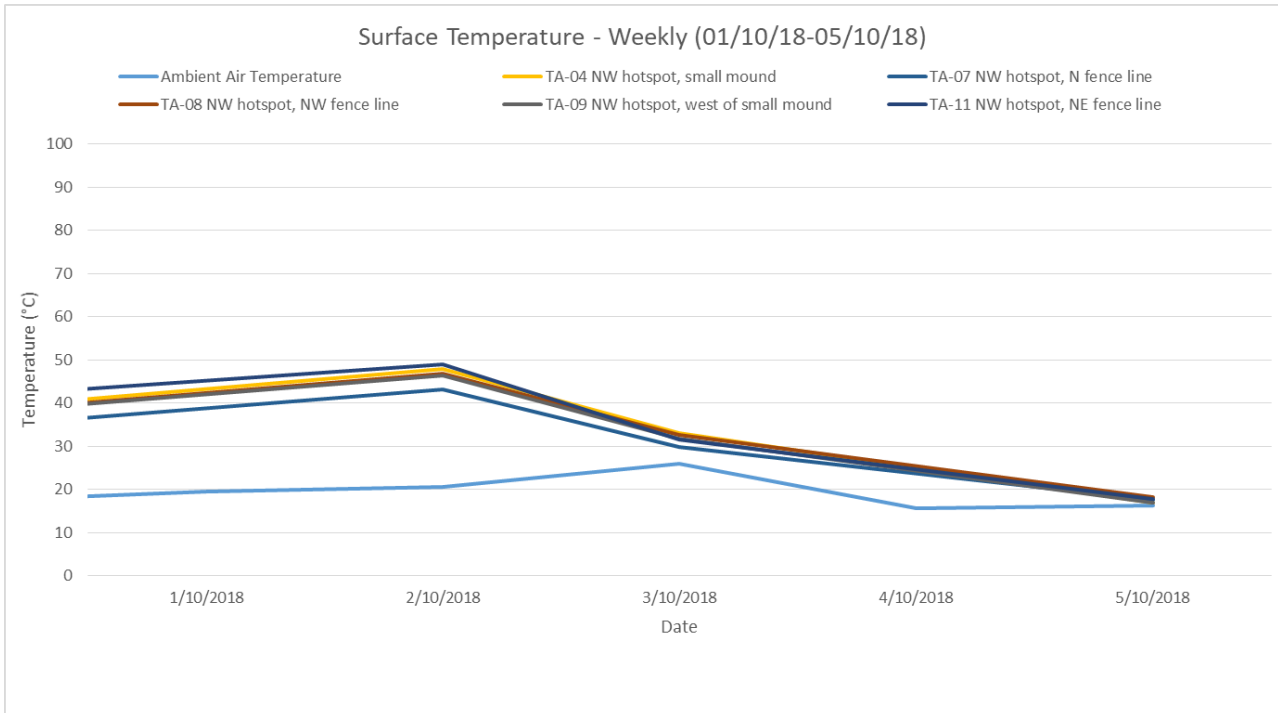
3.2. Surface Temperature Graph – Selected Points (Weekly)

Surface temperature measurements for key locations, over monitoring week – 01/10/2018 to 05/10/2018.

The surface temperature at selected points across the northwest hotspot over the week of monitoring – 01/10/2018 to 05/10/2018, appear to remain consistent.

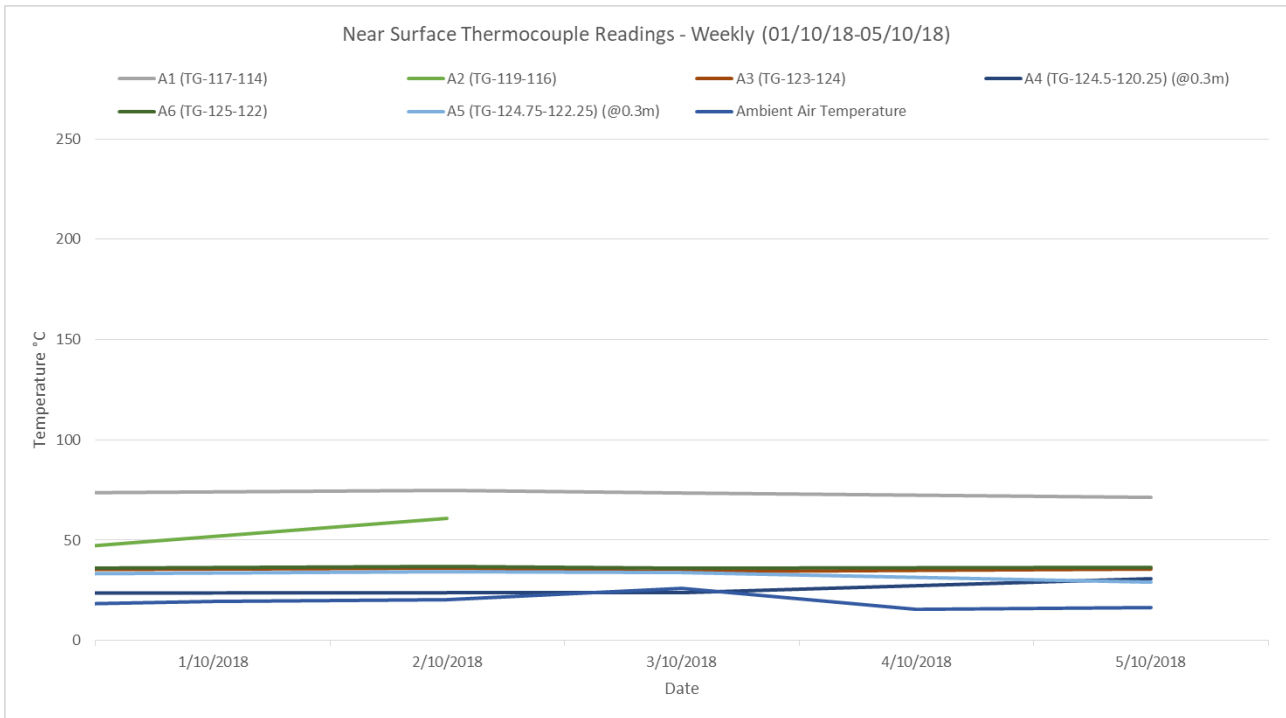
3.4. Near Surface Temperature Graph – Selected Points (Weekly)

Near surface temperature measurements for key thermocouple locations, over monitoring week - 01/10/2018 to 05/10/2018.

The near surface temperature at selected points across the northwest hotspot over the week of monitoring – 01/10/2018 to 05/10/2018, appear to remain consistent.

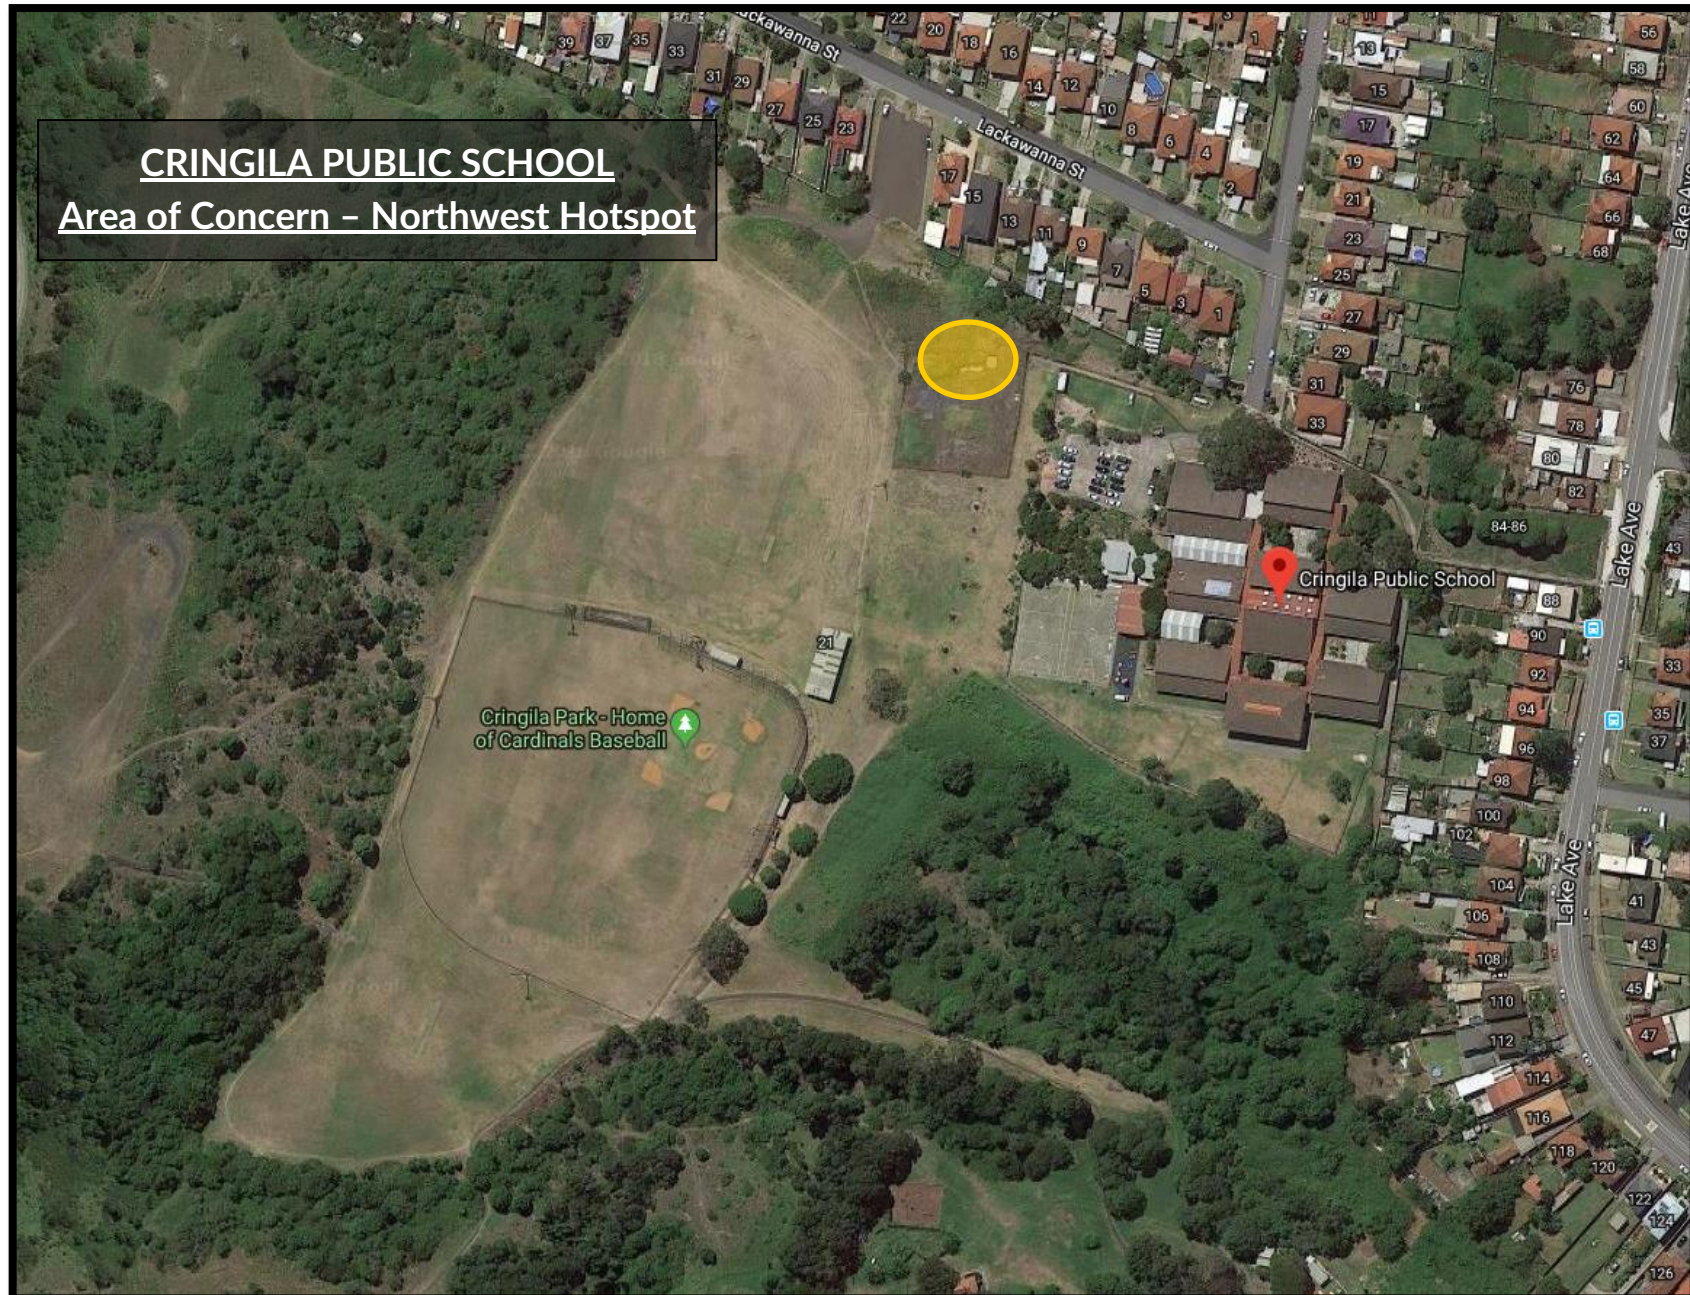
Appendix A: Area of Concern – Northwest Hotspot Map

CRINGILA PUBLIC SCHOOL
Area of Concern - Northwest Hotspot

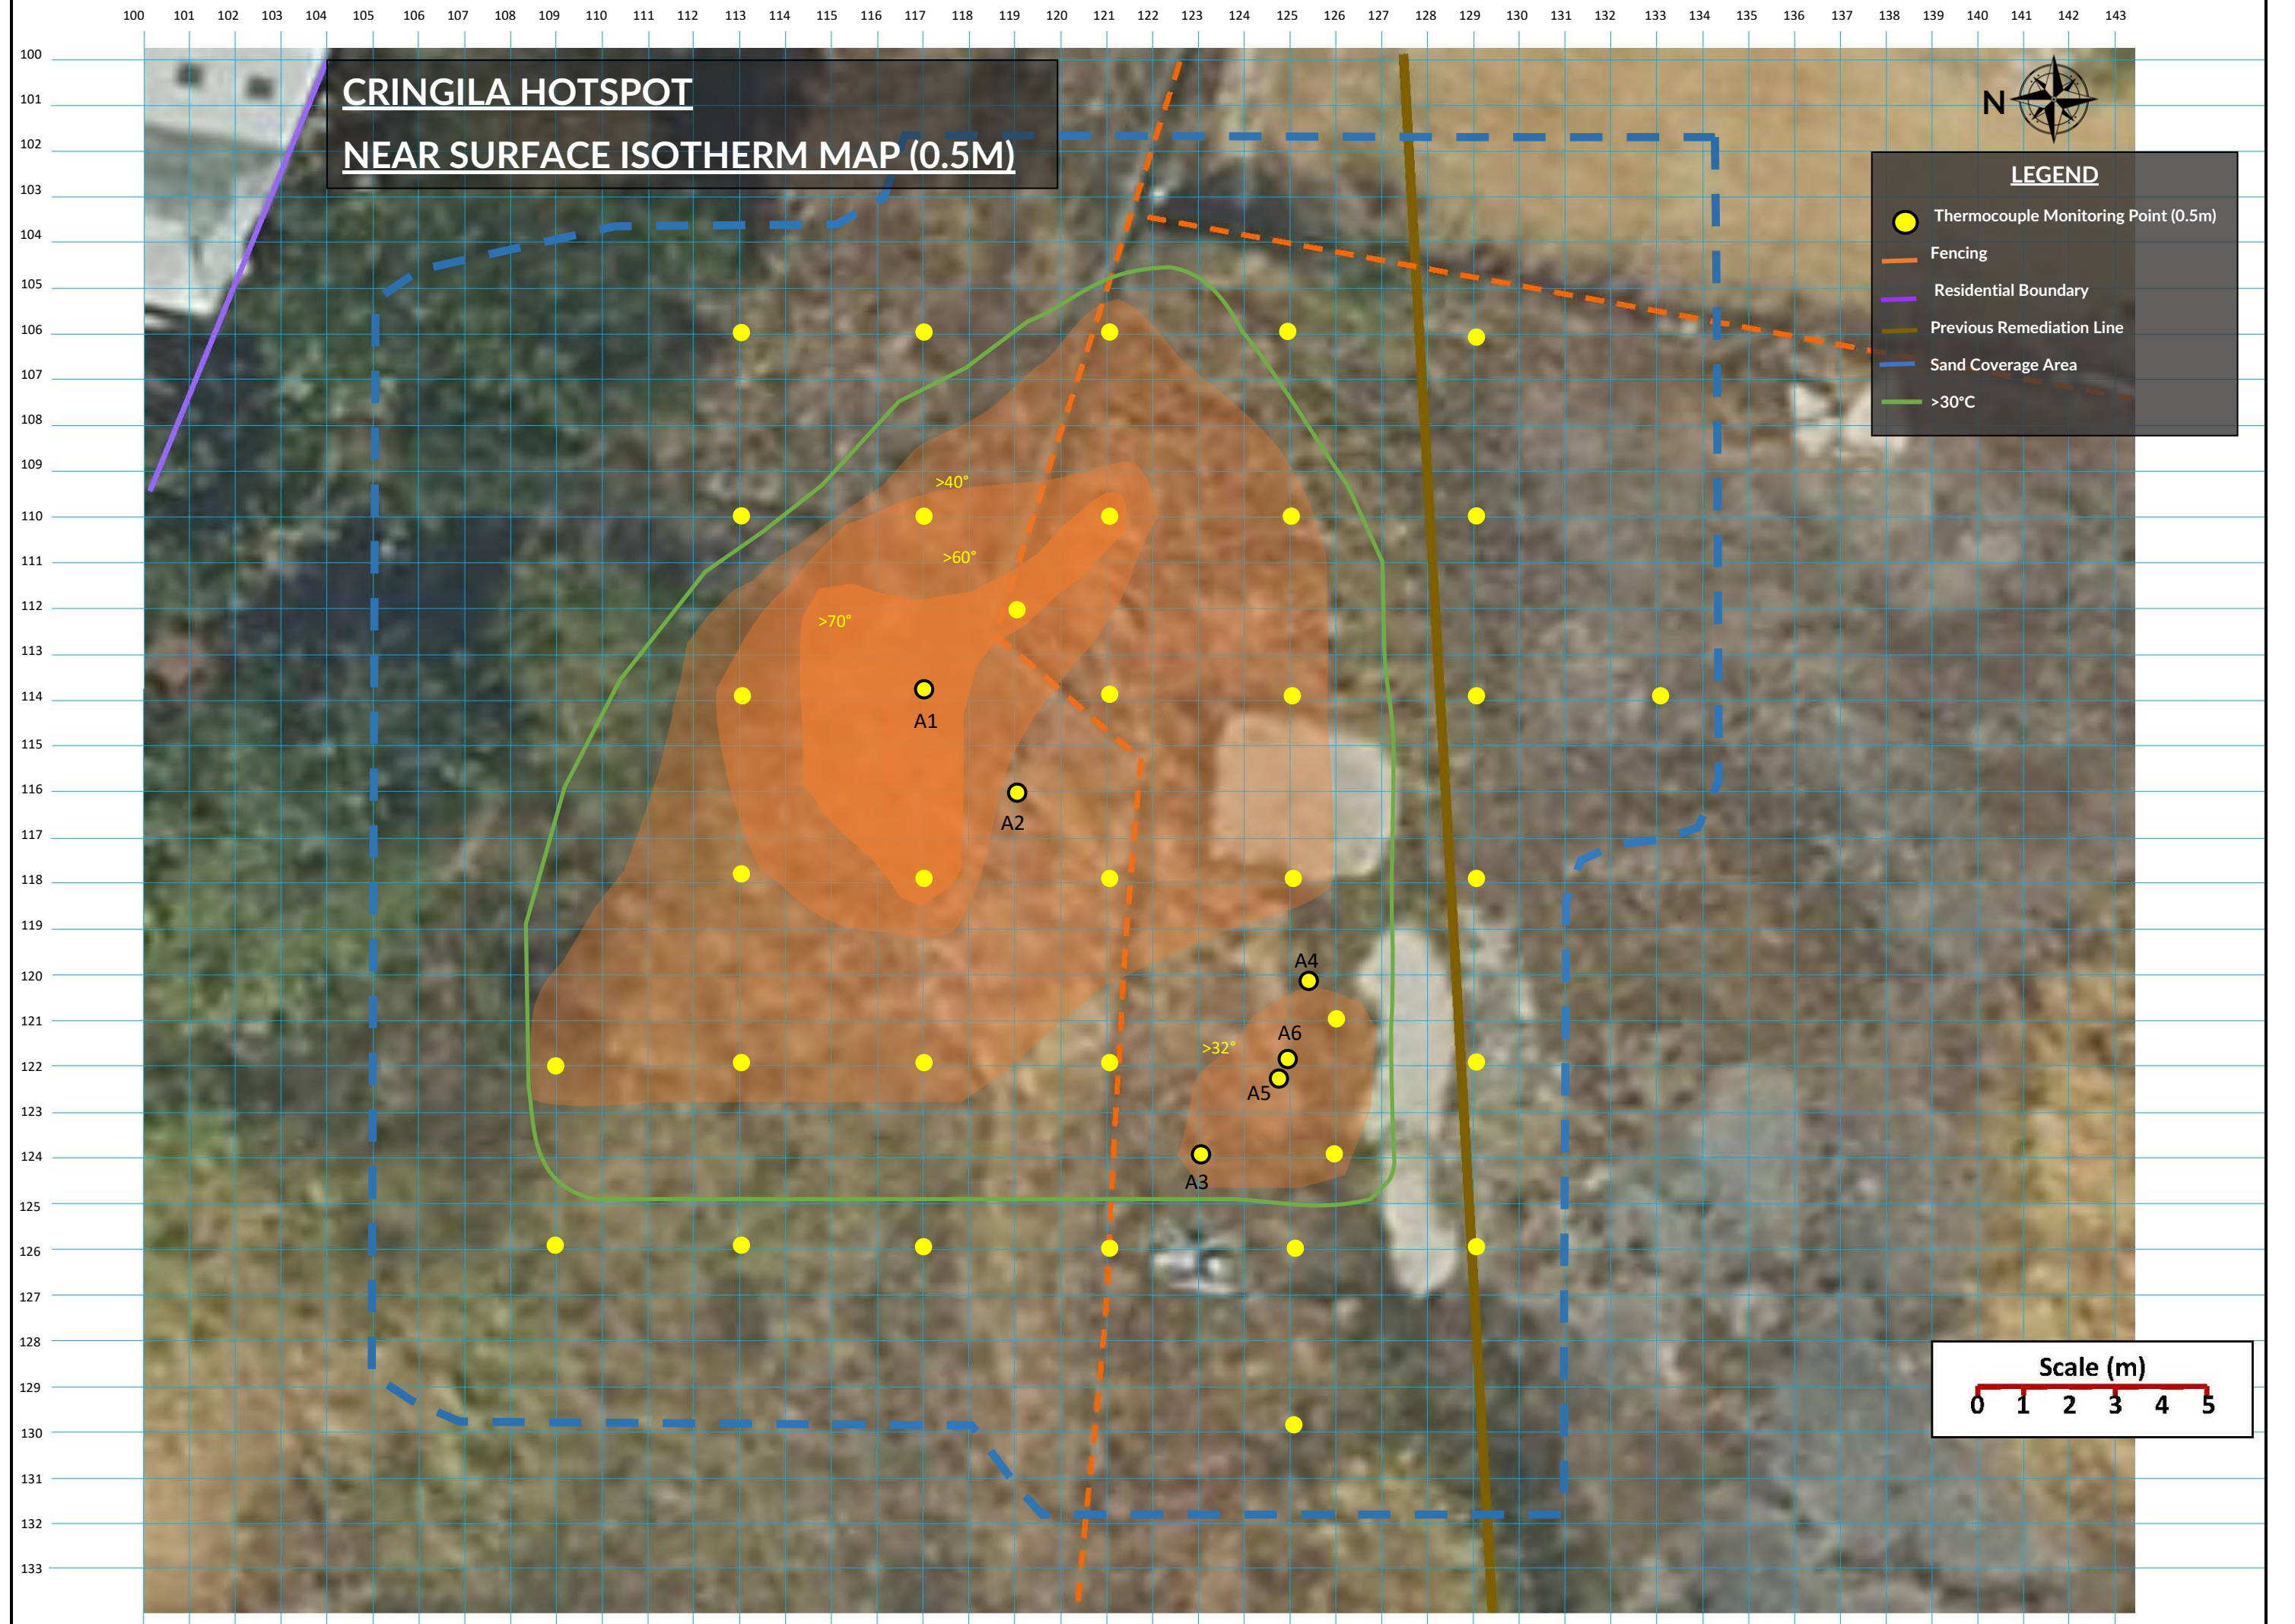
Appendix C: Near Surface Temperature Isotherm Map (0.5m)

The isotherm map shows the general zone of influence for temperatures between 30°C and 79°C at 0.5m, coloured orange. The isotherm map suggests that the hotspot may extend deeper than 0.5m and that the increased temperature in these areas is a result of heat venting to the surface.

It is noted that temperature at the near-surface may be variable across the hotspot due to inconsistencies in the consolidation and compaction of subsurface materials.

CRINGILA HOTSPOT NEAR SURFACE ISOTHERM MAP (0.5M)

It is recommended that weekly site inspections and recording are continued to monitor the surface and near surface temperatures surrounding the hotspot identified at the site.
