## NEAR SURFACE TEMPERATURE MONITORING CRINGILA PUBLIC SCHOOL - NW HOTSPOT

Weekly Summary Report  
08/10/2018 - 12/10/2018

Cringila Public School

# Near Surface Temperature Monitoring

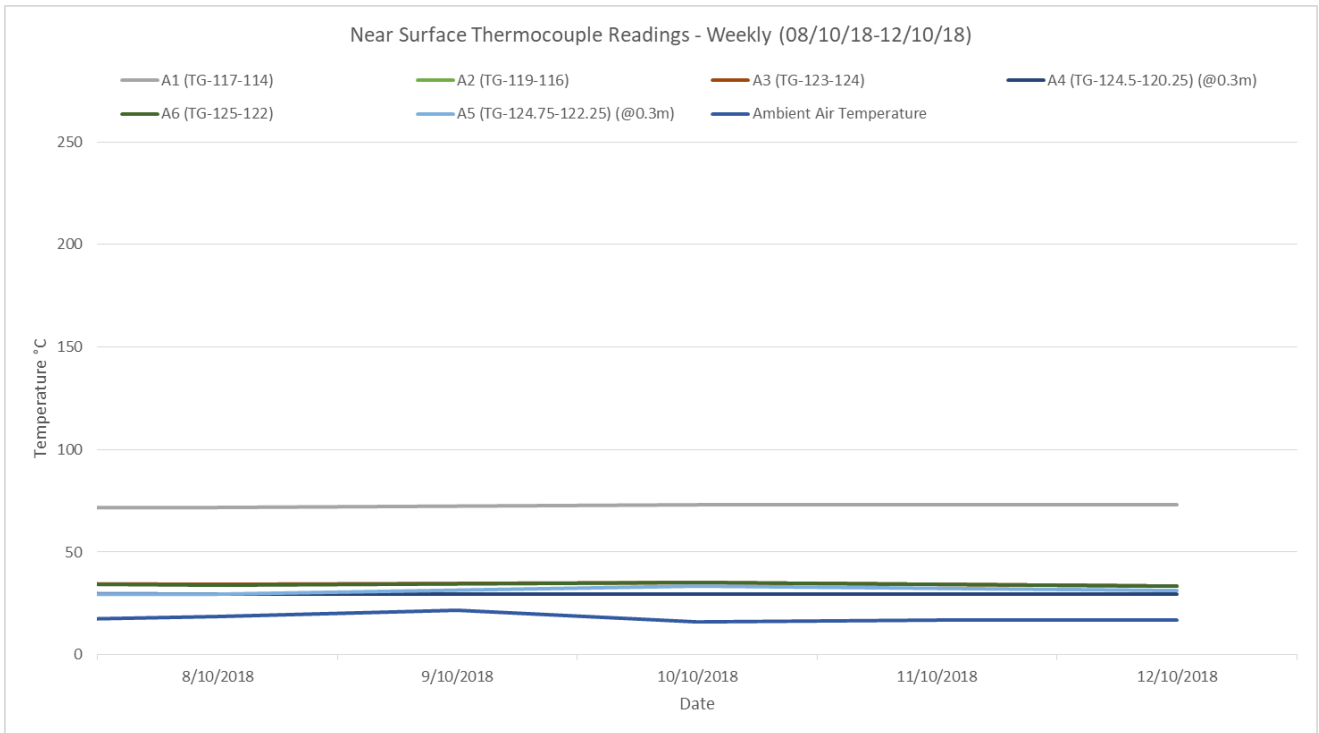
### 3.4. Near Surface Temperature Graph – Selected Points (Weekly)

Near surface temperature measurements for key thermocouple locations, over monitoring week - 08/10/2018 to 12/10/2018.

The near surface temperature at selected points across the northwest hotspot over the week of monitoring – 08/10/2018 to 12/10/2018, appear to remain consistent.

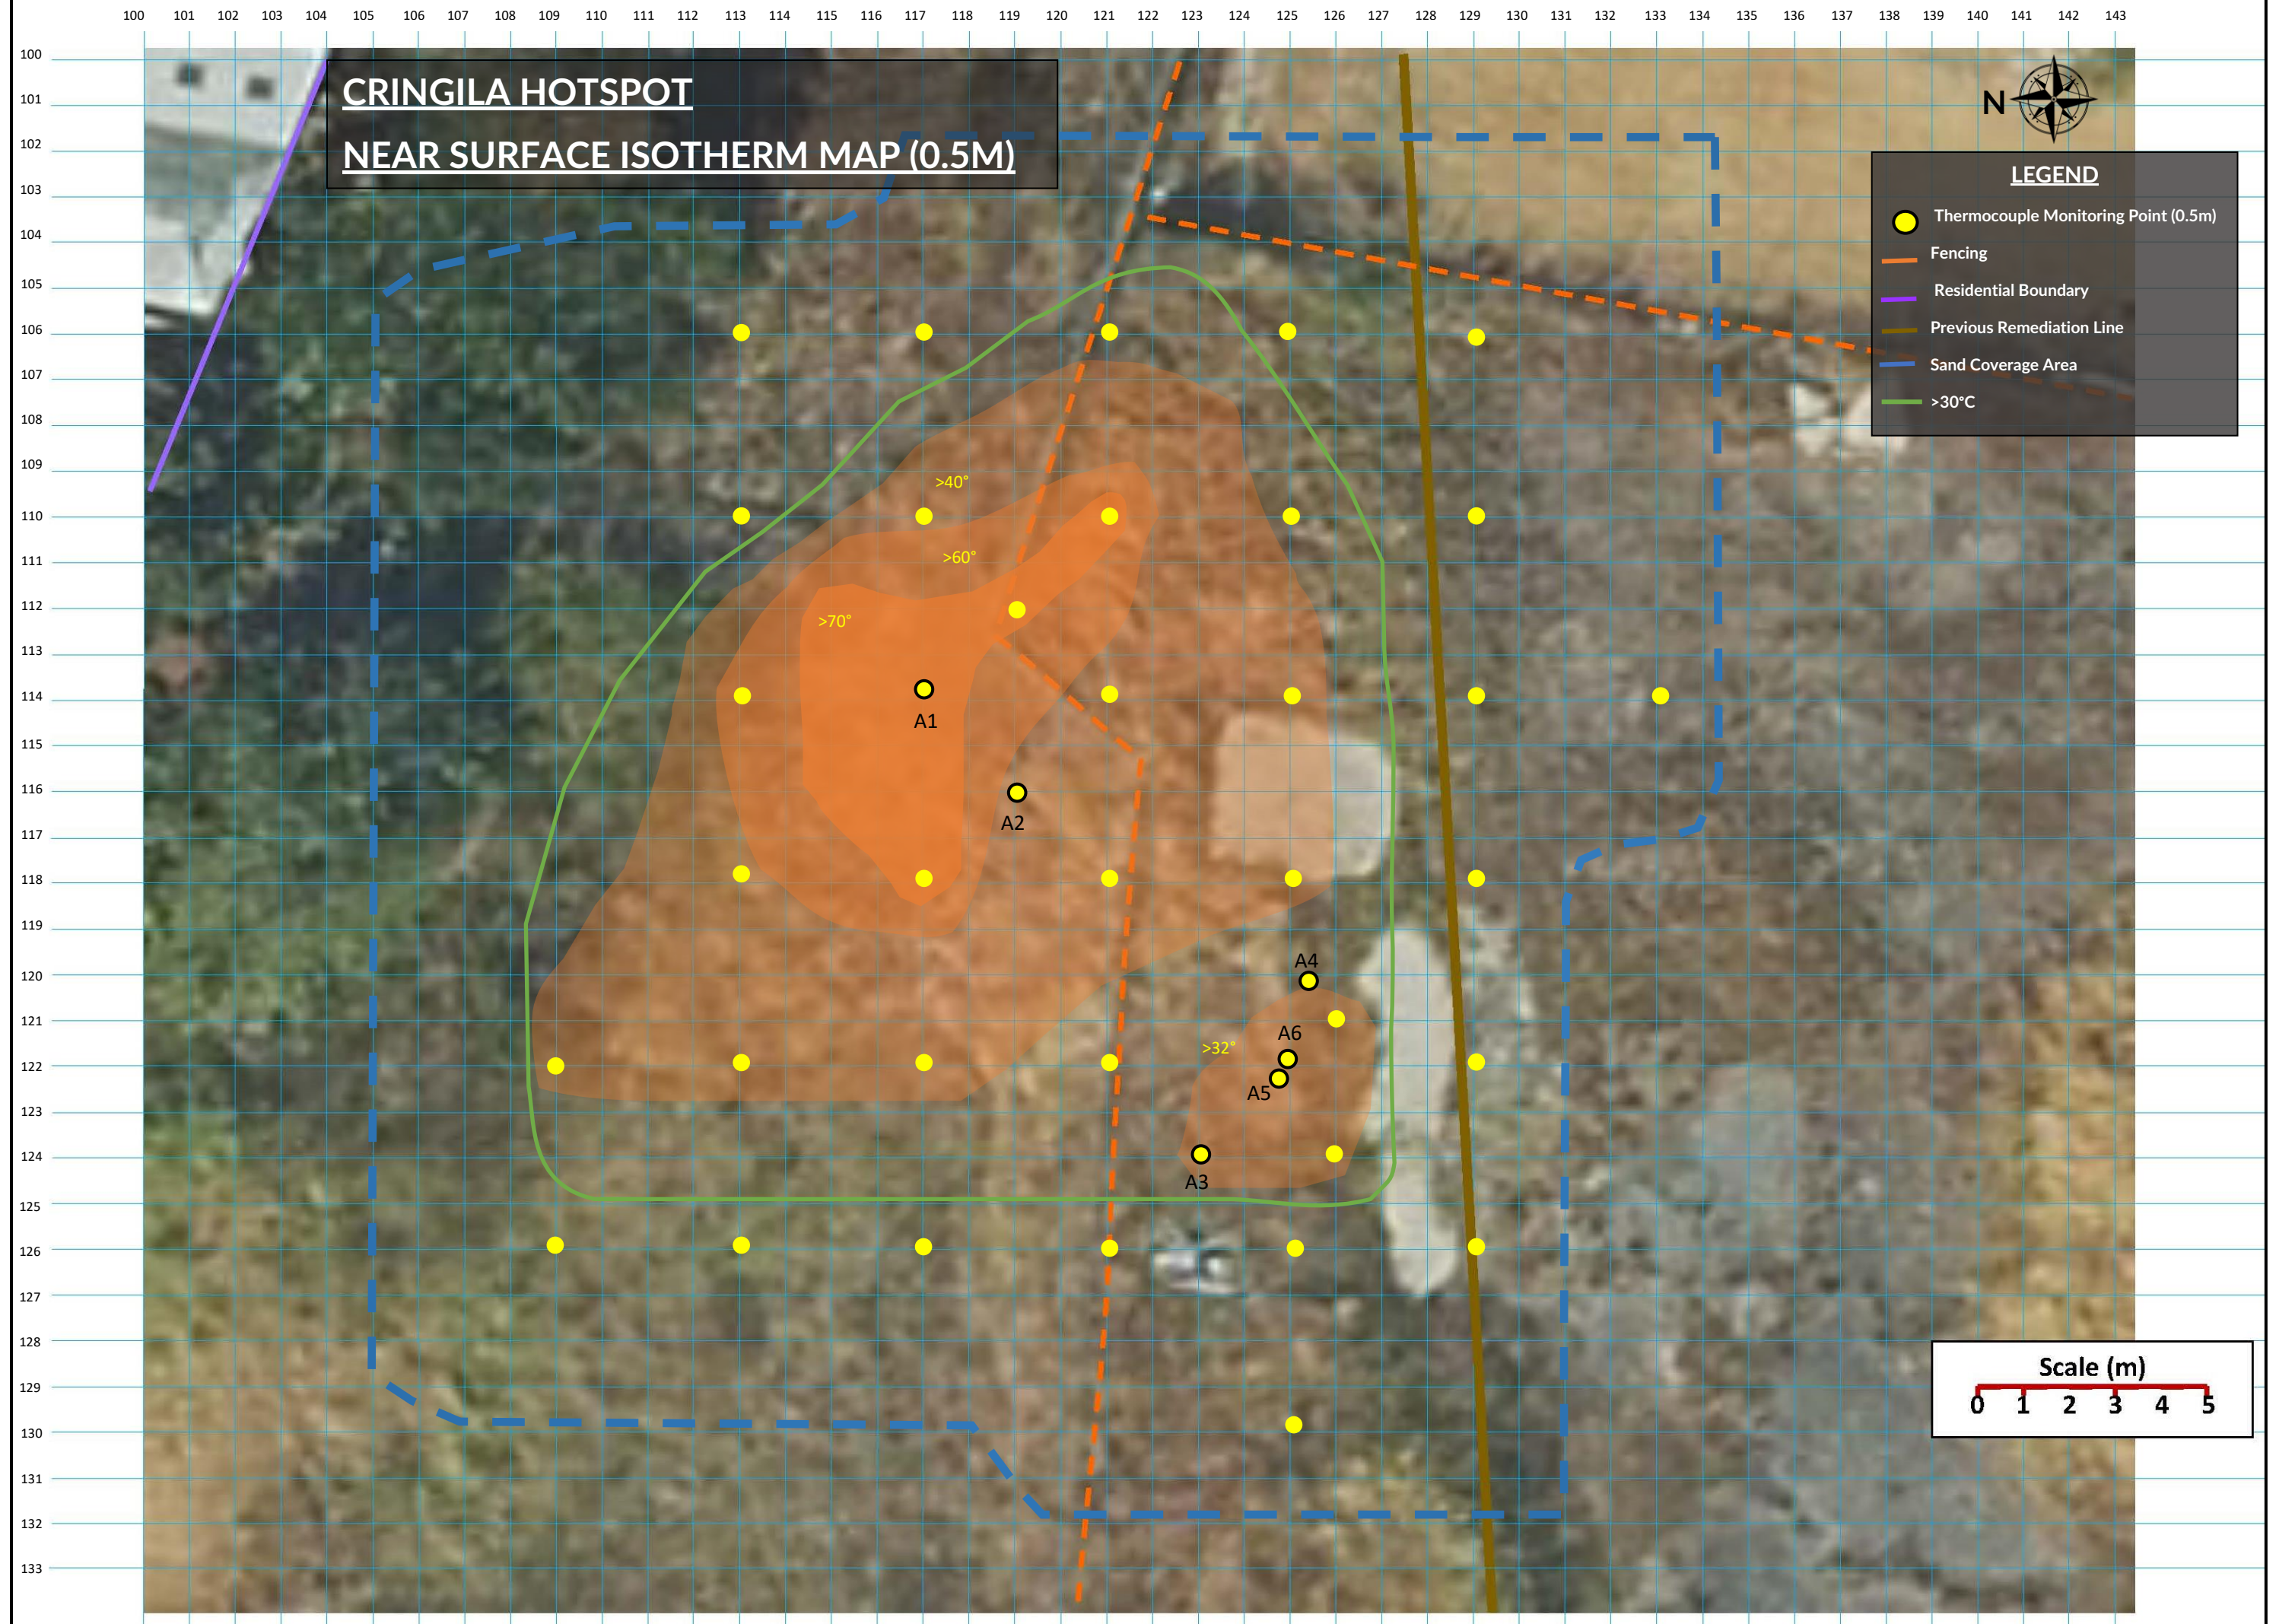
### Appendix C: Near Surface Temperature Isotherm Map (0.5m)

The isotherm map shows the general zone of influence for temperatures between 30°C and 78°C at 0.5m, coloured orange. The isotherm map suggests that the hotspot may extend deeper than 0.5m and that the increased temperature in these areas is a result of heat venting to the surface.

It is noted that temperature at the near-surface may be variable across the hotspot due to inconsistencies in the consolidation and compaction of subsurface materials.

# CRINGILA HOTSPOT NEAR SURFACE ISOTHERM MAP (0.5M)

It is recommended that weekly site inspections and recording are continued to monitor the surface and near surface temperatures surrounding the hotspot identified at the site.
