NEAR SURFACE TEMPERATURE MONITORING CRINGILA PUBLIC SCHOOL - NW HOTSPOT

Weekly Summary Report
22/10/2018 - 26/10/2018

Cringila Public School

35 Sheffield Street
Cringila NSW 2502

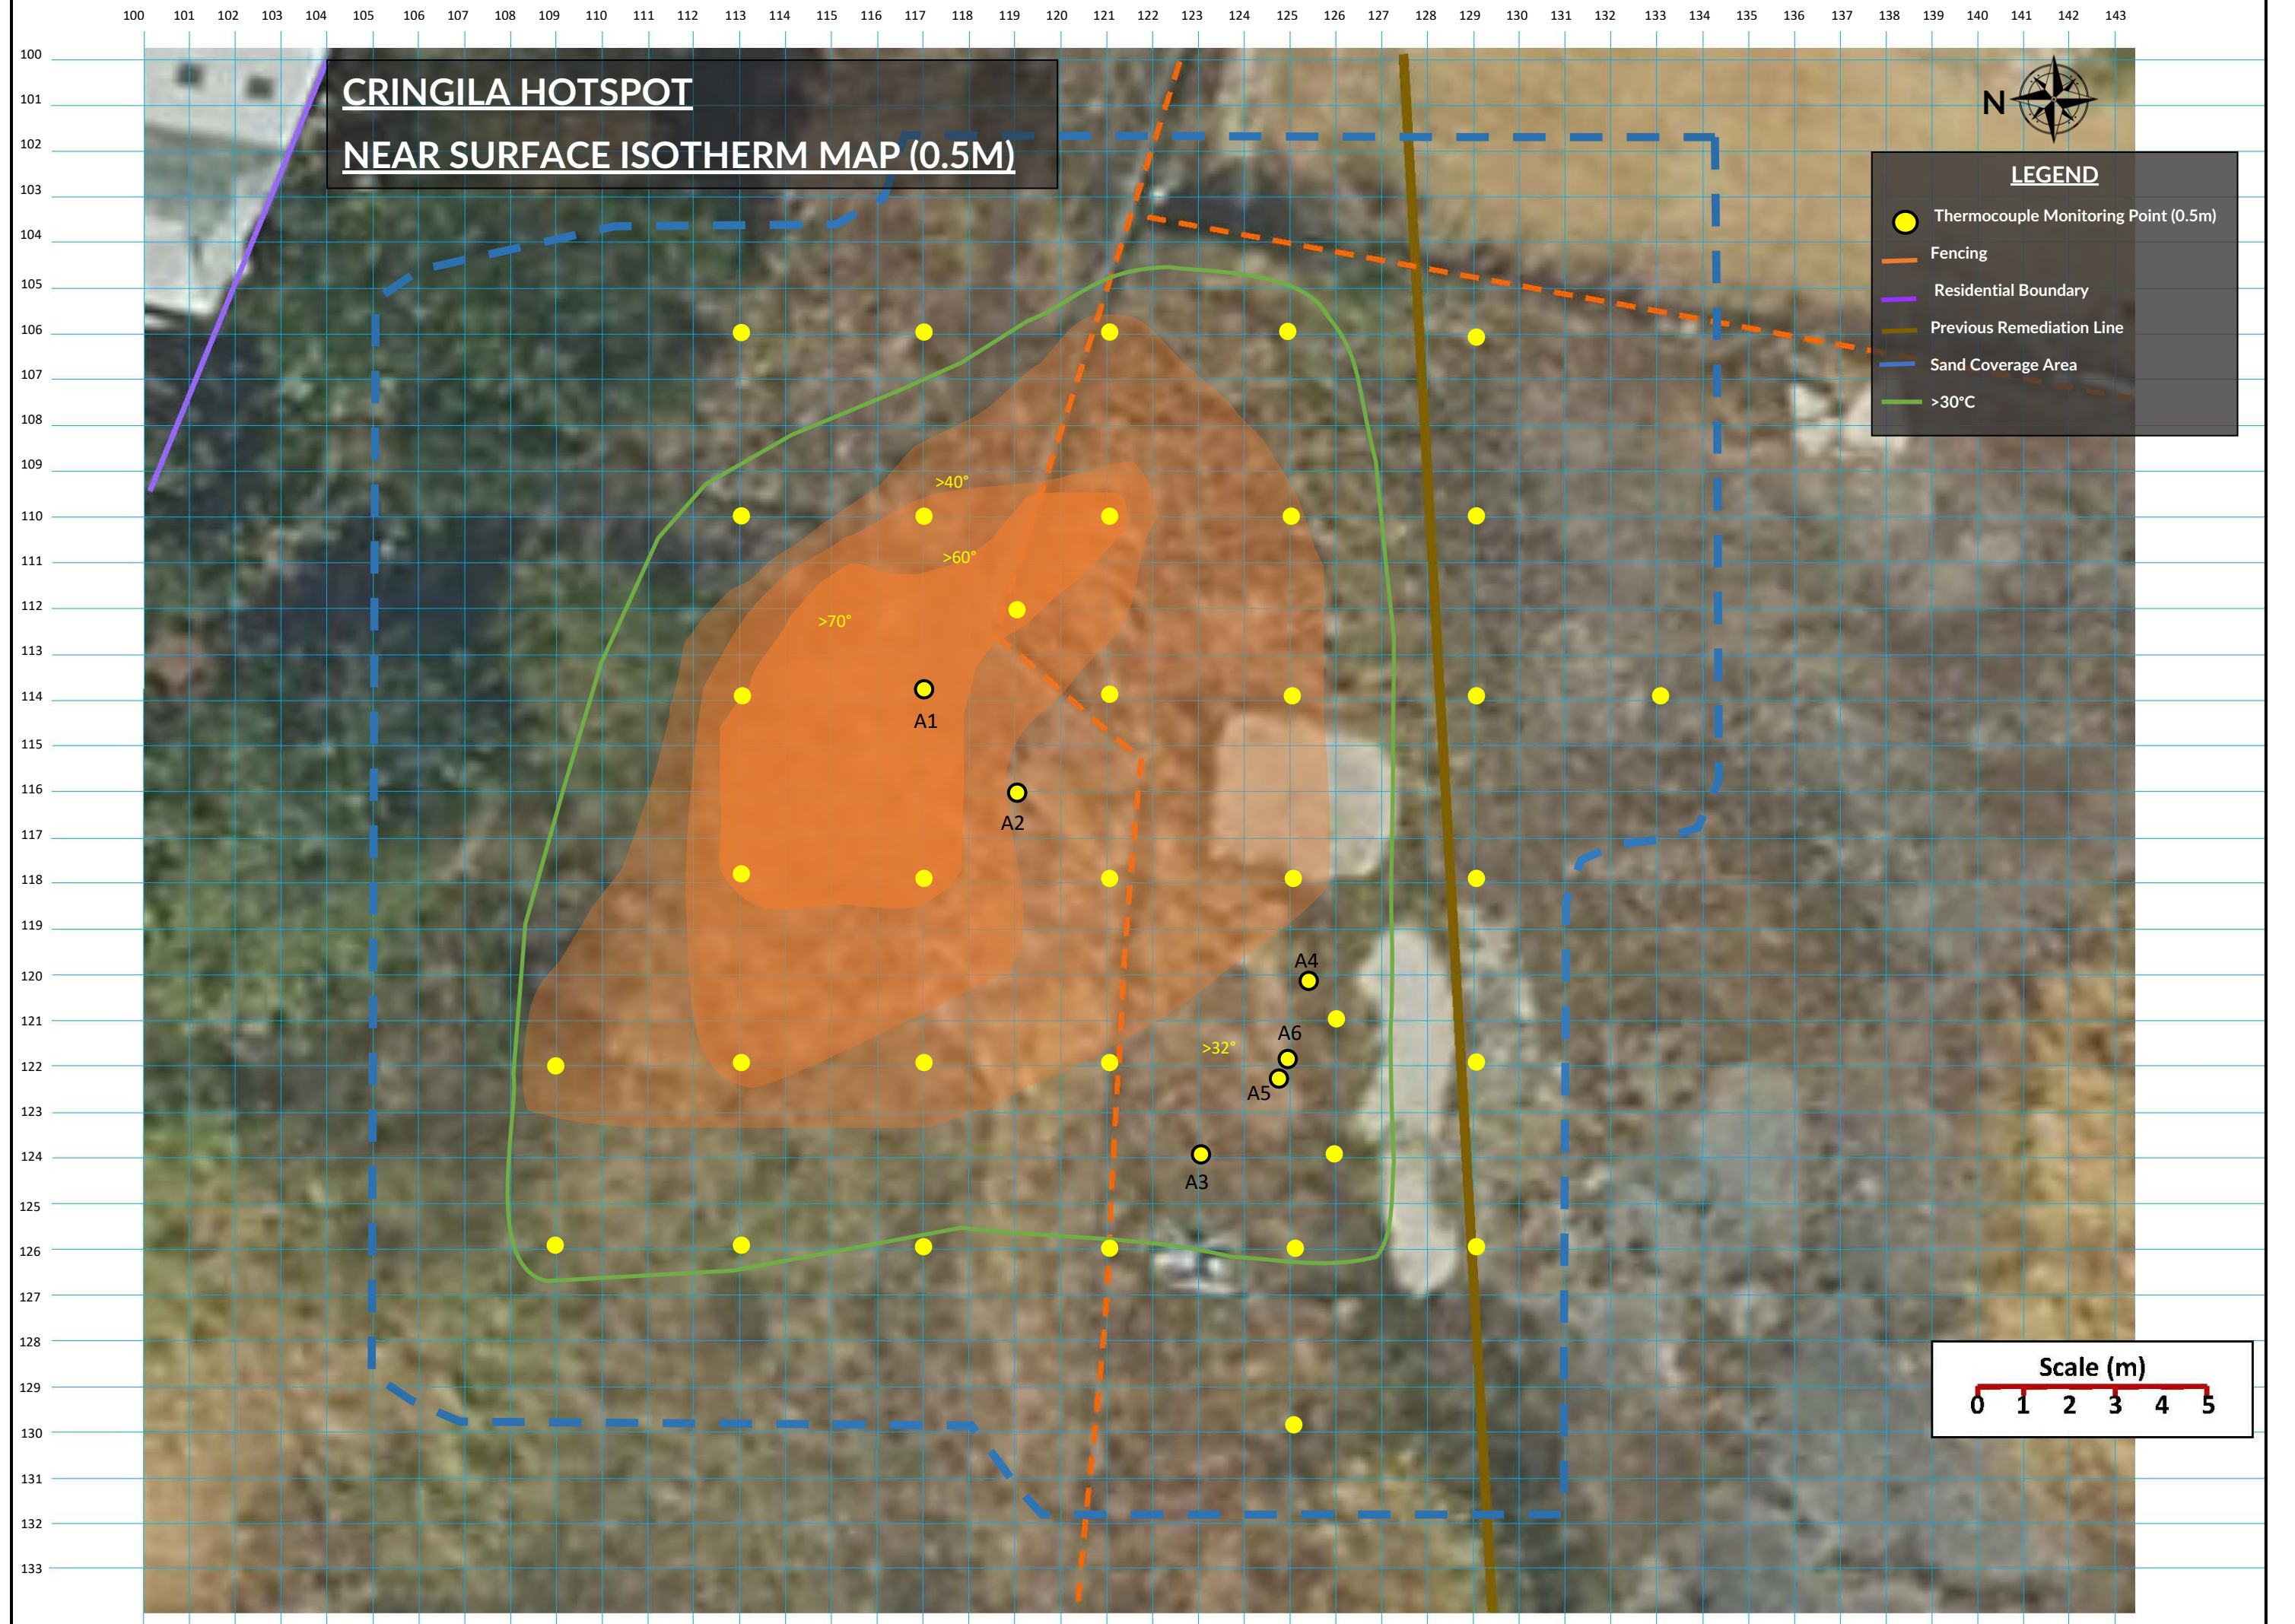
Appendix C: Near Surface Temperature Isotherm Map (0.5m)

The isotherm map shows the general zone of influence for temperatures between 30°C and 82°C at 0.5m, coloured orange. The isotherm map suggests that the hotspot may extend deeper than 0.5m and that the increased temperature in these areas is a result of heat venting to the surface.

It is noted that temperature at the near-surface may be variable across the hotspot due to inconsistencies in the consolidation and compaction of subsurface materials.

CRINGILA HOTSPOT NEAR SURFACE ISOTHERM MAP (0.5M)

It is recommended that weekly site inspections and recording are continued to monitor the surface and near surface temperatures surrounding the hotspot identified at the site.
