NEAR SURFACE TEMPERATURE MONITORING CRINGILA PUBLIC SCHOOL - NW HOTSPOT

Weekly Summary Report
29/10/2018 - 02/11/2018

NSW Department
of Education
Cringila Public School

November 2018
C107826: J153825: RC

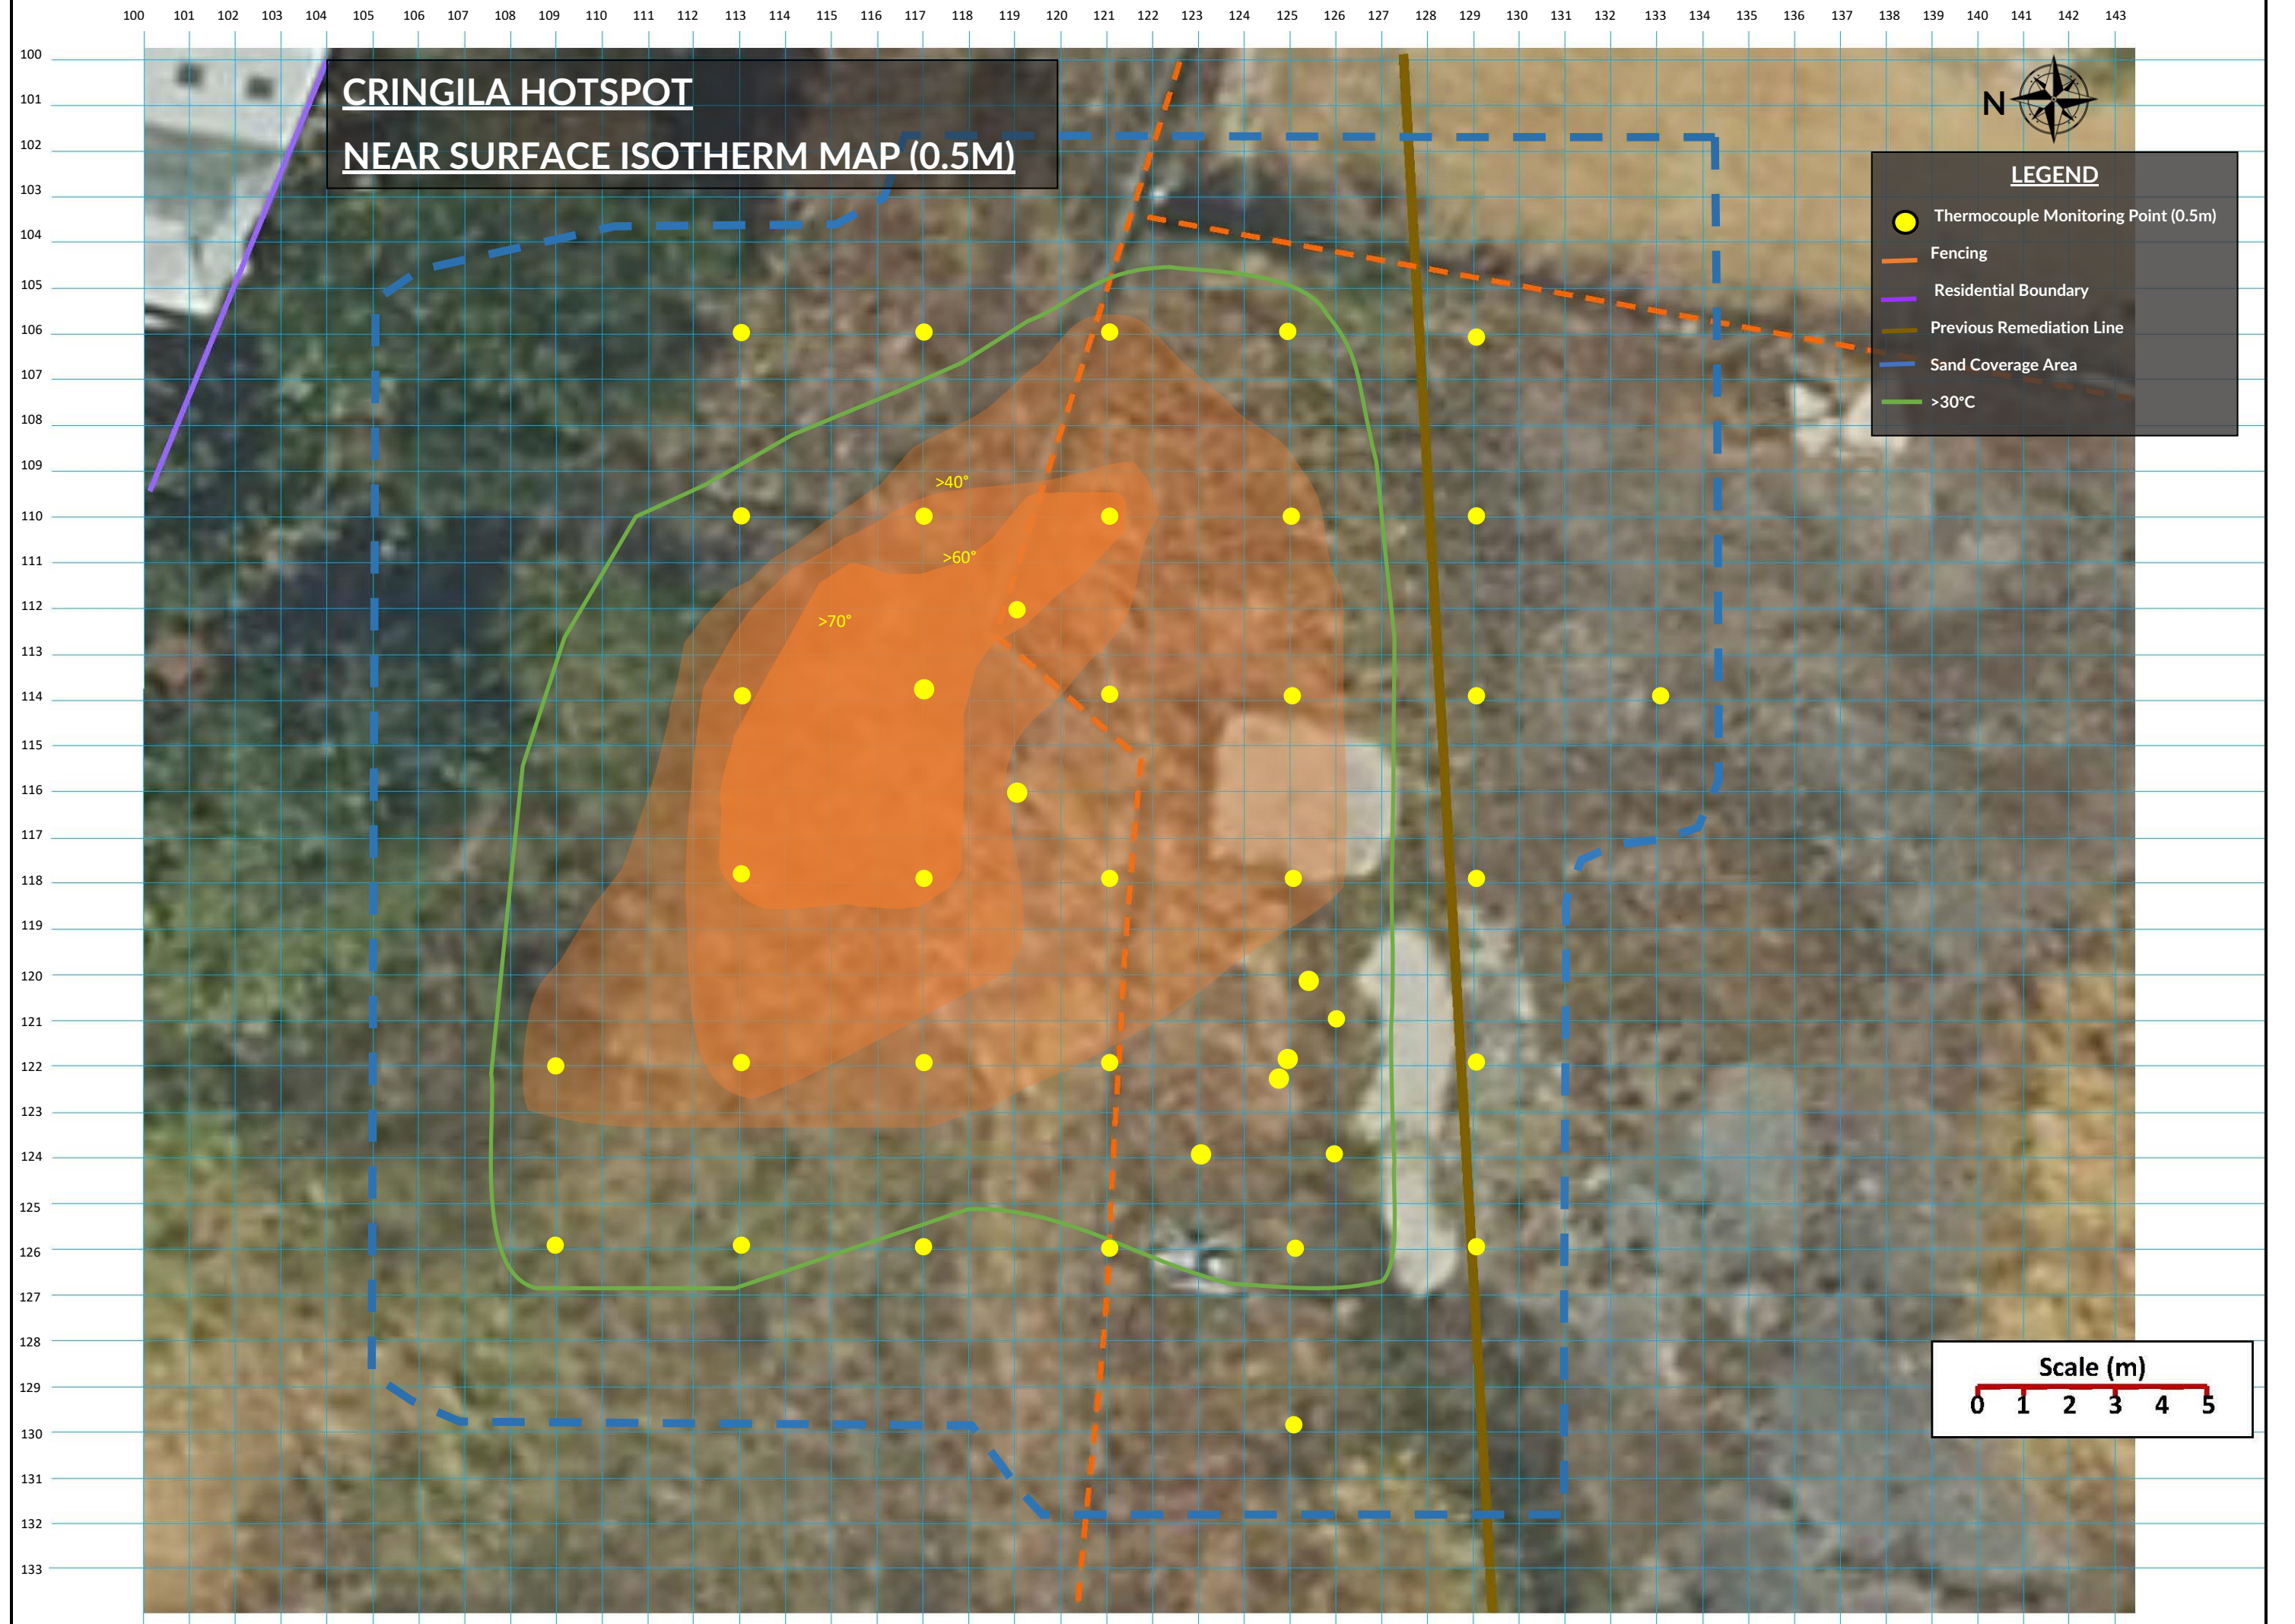
Appendix C: Near Surface Temperature Isotherm Map (0.5m)

The isotherm map shows the general zone of influence for temperatures between 30°C and 80°C at 0.5m, coloured orange. The isotherm map suggests that the hotspot may extend deeper than 0.5m and that the increased temperature in these areas is a result of heat venting to the surface.

It is noted that temperature at the near-surface may be variable across the hotspot due to inconsistencies in the consolidation and compaction of subsurface materials.

CRINGILA HOTSPOT NEAR SURFACE ISOTHERM MAP (0.5M)

It is recommended that weekly site inspections and recording are continued to monitor the surface and near surface temperatures surrounding the hotspot identified at the site.
