NEAR SURFACE TEMPERATURE MONITORING CRINGILA PUBLIC SCHOOL - NW HOTSPOT

Weekly Summary Report
05/11/2018 - 09/11/2018

NSW Department
of Education
Cringila Public School

November 2018
C107826: J153825: RC

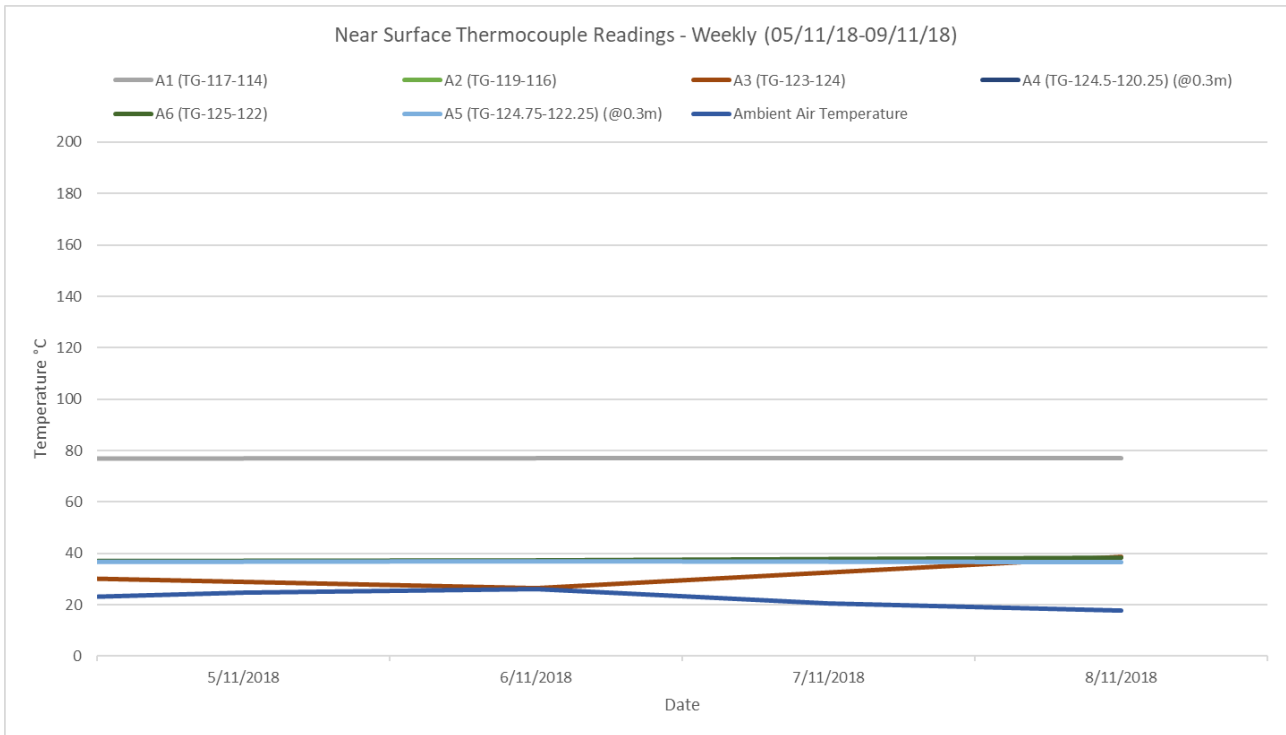
3.2. Near Surface Temperature Graph – Selected Points (Weekly)

Near surface temperature measurements for key thermocouple locations, over monitoring week - 05/11/2018 to 09/11/2018.

The near surface temperature at selected points across the northwest hotspot over the week of monitoring appear to remain consistent.

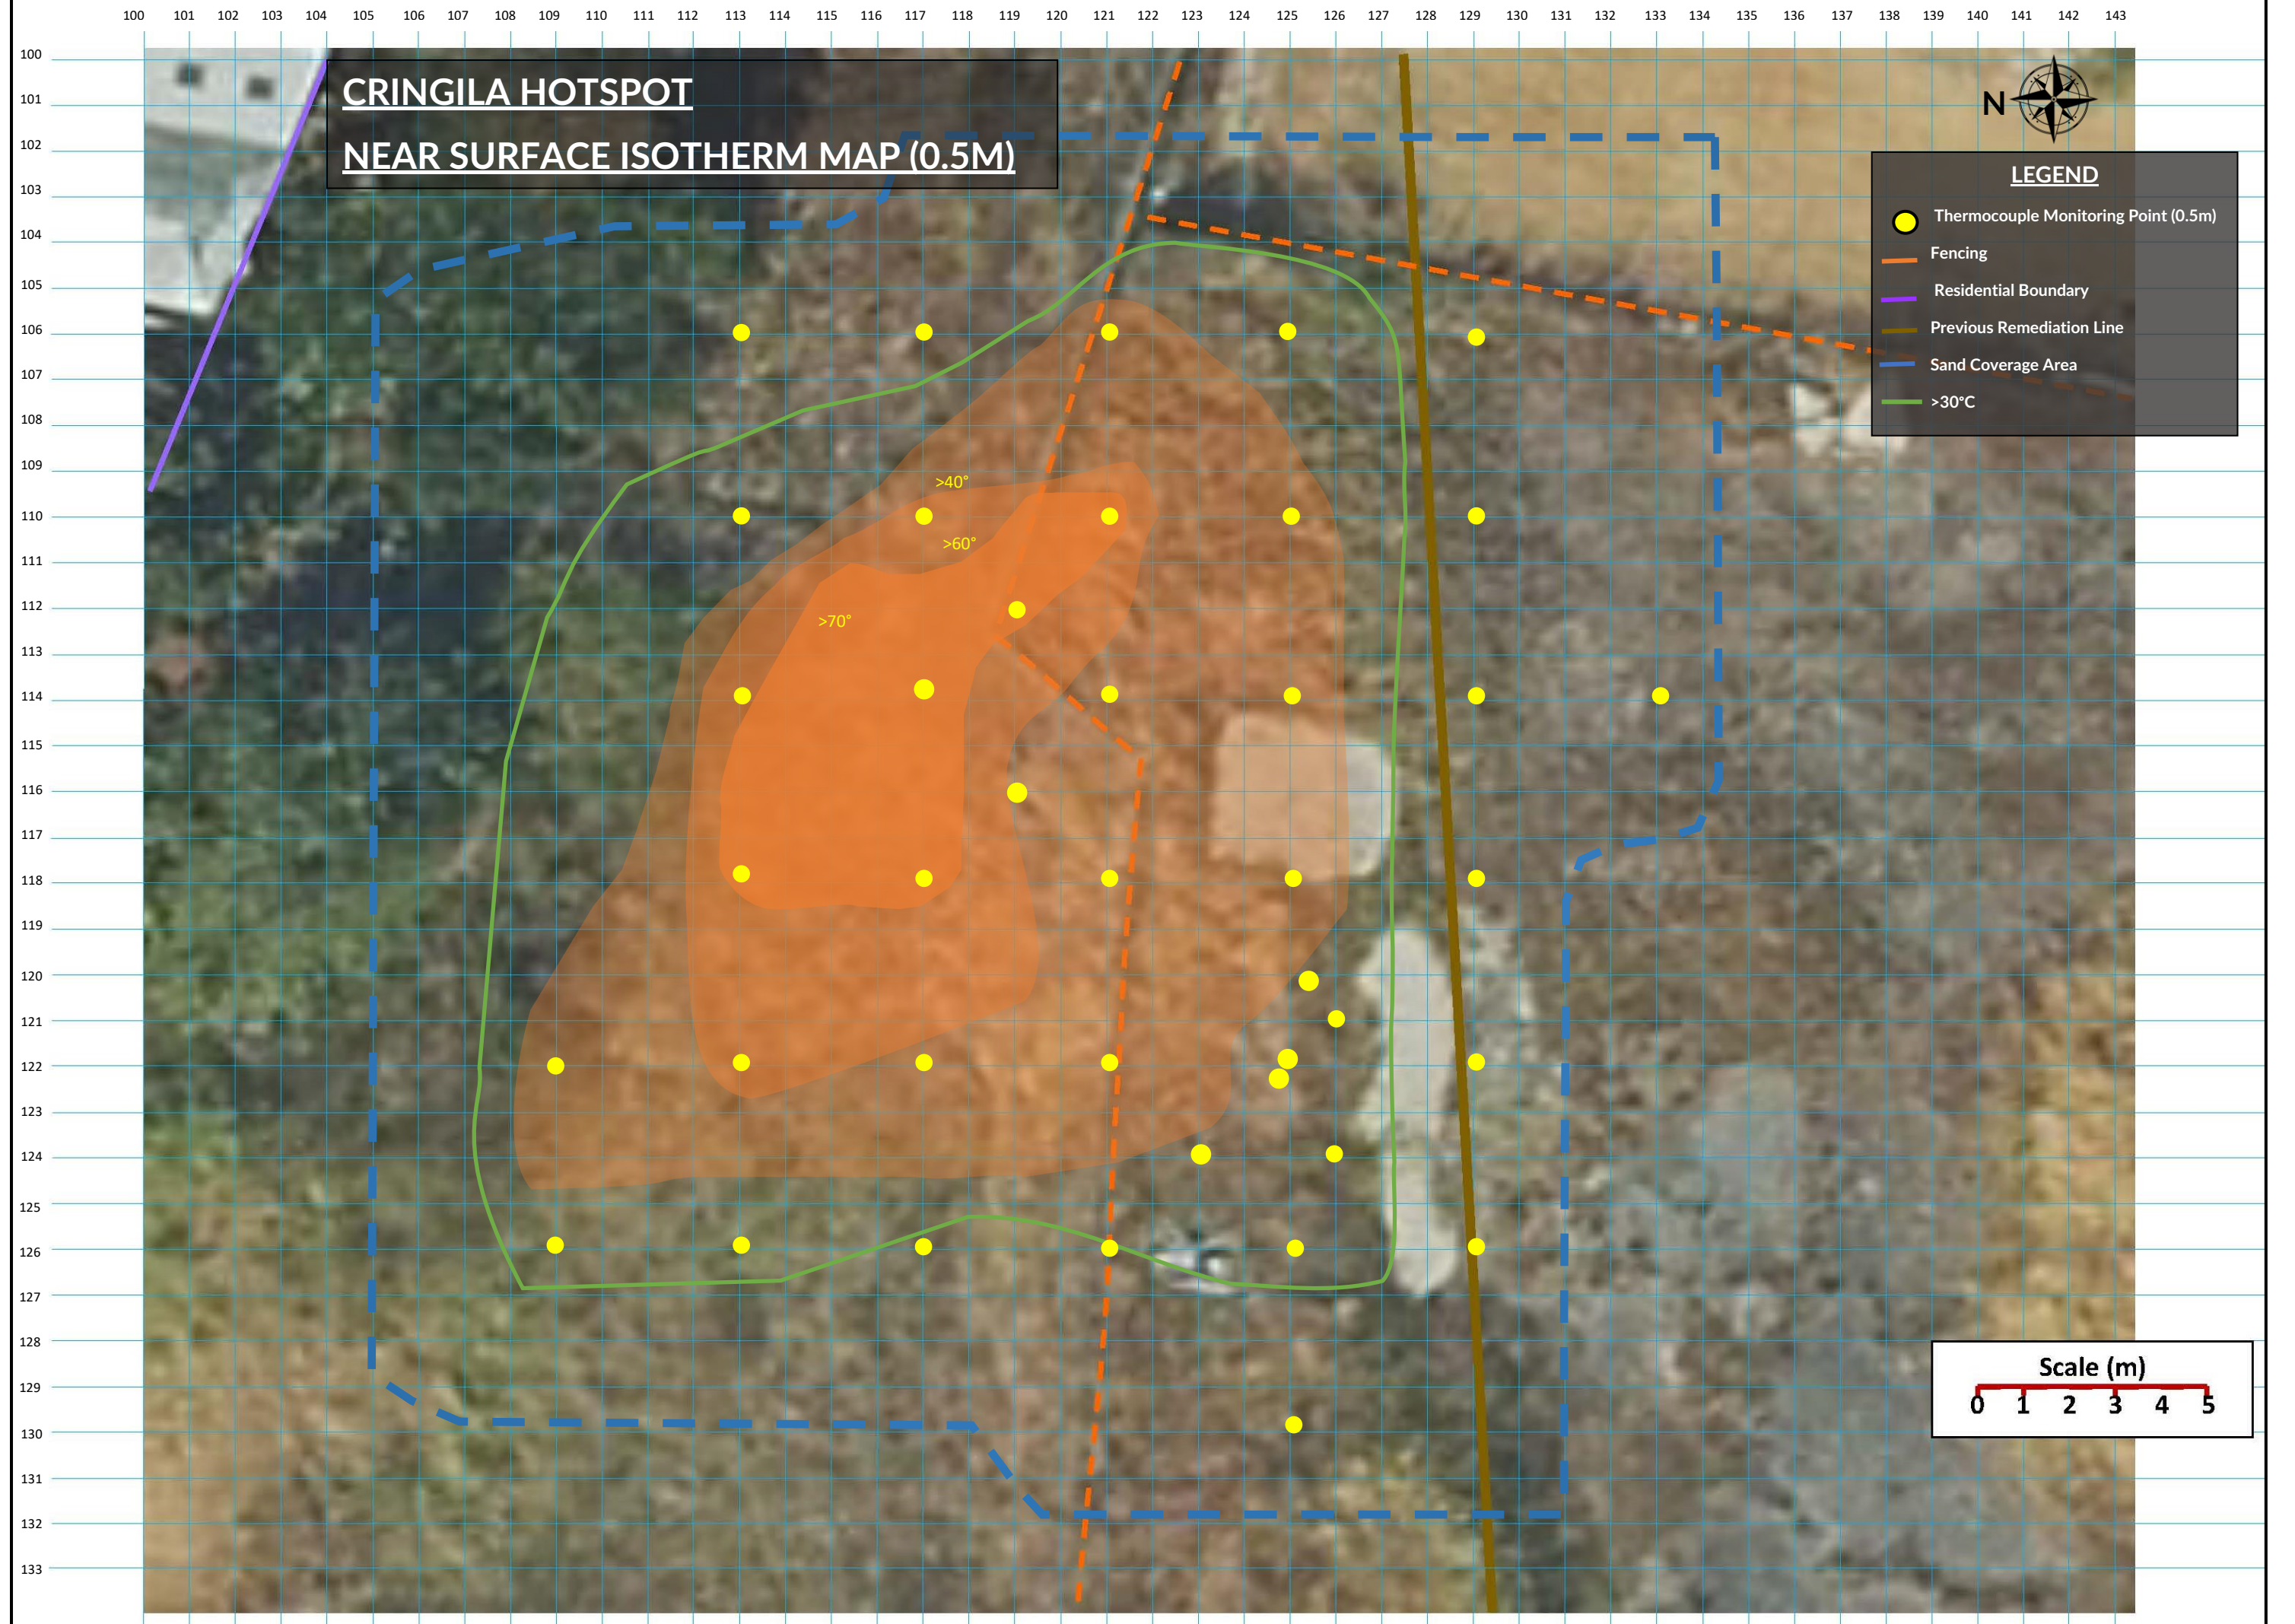
Appendix B: Near Surface Temperature Isotherm Map (0.5m)

The isotherm map shows the general zone of influence for temperatures between 30°C and 78°C at 0.5m, coloured orange. The isotherm map suggests that the hotspot may extend deeper than 0.5m and that the increased temperature in these areas is a result of heat venting to the surface.

It is noted that temperature at the near-surface may be variable across the hotspot due to inconsistencies in the consolidation and compaction of subsurface materials.

CRINGILA HOTSPOT NEAR SURFACE ISOTHERM MAP (0.5M)

It is recommended that weekly site inspections and recording are continued to monitor the near surface temperatures surrounding the hotspot identified at the site.
