## NEAR SURFACE TEMPERATURE MONITORING CRINGILA PUBLIC SCHOOL - NW HOTSPOT

Weekly Summary Report  
19/11/2018 – 23/11/2018

NSW Department  
of Education  
Cringila Public School

35 Sheffield Street  
Cringila NSW 2502

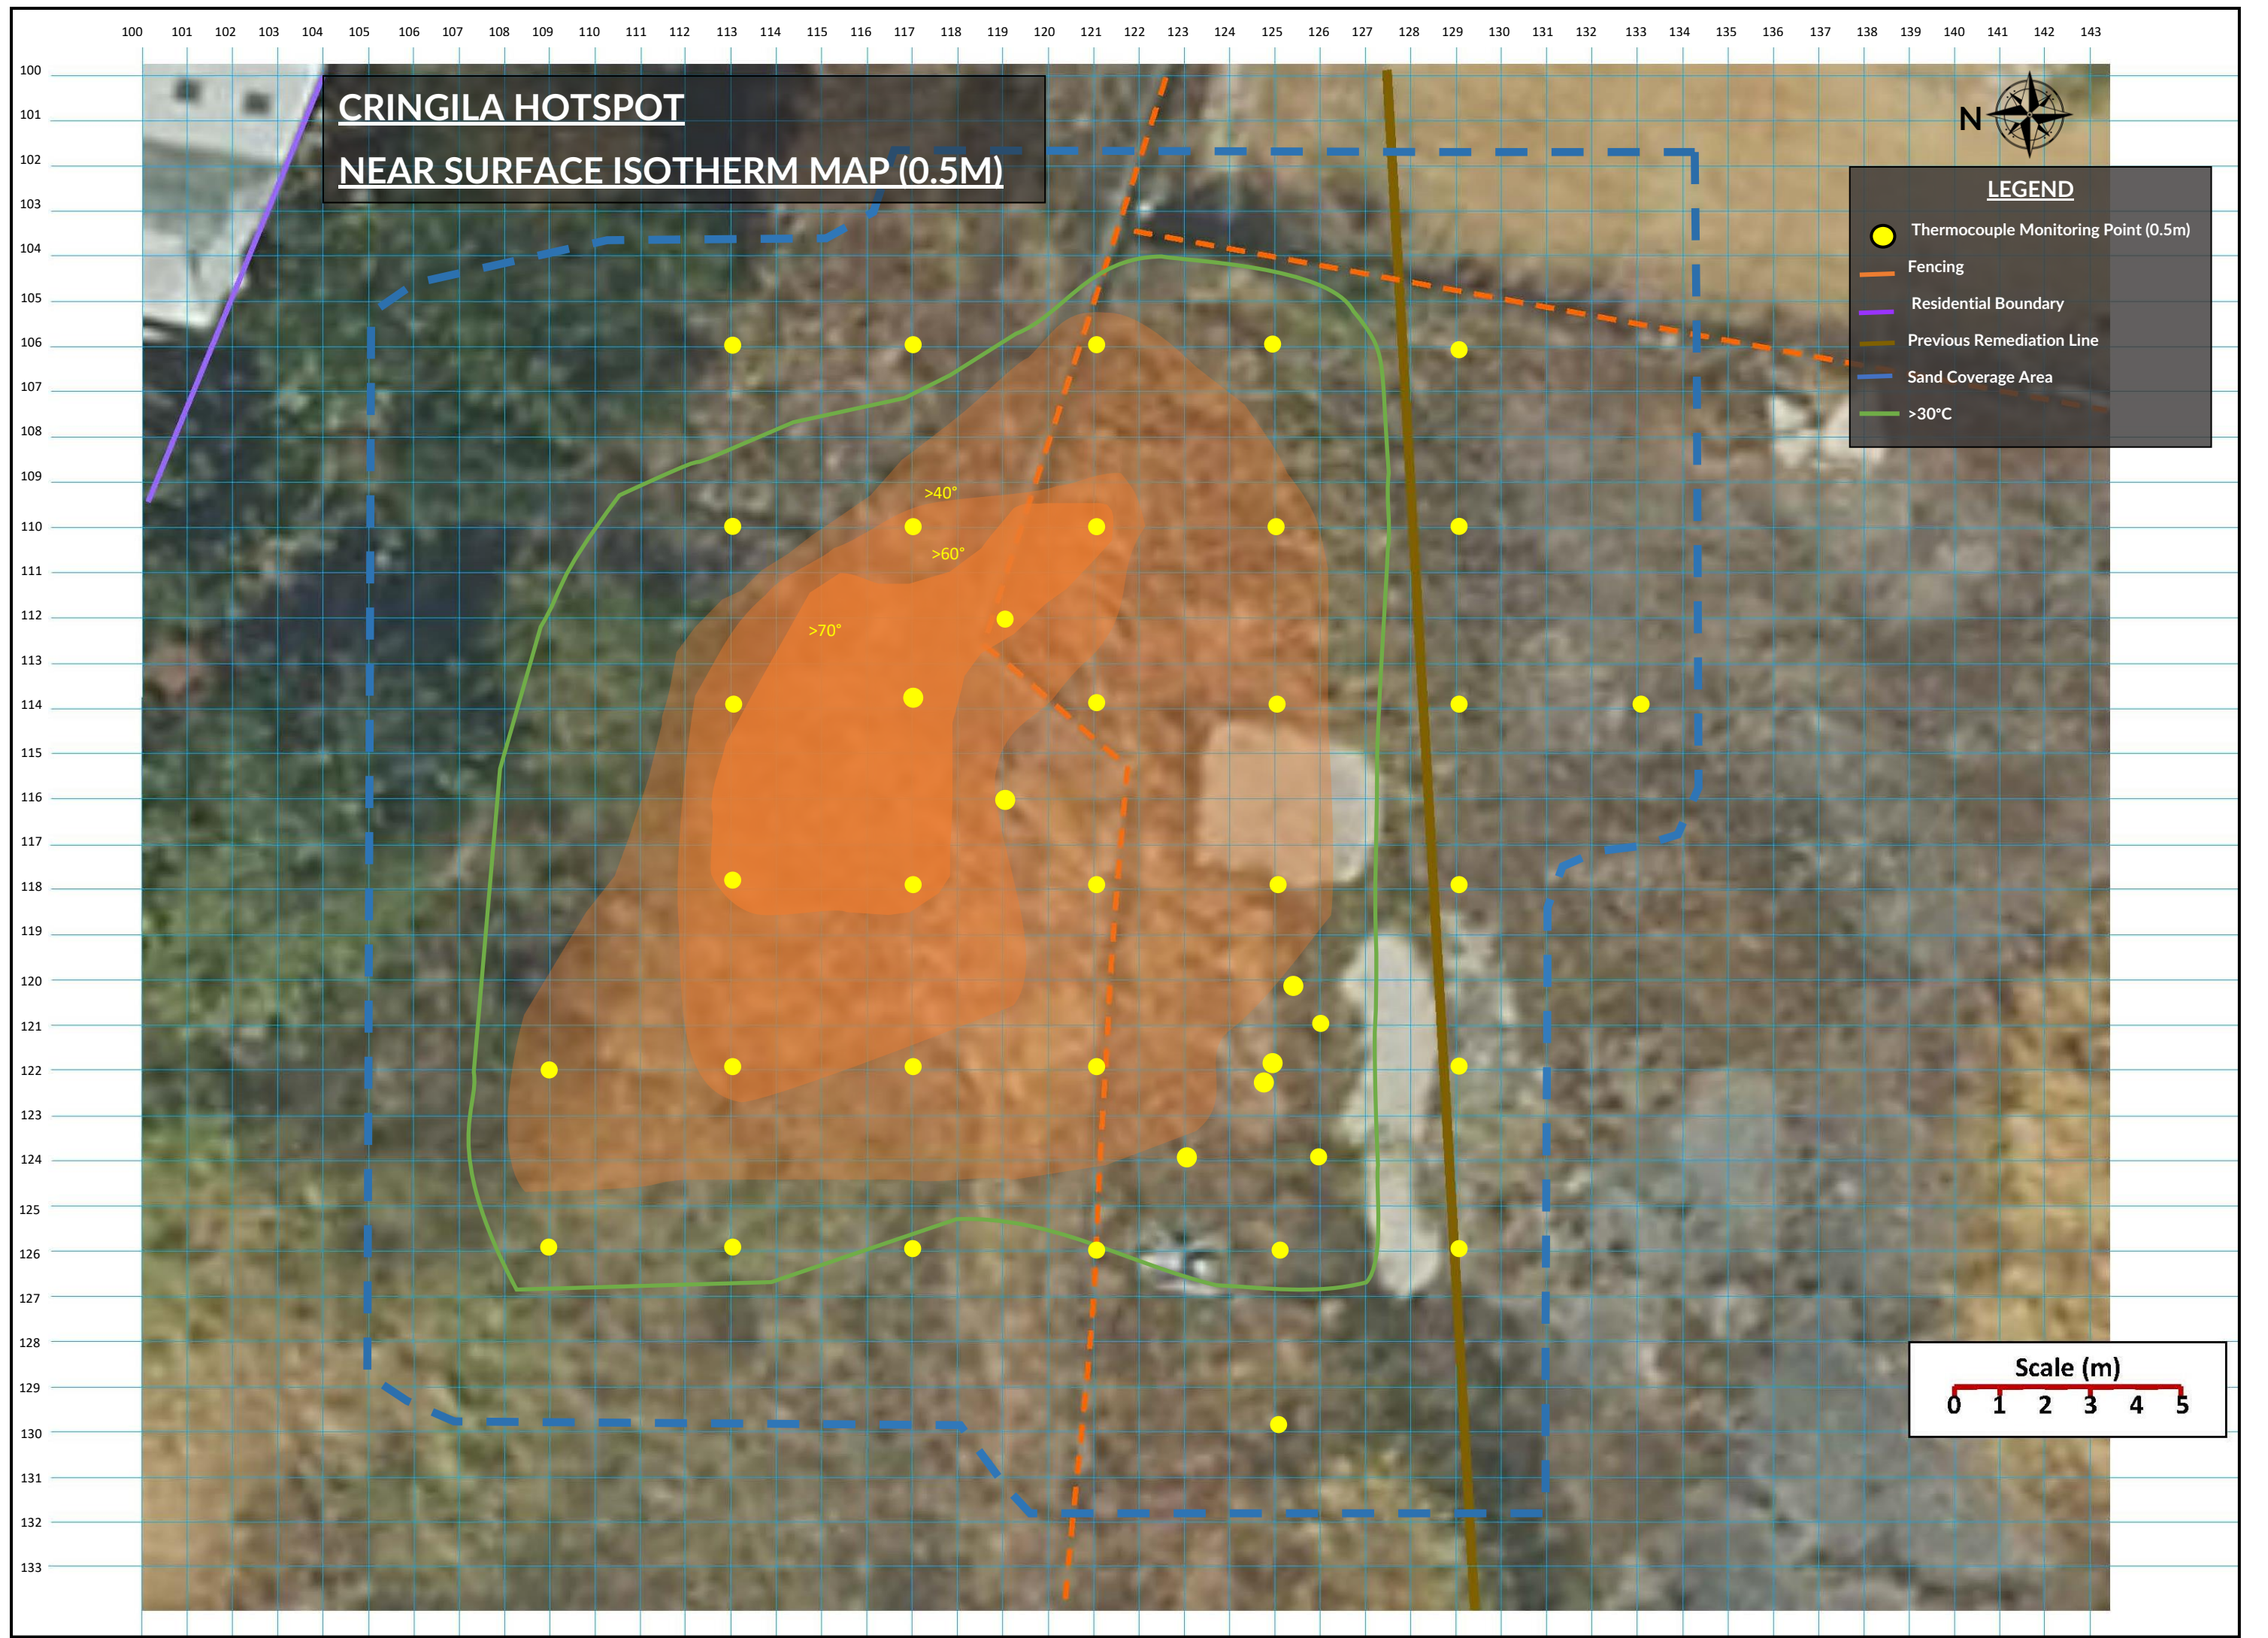
### Appendix B: Near Surface Temperature Isotherm Map (0.5m)

The isotherm map shows the general zone of influence for temperatures between 30°C and 76°C at 0.5m, coloured orange. The isotherm map suggests that the hotspot may extend deeper than 0.5m and that the increased temperature in these areas is a result of heat venting to the surface.

It is noted that temperature at the near-surface may be variable across the hotspot due to inconsistencies in the consolidation and compaction of subsurface materials.

# CRINGILA HOTSPOT NEAR SURFACE ISOTHERM MAP (0.5M)

It is recommended that weekly site inspections and recording are continued to monitor the near surface temperatures surrounding the hotspot identified at the site.
