## NEAR SURFACE TEMPERATURE MONITORING CRINGILA PUBLIC SCHOOL - NW HOTSPOT

Weekly Summary Report  
26/11/2018 - 30/11/2018

NSW Department  
of Education  
Cringila Public School

November 2018  
C107826: J153825: RC

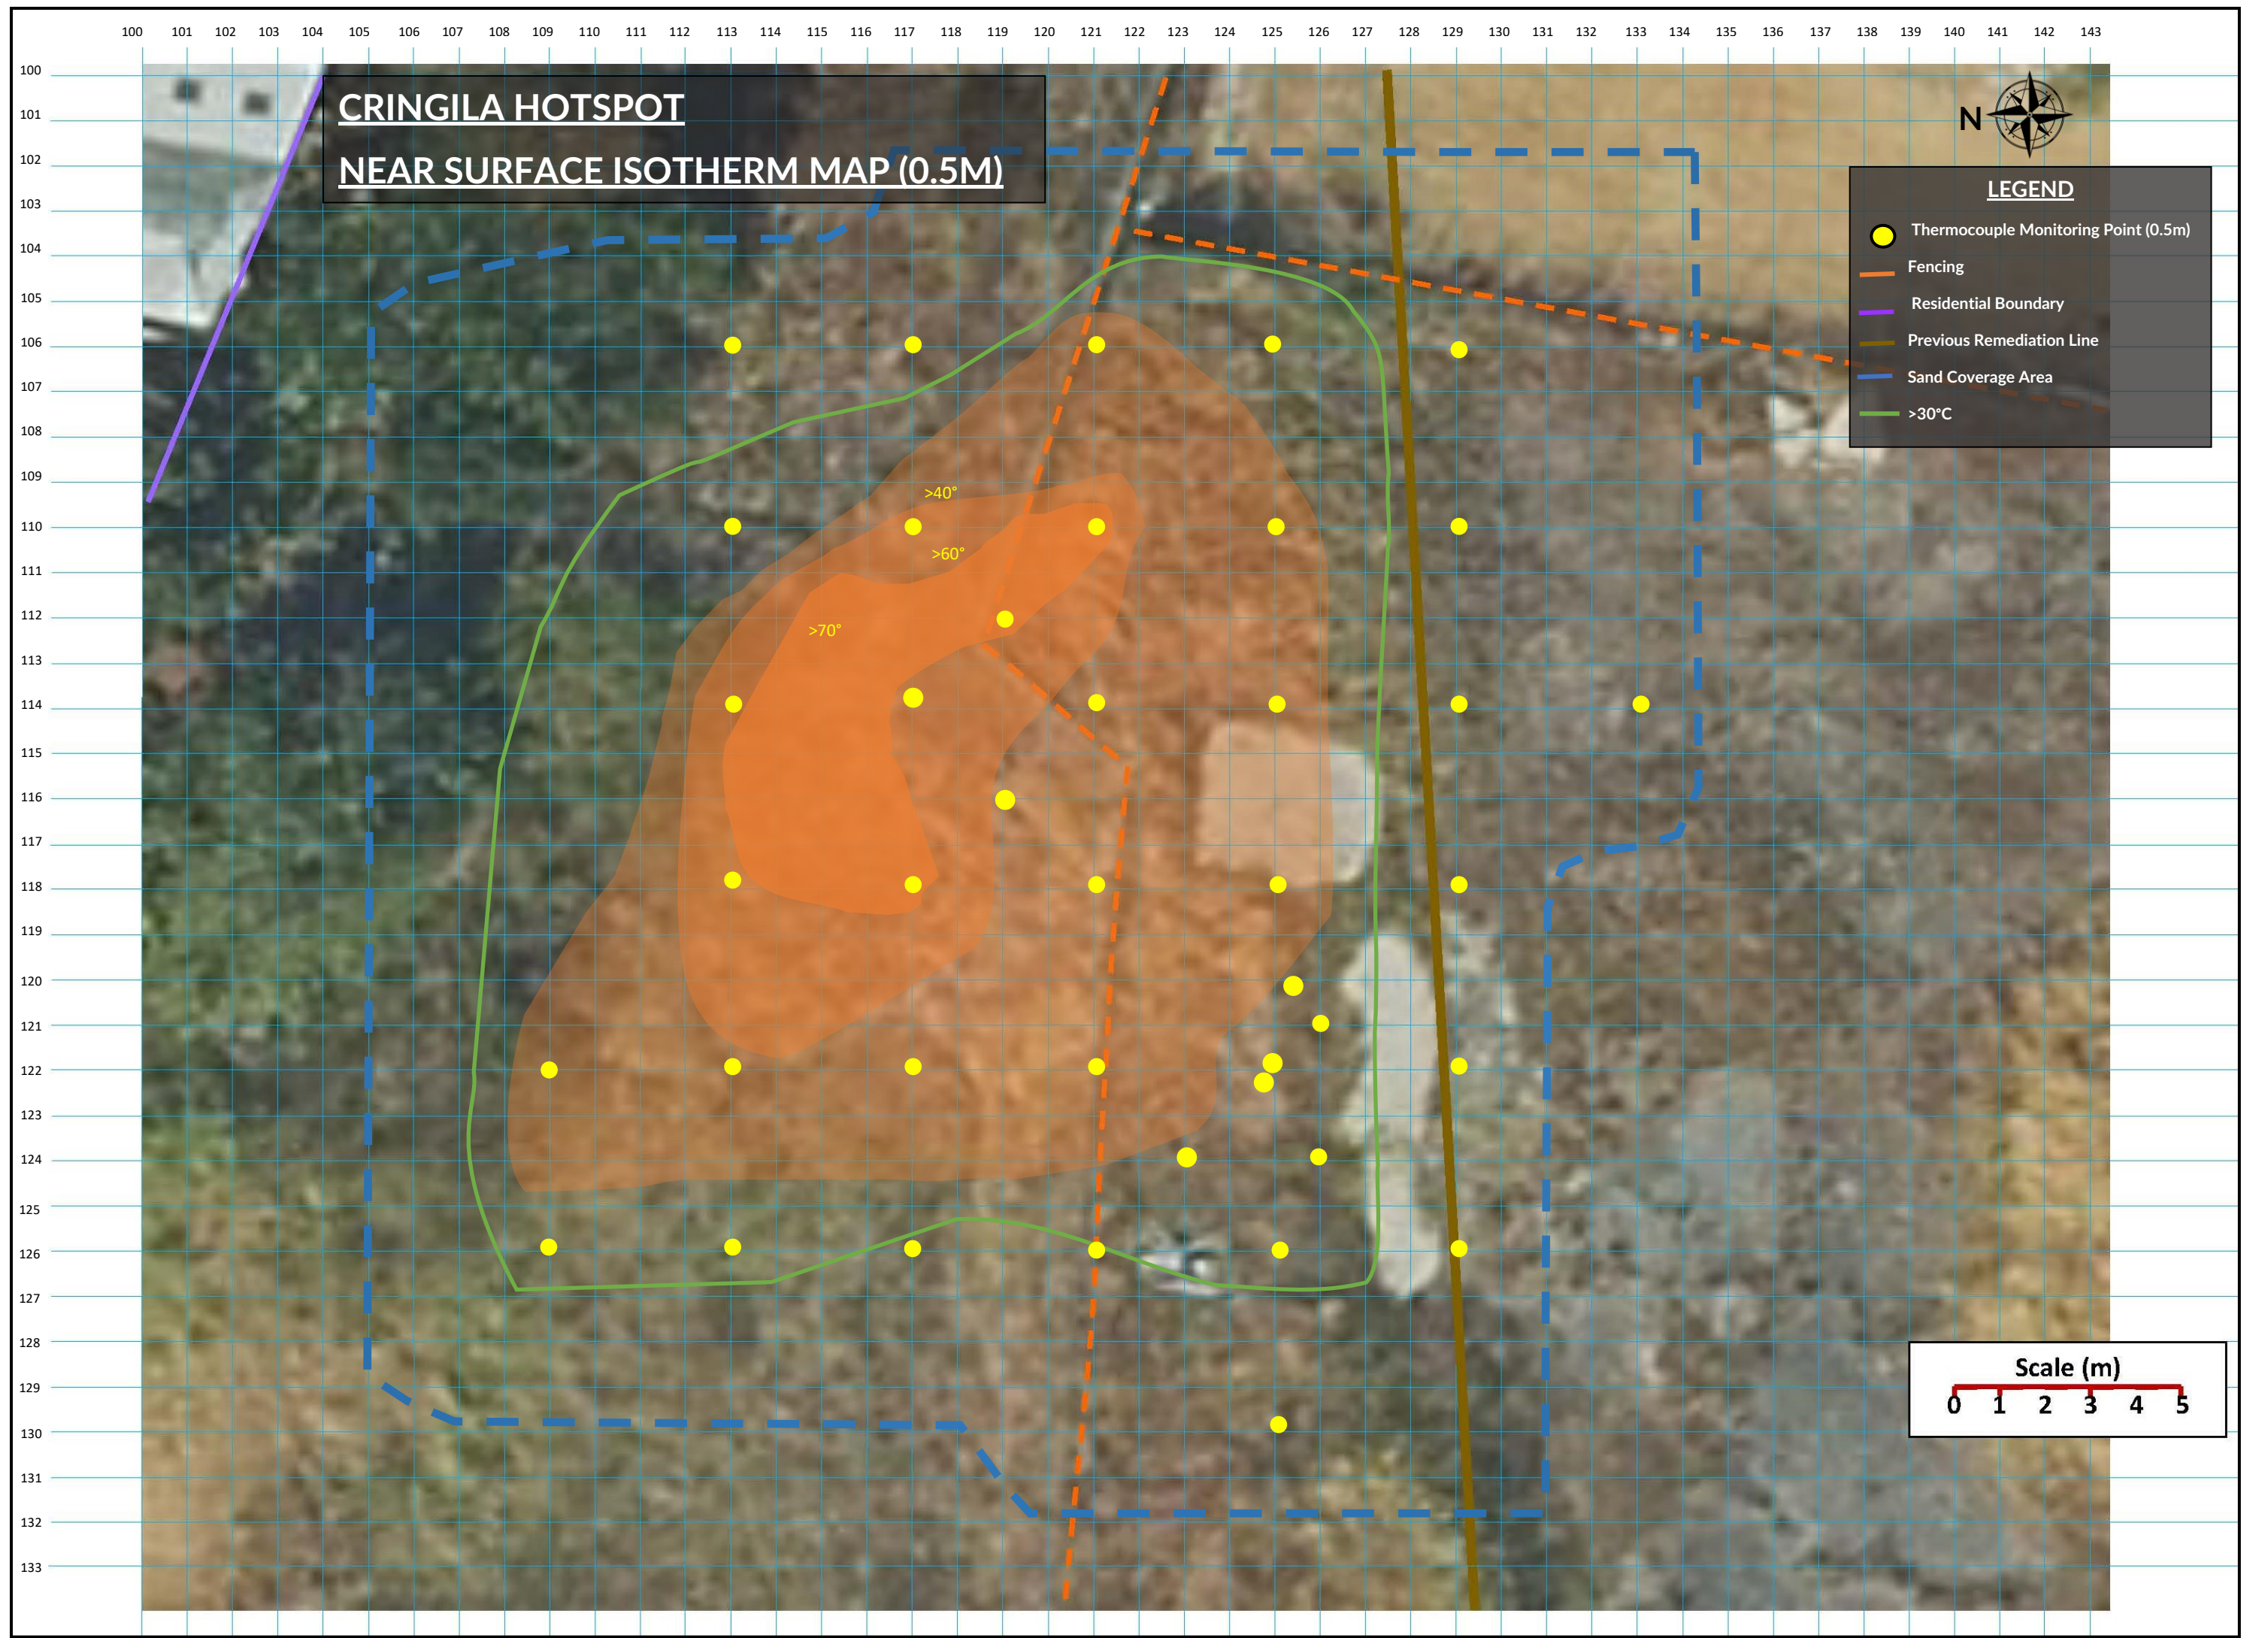
### Appendix B: Near Surface Temperature Isotherm Map (0.5m)

The isotherm map shows the general zone of influence for temperatures between 30°C and 72°C at 0.5m, coloured orange. The isotherm map suggests that the hotspot may extend deeper than 0.5m and that the increased temperature in these areas is a result of heat venting to the surface.

It is noted that temperature at the near-surface may be variable across the hotspot due to inconsistencies in the consolidation and compaction of subsurface materials.

# CRINGILA HOTSPOT NEAR SURFACE ISOTHERM MAP (0.5M)

It is recommended that weekly site inspections and recording are continued to monitor the near surface temperatures surrounding the hotspot identified at the site.
