NEAR SURFACE TEMPERATURE MONITORING CRINGILA PUBLIC SCHOOL - NW HOTSPOT

Weekly Summary Report
03/12/2018 - 07/12/2018

NSW Department
of Education
Cringila Public School

December 2018
C107826: J153825: RC

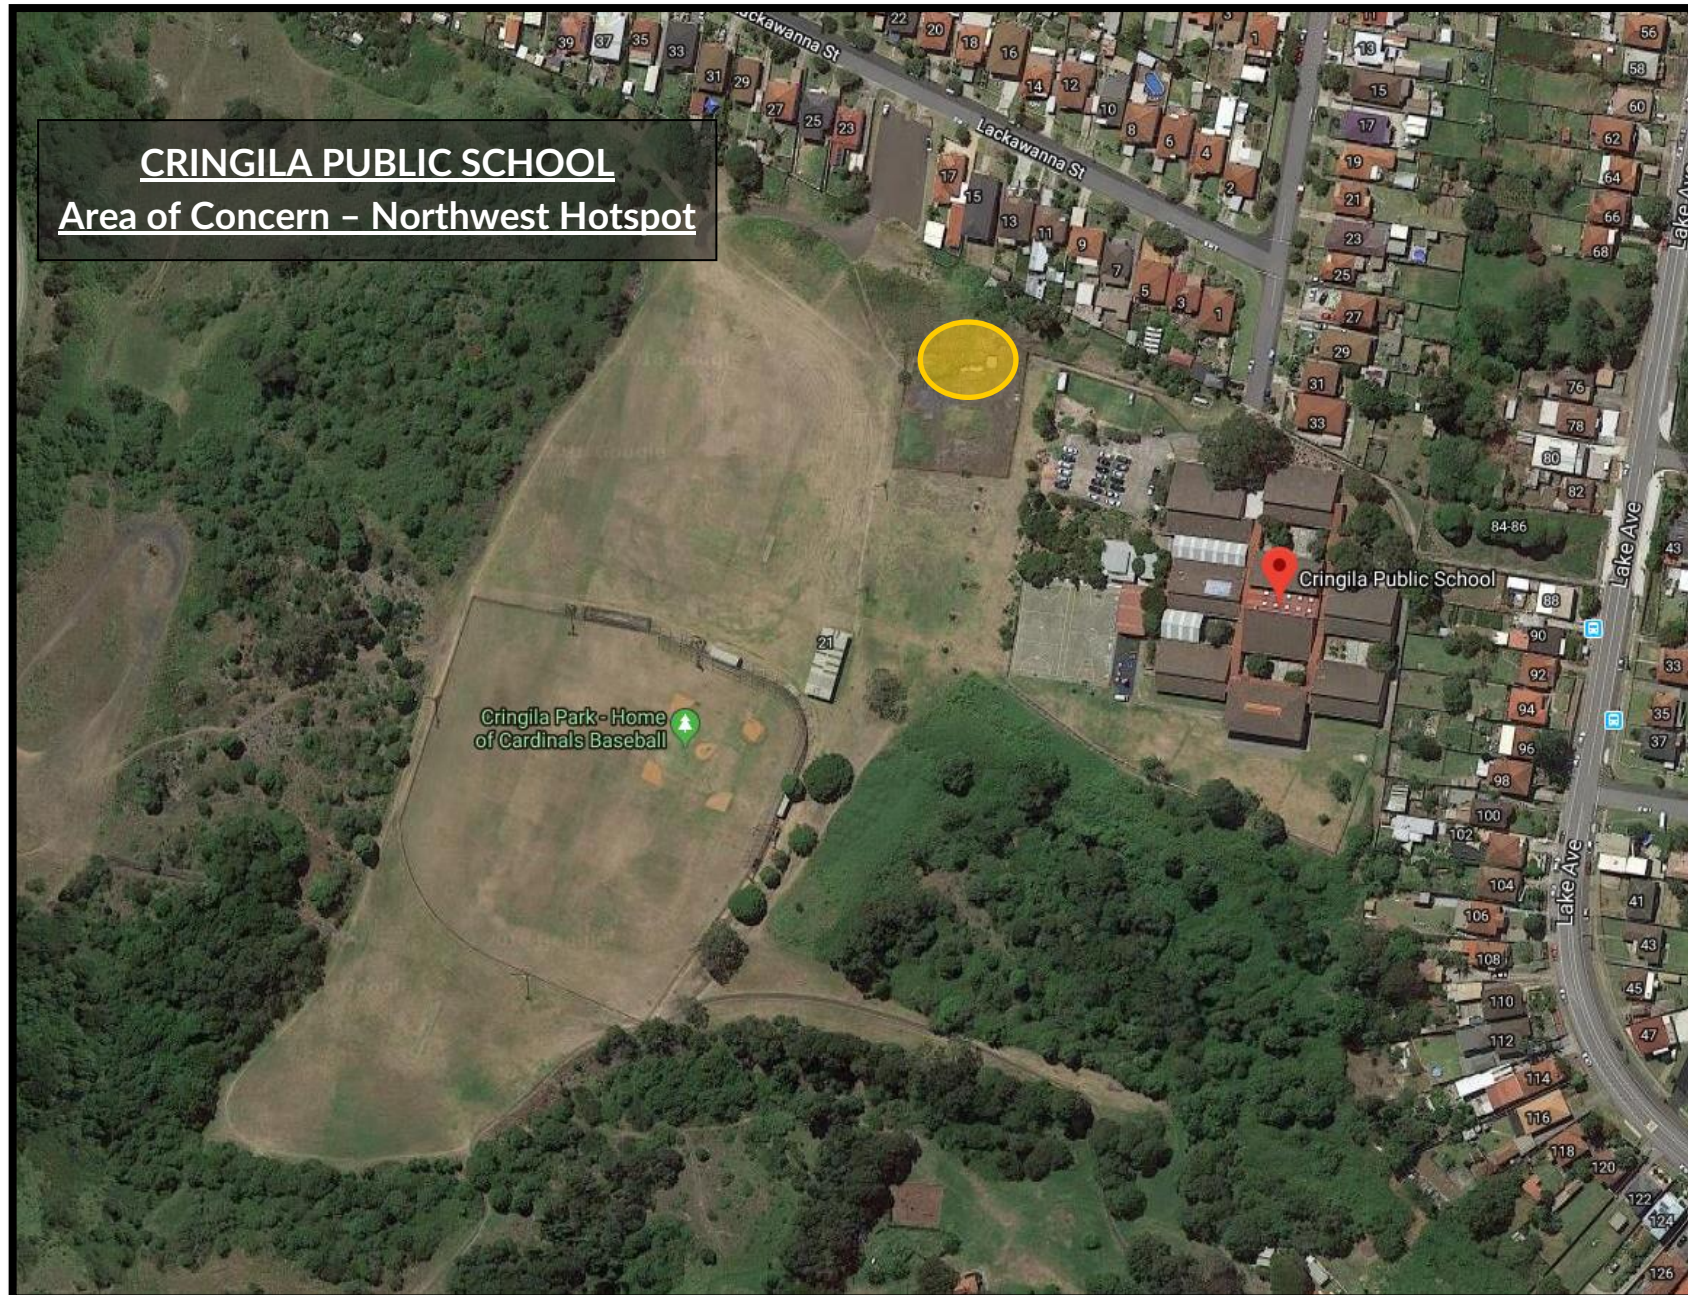
Appendix A: Area of Concern – Northwest Hotspot Map

CRINGILA PUBLIC SCHOOL
Area of Concern - Northwest Hotspot

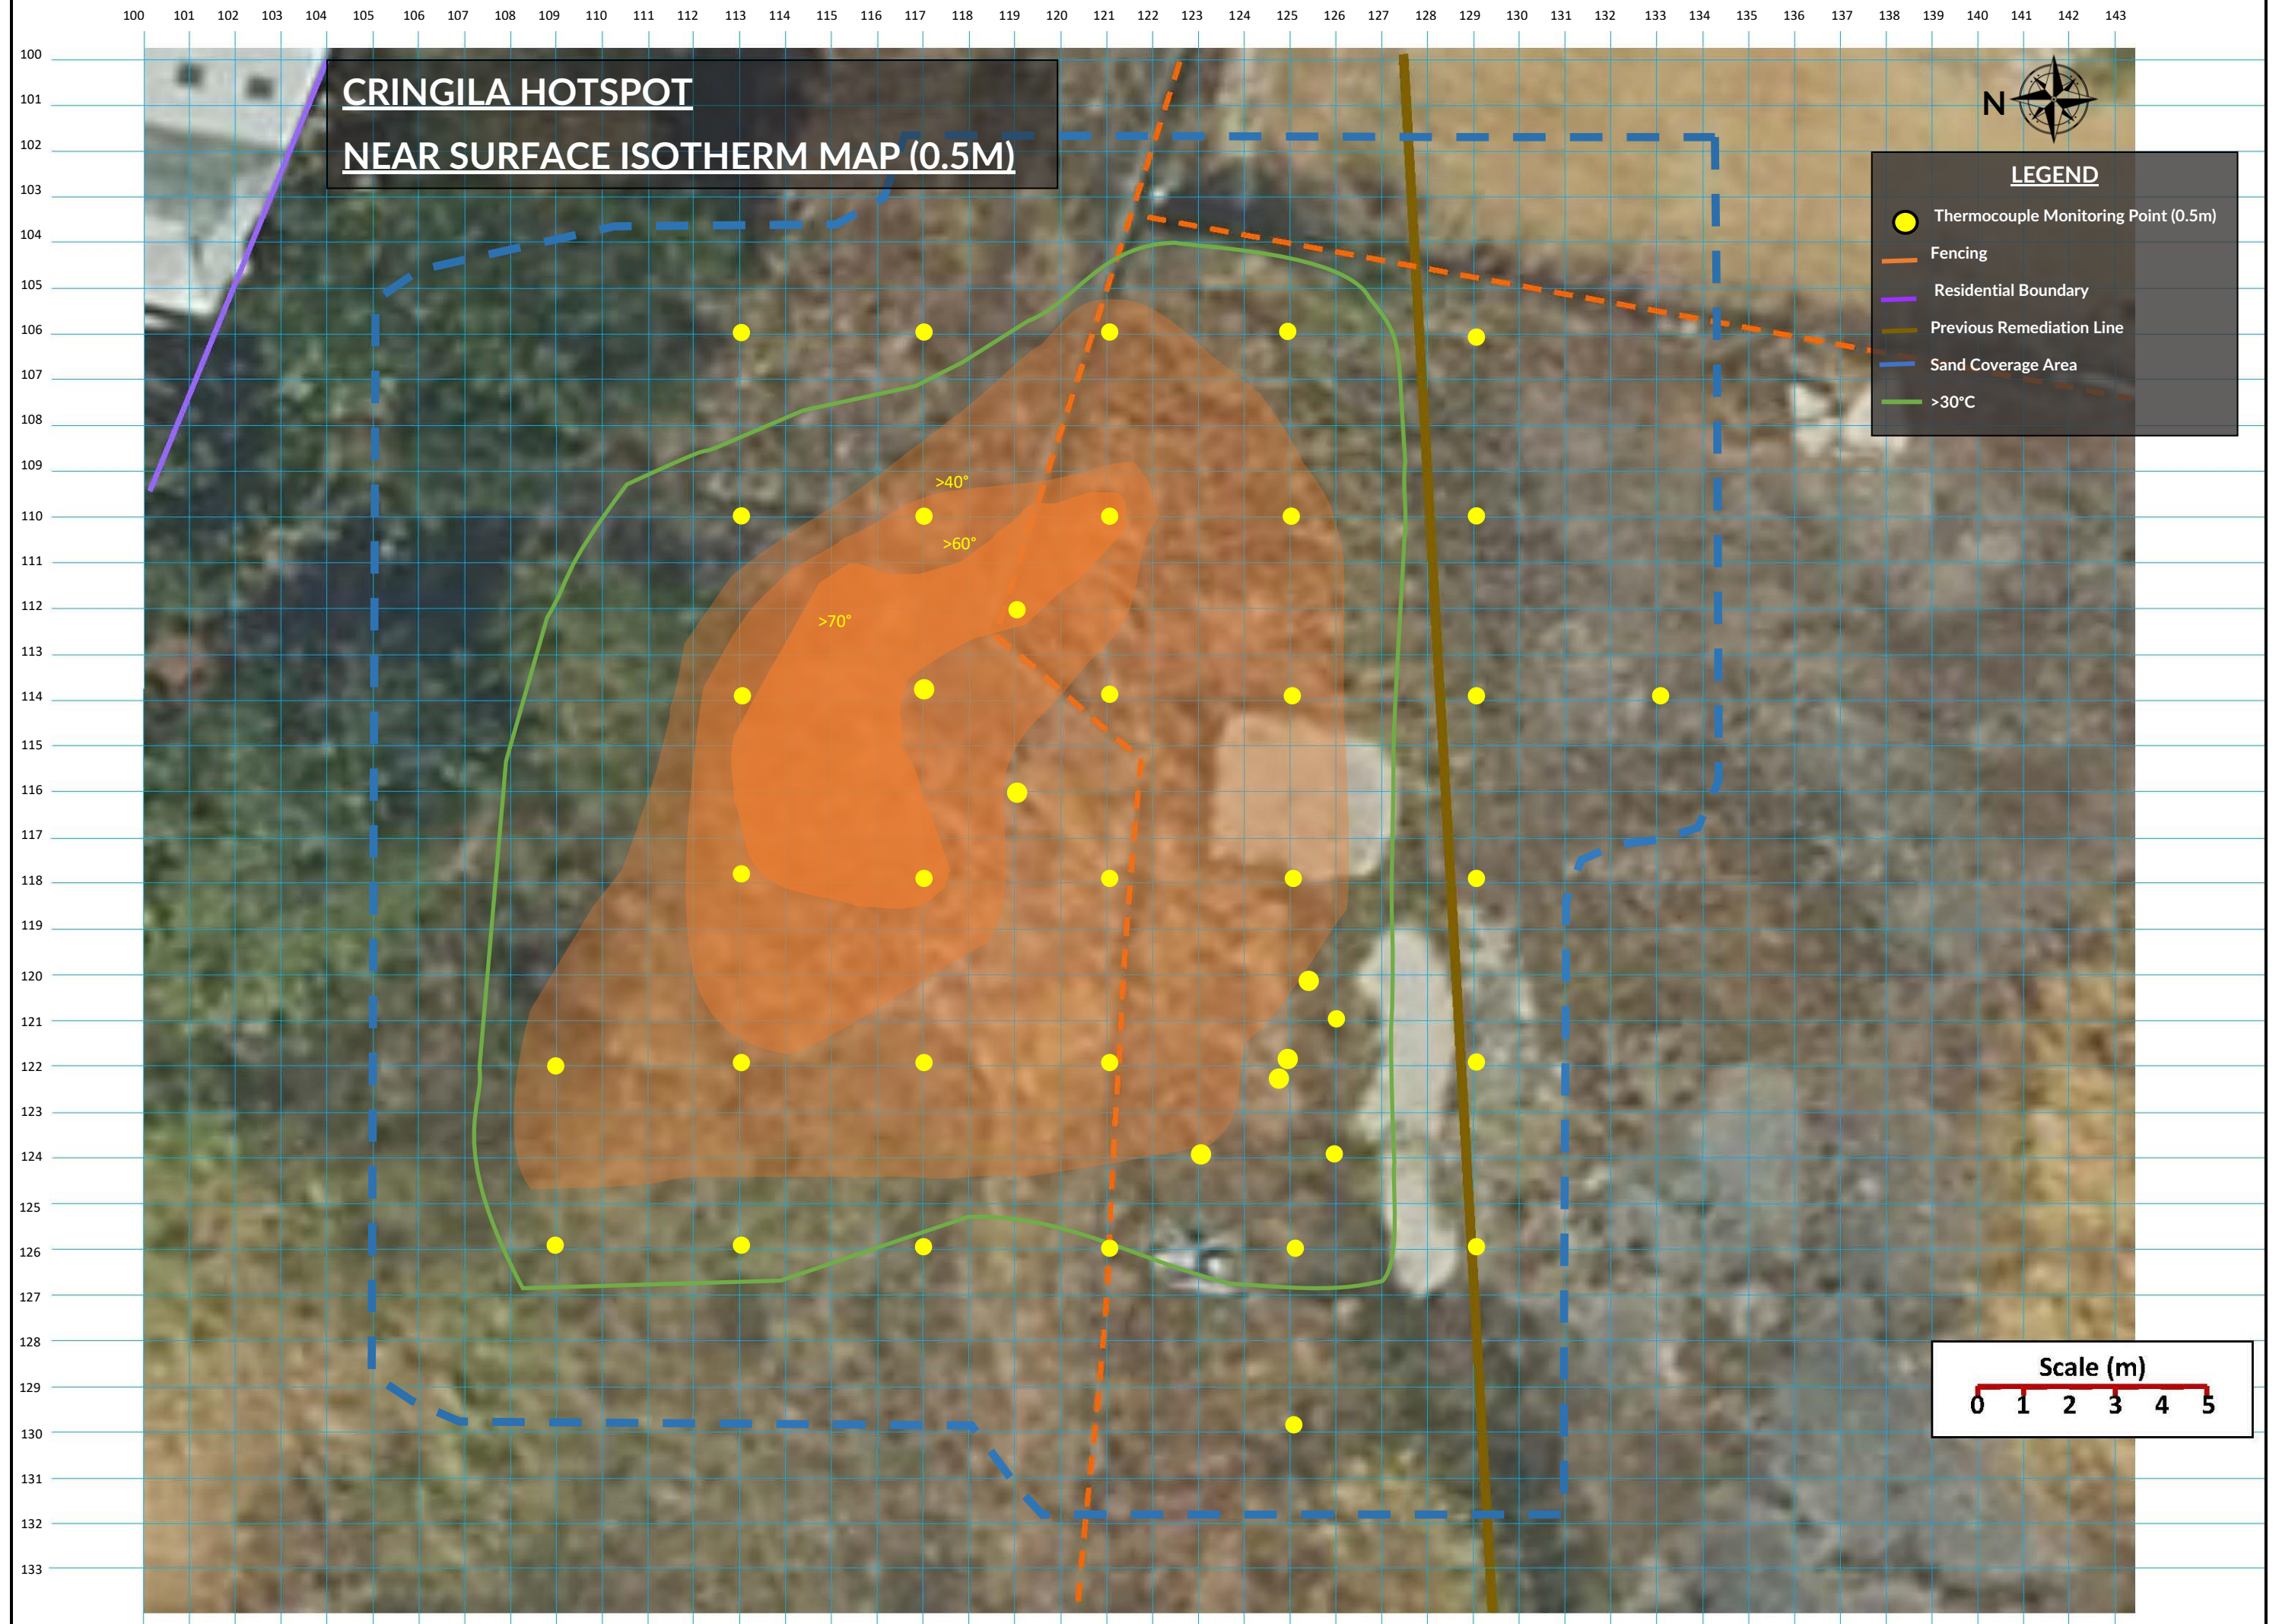
Appendix B: Near Surface Temperature Isotherm Map (0.5m)

The isotherm map shows the general zone of influence for temperatures between 30°C and 76°C at 0.5m, coloured orange. The isotherm map suggests that the hotspot may extend deeper than 0.5m and that the increased temperature in these areas is a result of heat venting to the surface.

It is noted that temperature at the near-surface may be variable across the hotspot due to inconsistencies in the consolidation and compaction of subsurface materials.

CRINGILA HOTSPOT NEAR SURFACE ISOTHERM MAP (0.5M)

The near surface temperature monitoring conducted between 3rd December 2018 and 7th December 2018 indicates that the spatial extent of the northwest hotspot appears to remain localised.

It is recommended that weekly site inspections and recording are continued to monitor the near surface temperatures surrounding the hotspot identified at the site.
