NEAR SURFACE TEMPERATURE MONITORING CRINGILA PUBLIC SCHOOL - NW HOTSPOT

Weekly Summary Report
10/12/2018 - 14/12/2018

NSW Department
of Education
Cringila Public School

December 2018
C107826: J153825: RC

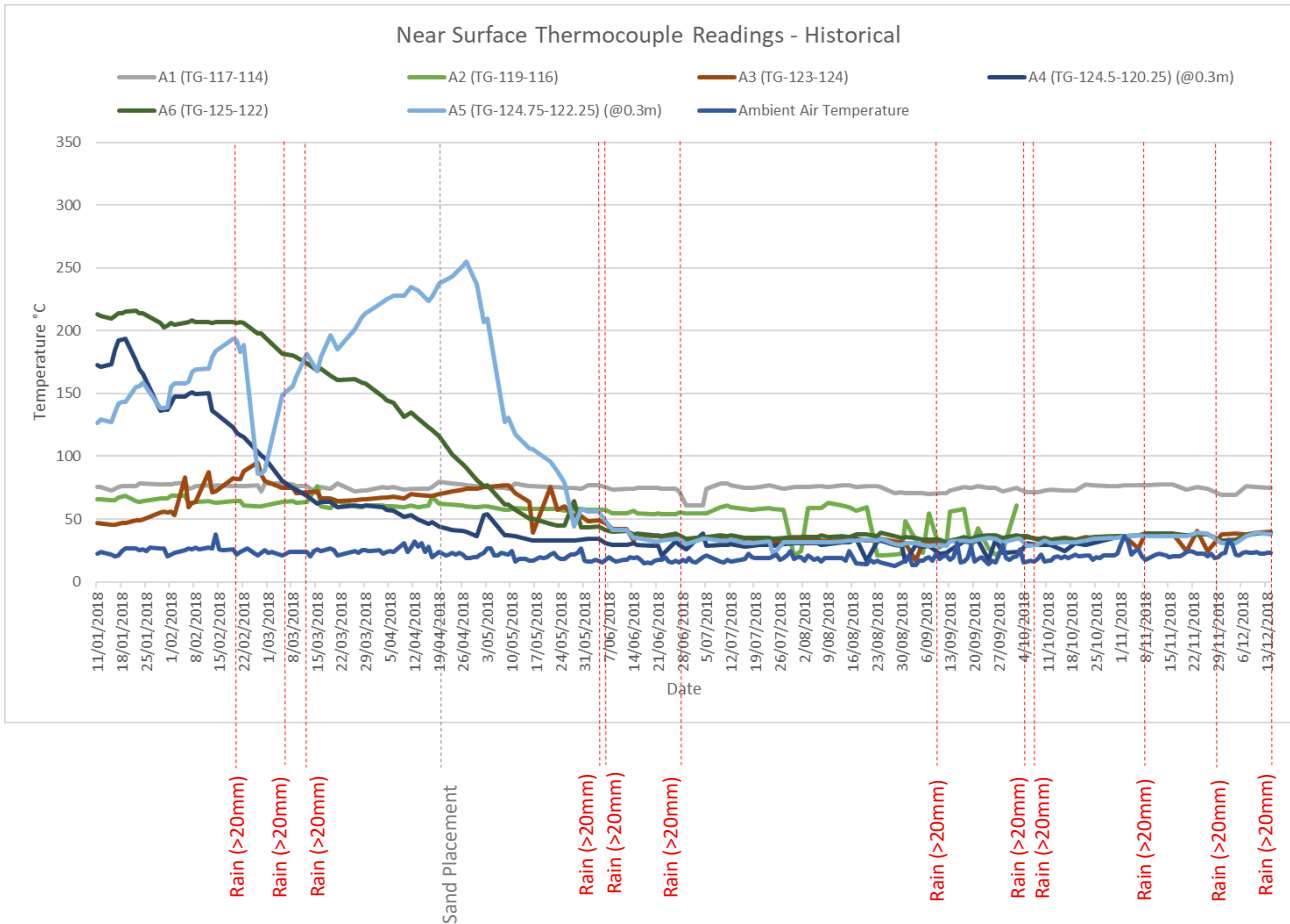
3.1. Near Surface Temperature Graph – Selected Points (Historical)

Near surface temperature measurements for key thermocouple locations, progressive from Thursday 11th January 2018 to present.

The near surface temperature appears to be trending downwards following the placement of sand (approximately 100mm) across the surface of the northwest hotspot grid monitoring area.

Fluctuations in near surface temperature are evident following significant rain events (i.e. over 20mm rain).

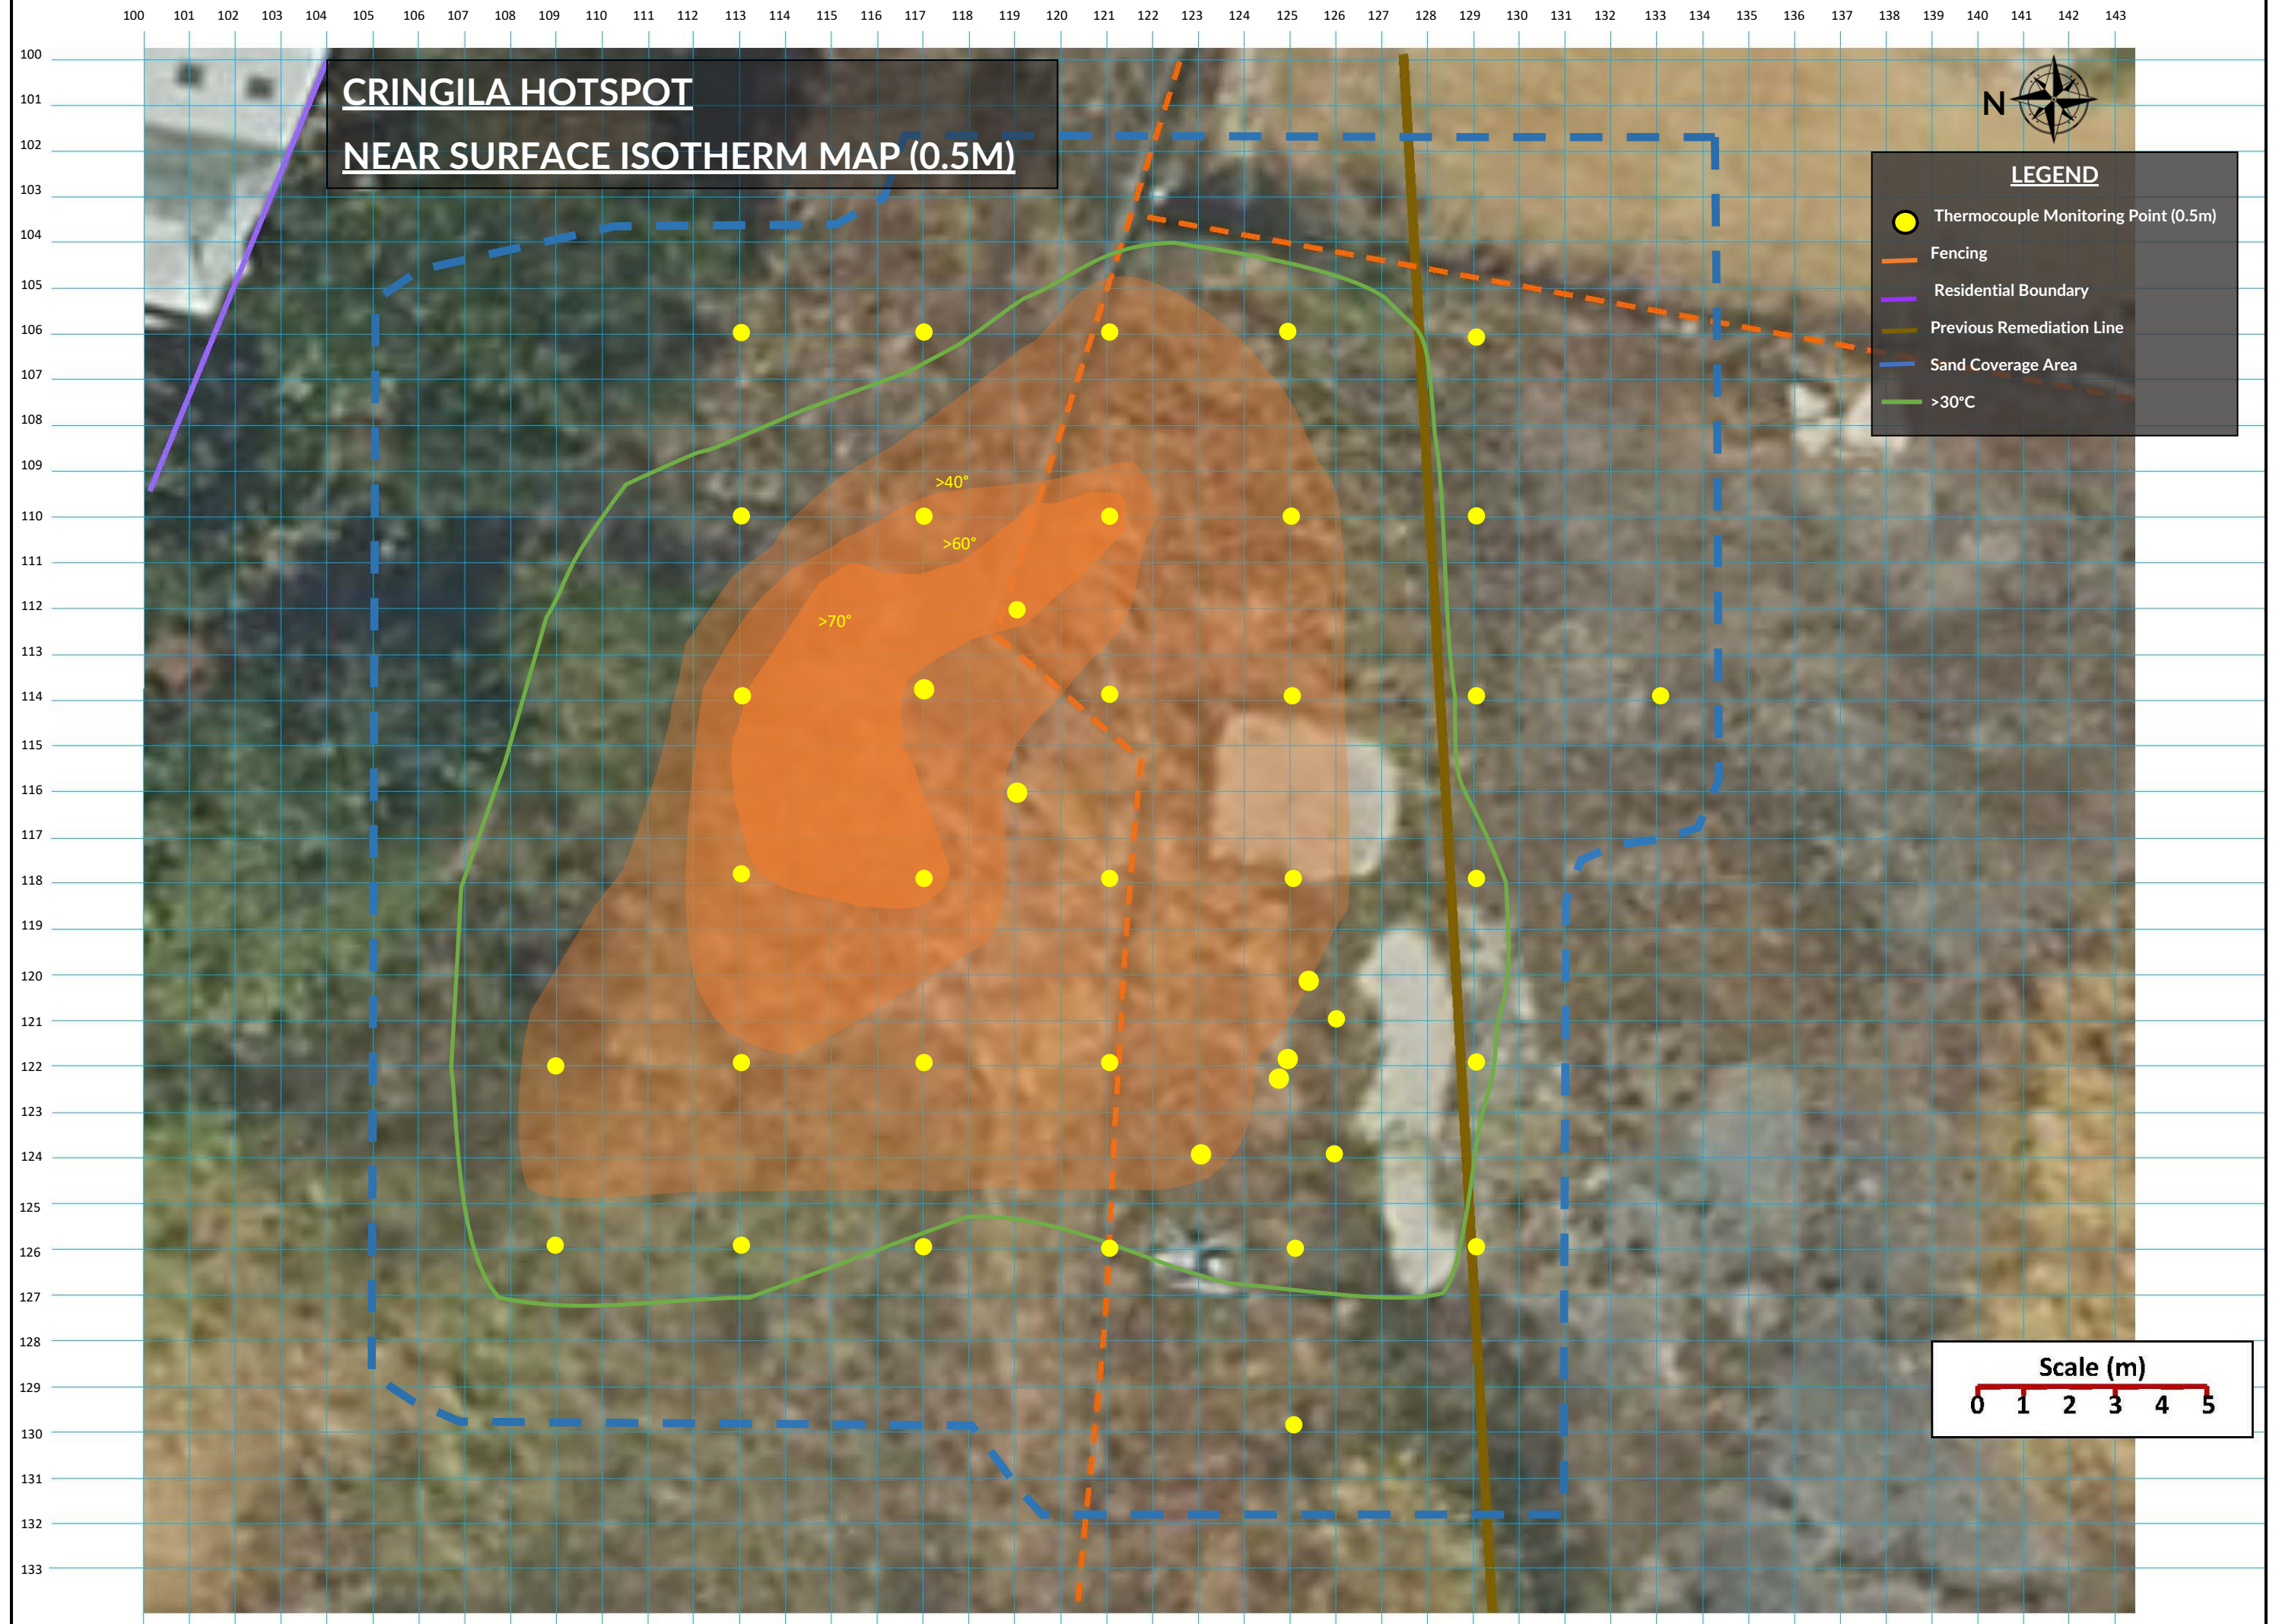
Appendix B: Near Surface Temperature Isotherm Map (0.5m)

The isotherm map shows the general zone of influence for temperatures between 30°C and 77°C at 0.5m, coloured orange. The isotherm map suggests that the hotspot may extend deeper than 0.5m and that the increased temperature in these areas is a result of heat venting to the surface.

It is noted that temperature at the near-surface may be variable across the hotspot due to inconsistencies in the consolidation and compaction of subsurface materials.

CRINGILA HOTSPOT NEAR SURFACE ISOTHERM MAP (0.5M)

The near surface temperatures for representative monitoring locations, spread across the northwest Hotspot, are presented in the tables below. Temperature isotherms have been plotted on a site map to show an illustration of the near surface temperatures in a spatial context. Refer to **Appendix B: Near Surface Temperature Isotherm Map (0.5m)**.
