## NEAR SURFACE TEMPERATURE MONITORING CRINGILA PUBLIC SCHOOL - NW HOTSPOT

Summary Report  
24/12/2018 - 11/01/2019

NSW Department  
of Education  
Cringila Public School

35 Sheffield Street  
Cringila NSW 2502

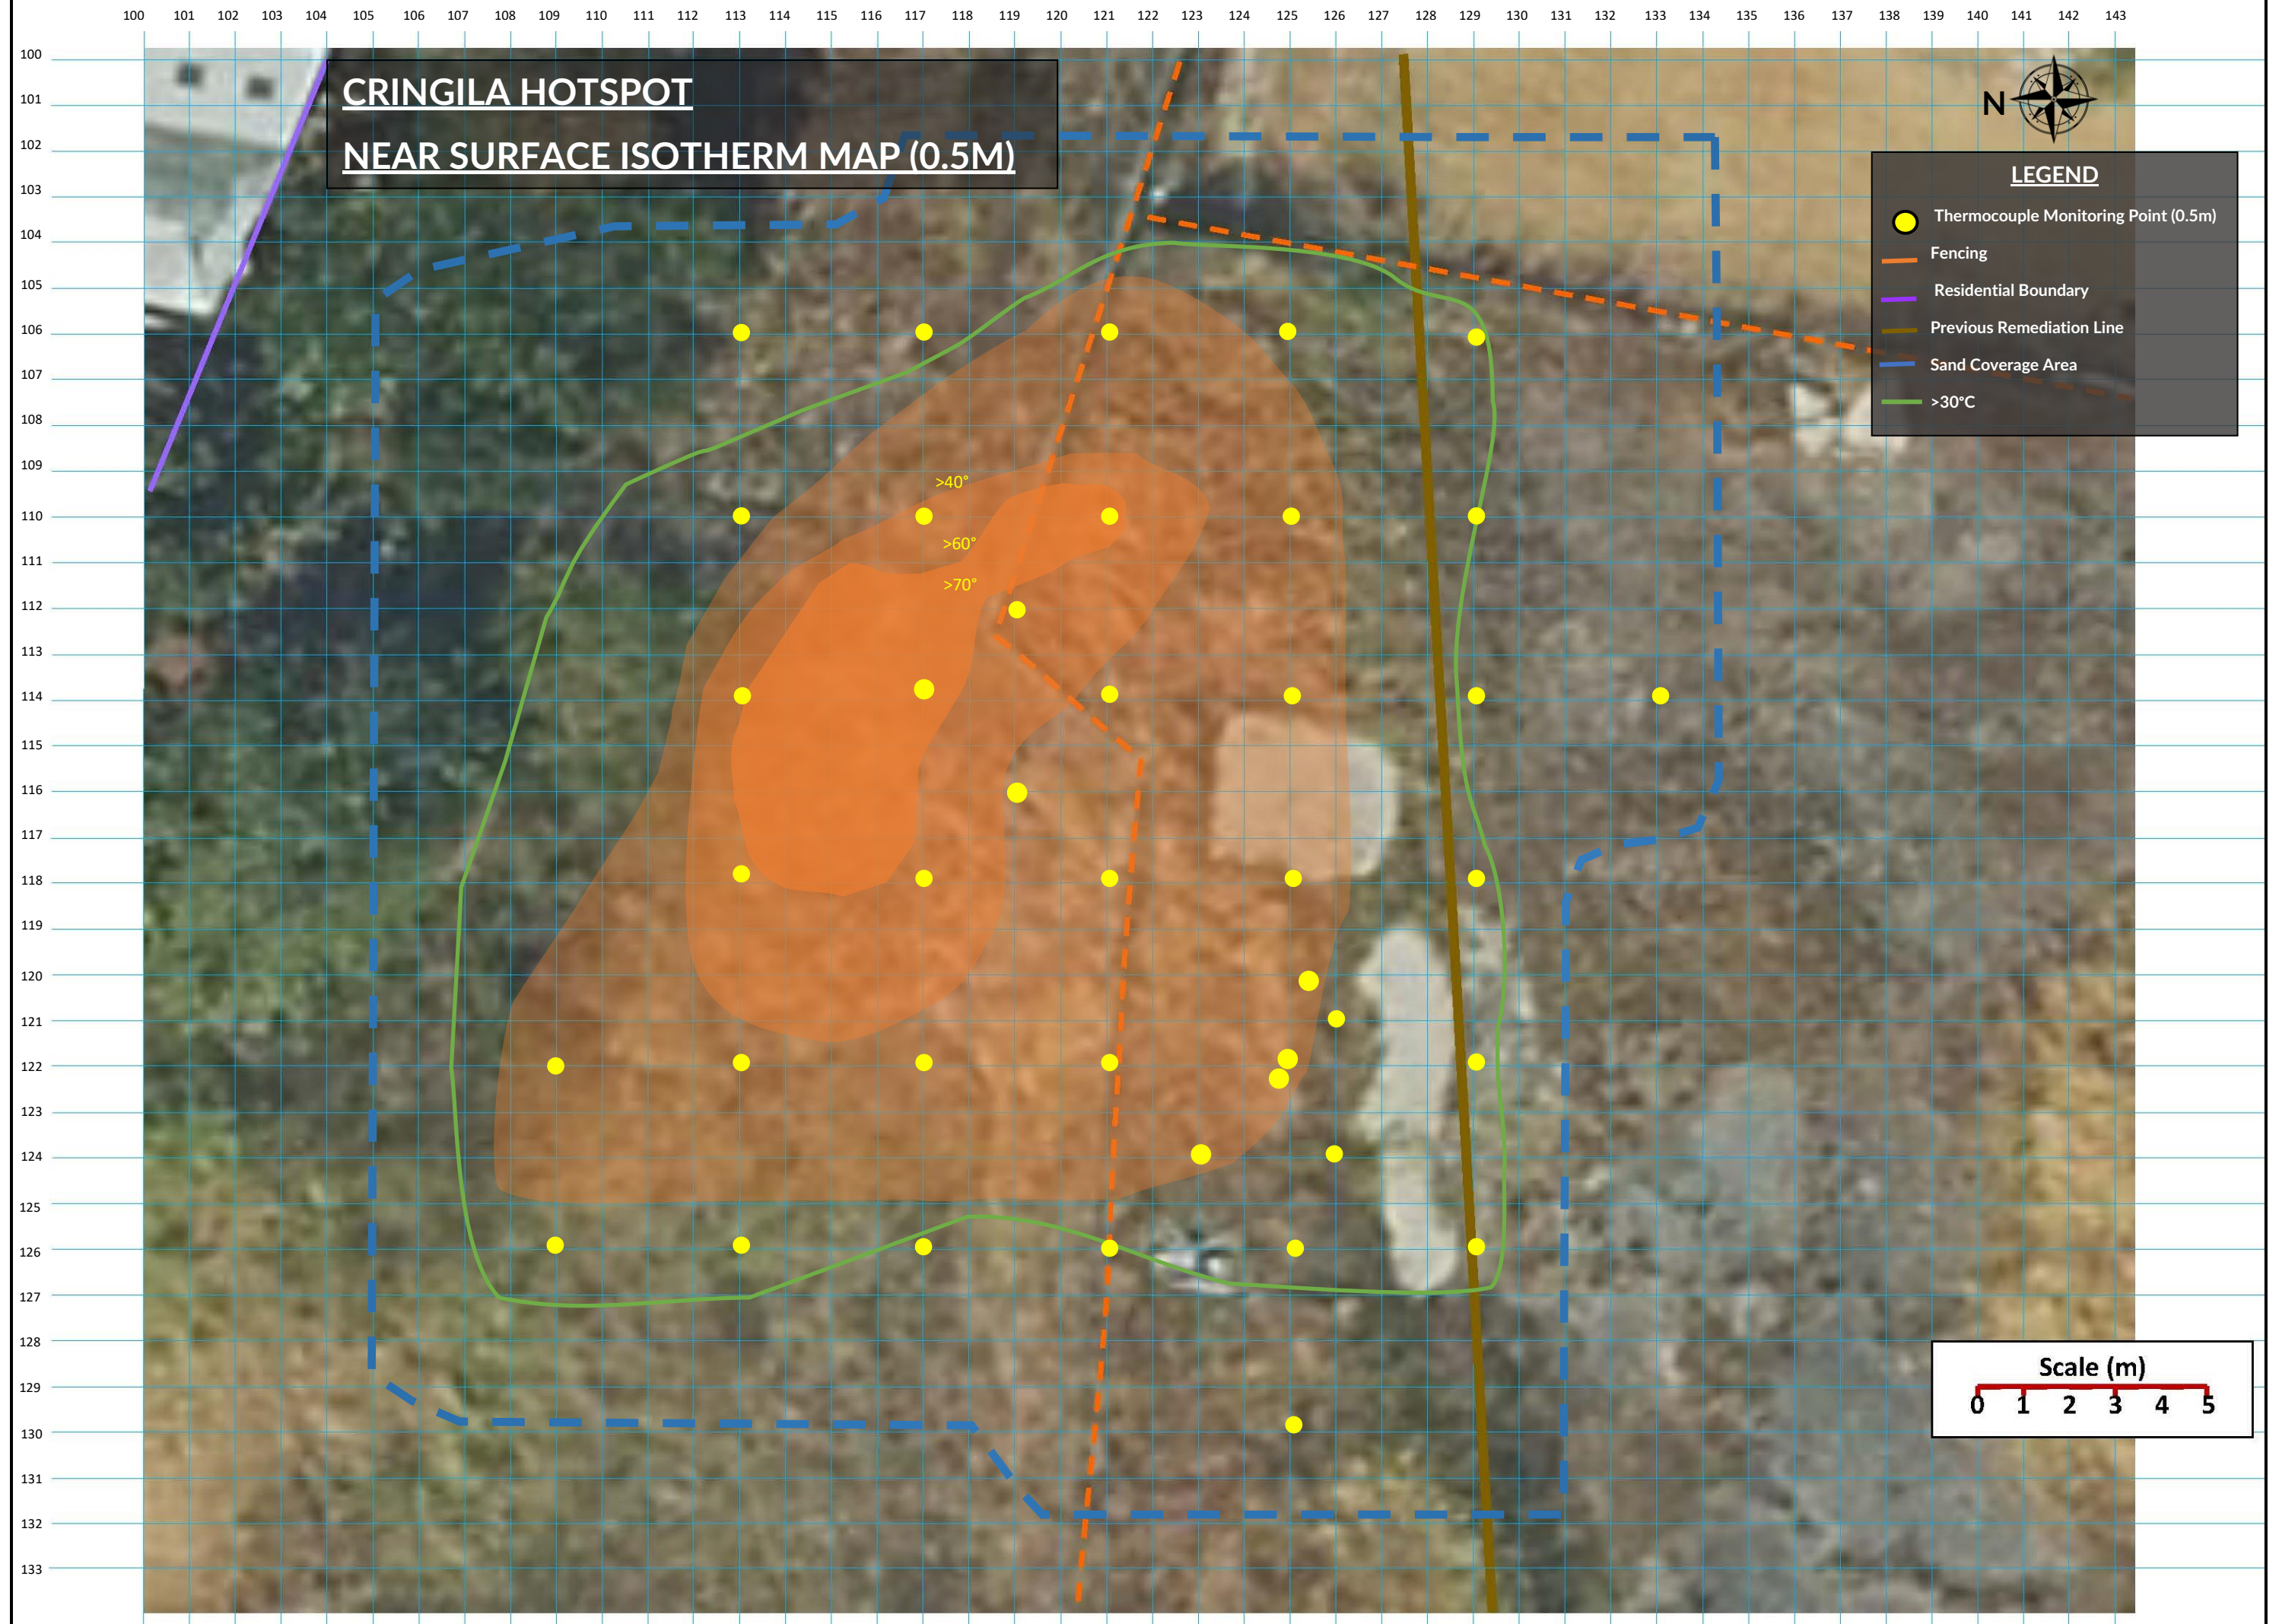
### Appendix B: Near Surface Temperature Isotherm Map (0.5m)

The isotherm map shows the general zone of influence for temperatures between 30°C and 70°C at 0.5m, coloured orange. The isotherm map suggests that the hotspot may extend deeper than 0.5m and that the increased temperature in these areas is a result of heat venting to the surface.

It is noted that temperature at the near-surface may be variable across the hotspot due to inconsistencies in the consolidation and compaction of subsurface materials.

# CRINGILA HOTSPOT NEAR SURFACE ISOTHERM MAP (0.5M)
