NEAR SURFACE TEMPERATURE MONITORING CRINGILA PUBLIC SCHOOL - NW HOTSPOT

Summary Report
14/01/2019 - 25/01/2019

NSW Department
of Education
Cringila Public School

35 Sheffield Street
Cringila NSW 2502

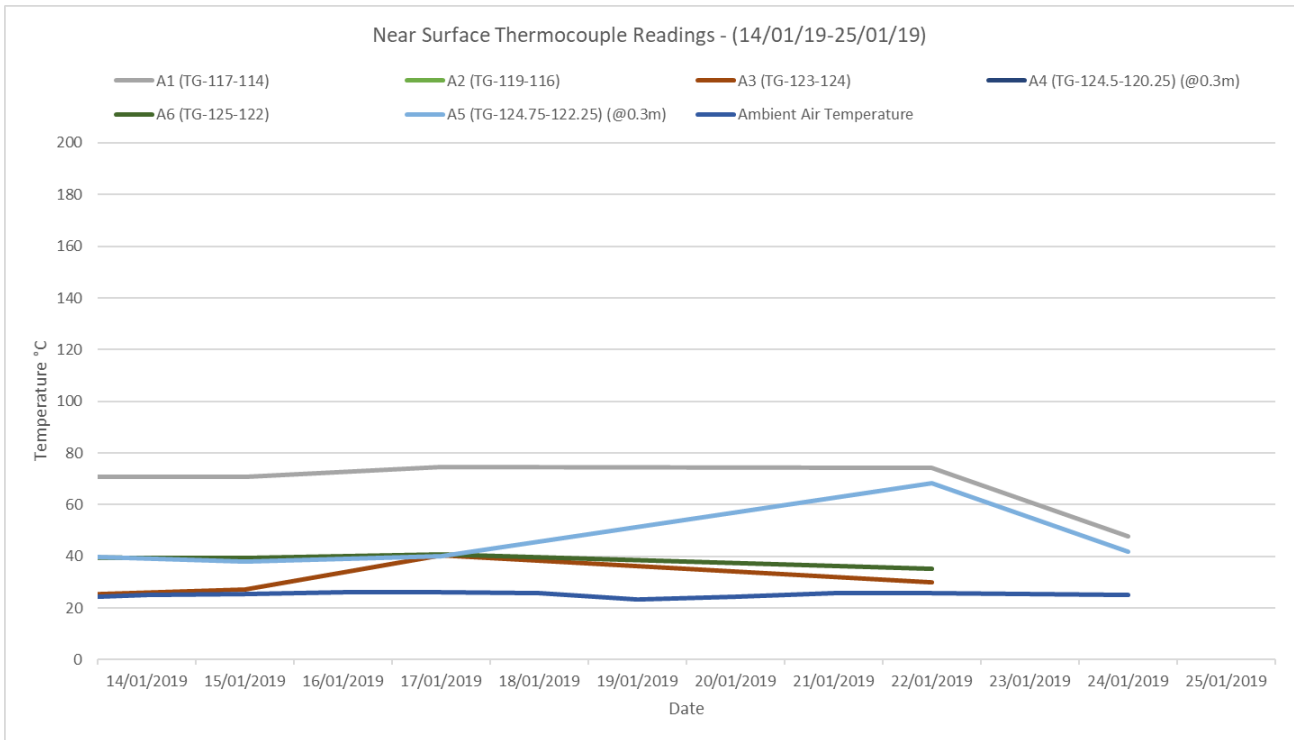
3.2. Near Surface Temperature Graph – Selected Points (Weekly)

Near surface temperature measurements for key thermocouple locations, over monitoring period - 14/01/2019 to 25/01/2019.

The near surface temperature at selected points across the northwest hotspot over the period of monitoring appear to remain consistent.

The near surface temperature monitoring conducted between 14th January 2019 and 25th January 2019 indicates that the spatial extent of the northwest hotspot appears to remain localised.

There were no significant near surface temperature variations identified during the period of monitoring.

It is recommended that weekly site inspections and recording are continued to monitor the near surface temperatures surrounding the hotspot identified at the site.

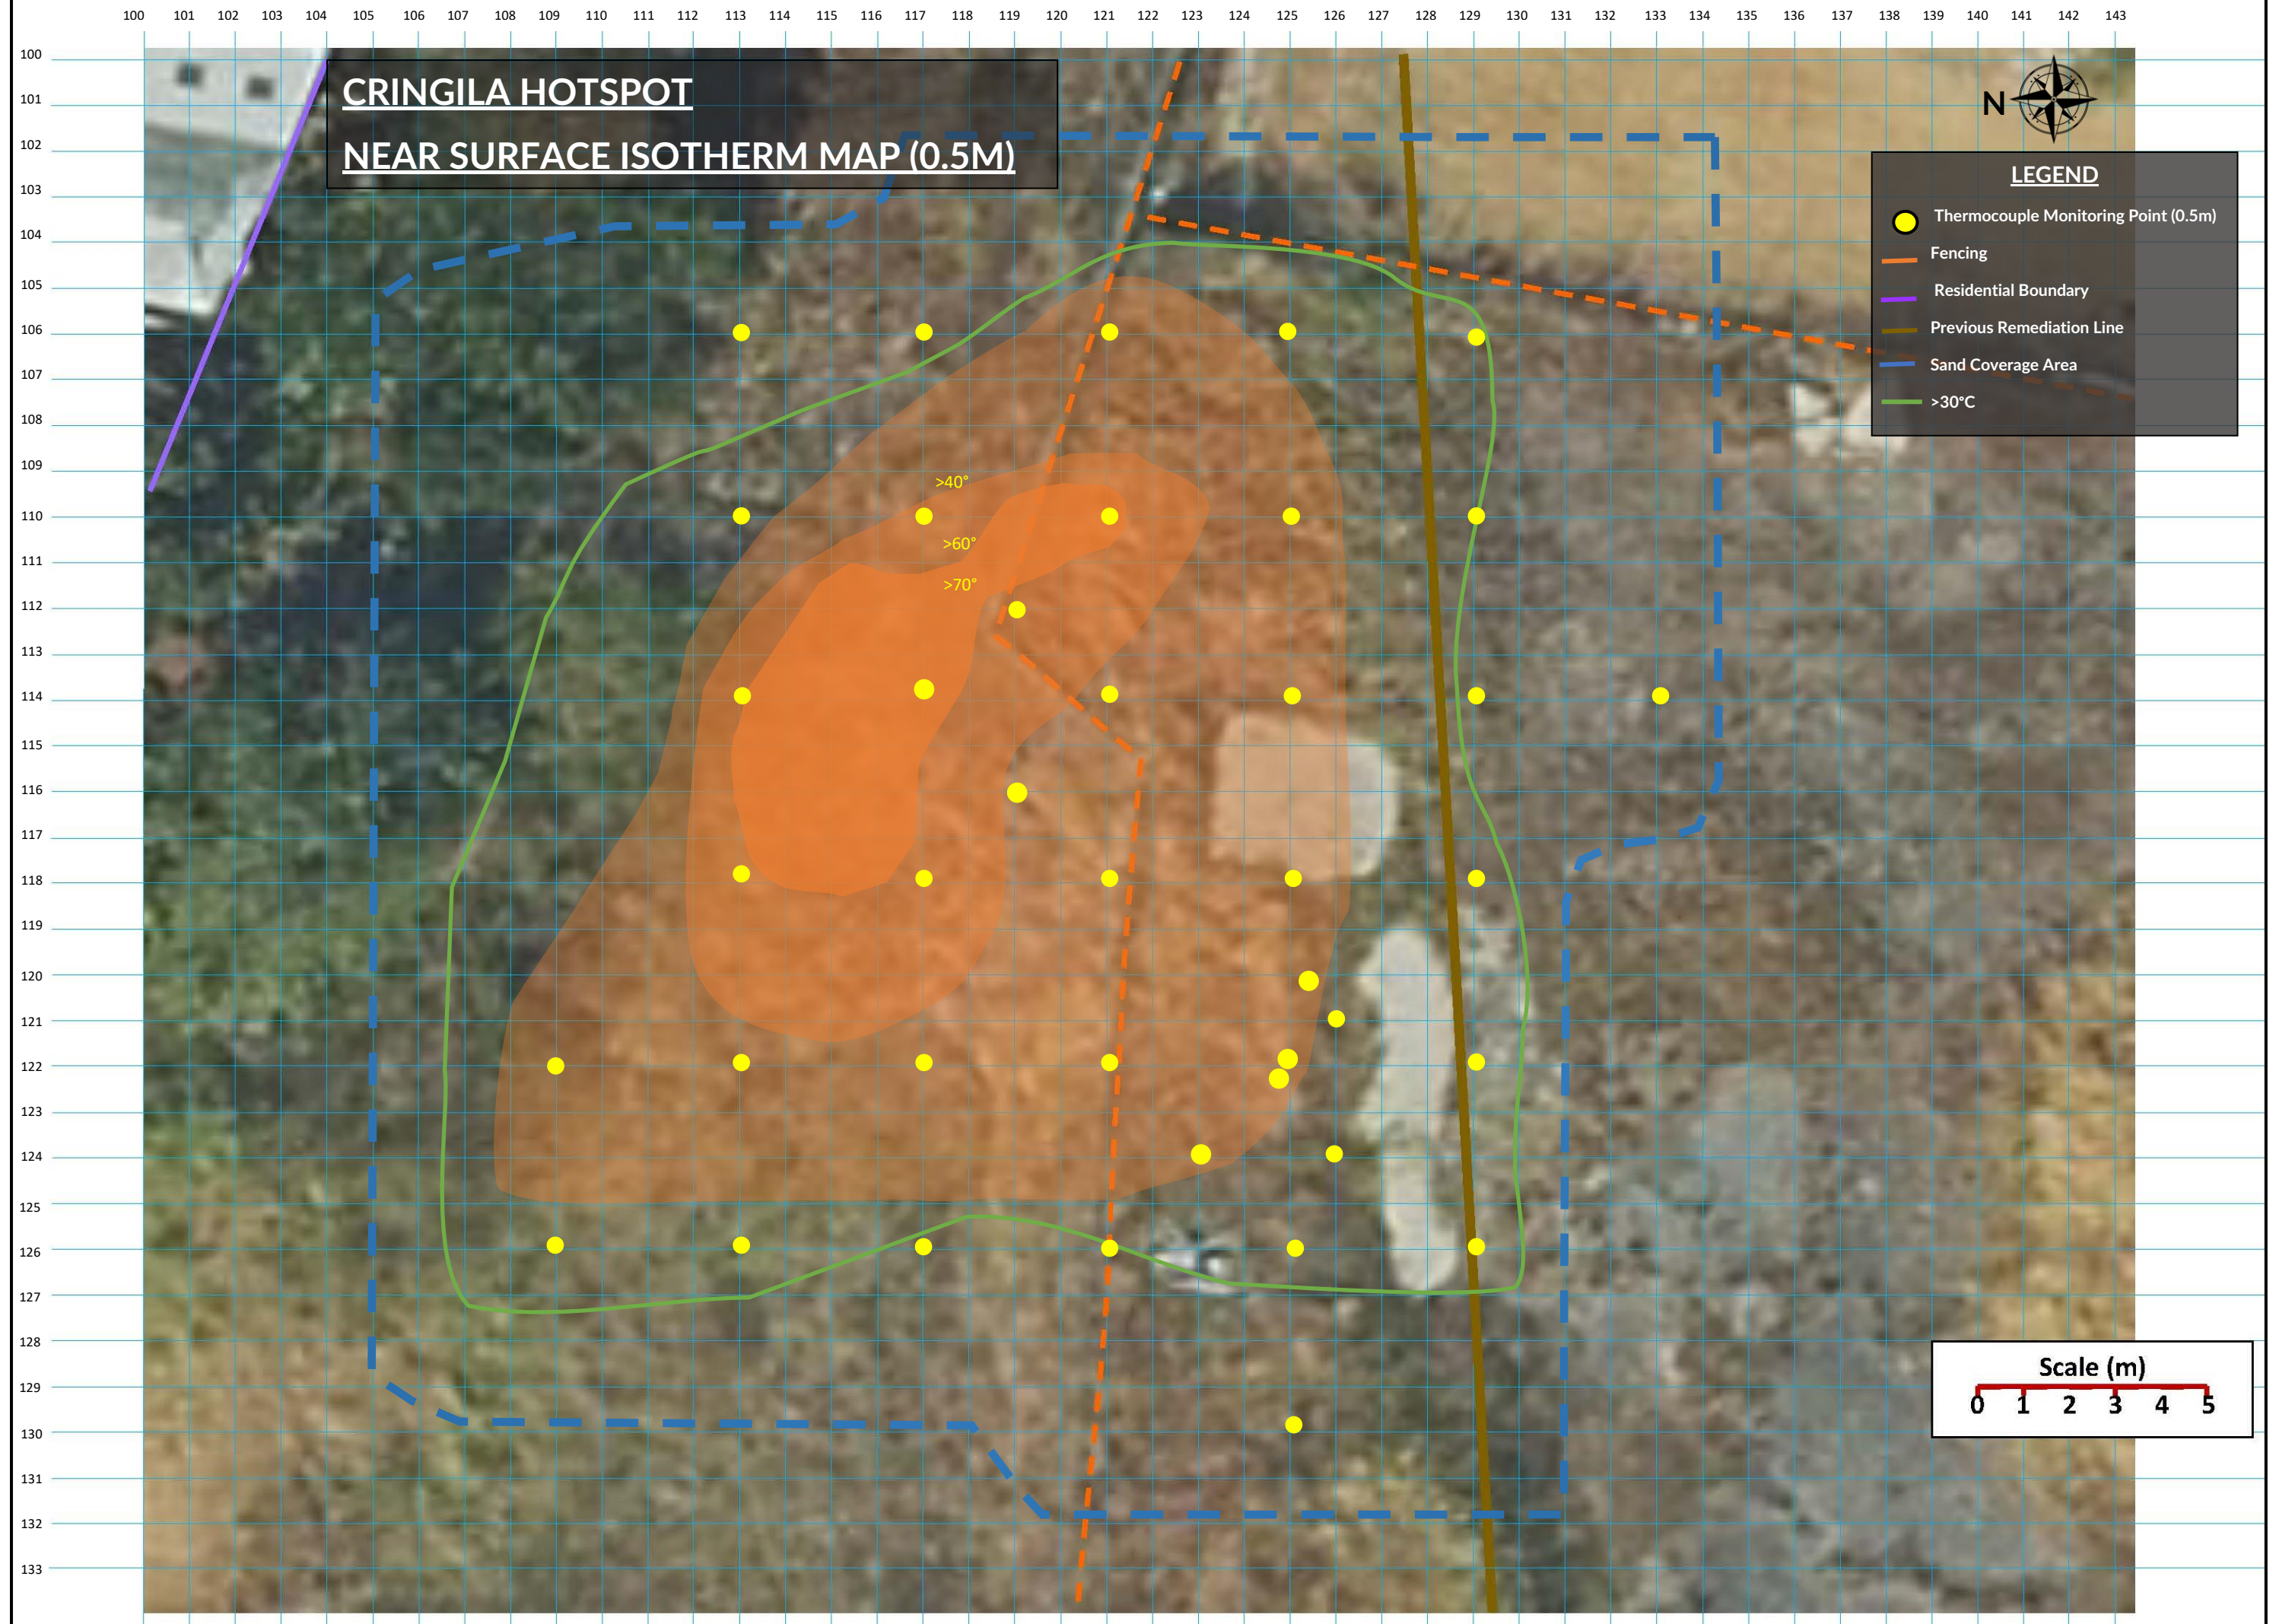
Appendix B: Near Surface Temperature Isotherm Map (0.5m)

The isotherm map shows the general zone of influence for temperatures between 30°C and 66°C at 0.5m, coloured orange. The isotherm map suggests that the hotspot may extend deeper than 0.5m and that the increased temperature in these areas is a result of heat venting to the surface.

It is noted that temperature at the near-surface may be variable across the hotspot due to inconsistencies in the consolidation and compaction of subsurface materials.

CRINGILA HOTSPOT NEAR SURFACE ISOTHERM MAP (0.5M)
