Asbestos in Grounds, Asbestos Management Plan, Blackheath Public School, Blackheath, NSW

March 2014

NSW Public Works

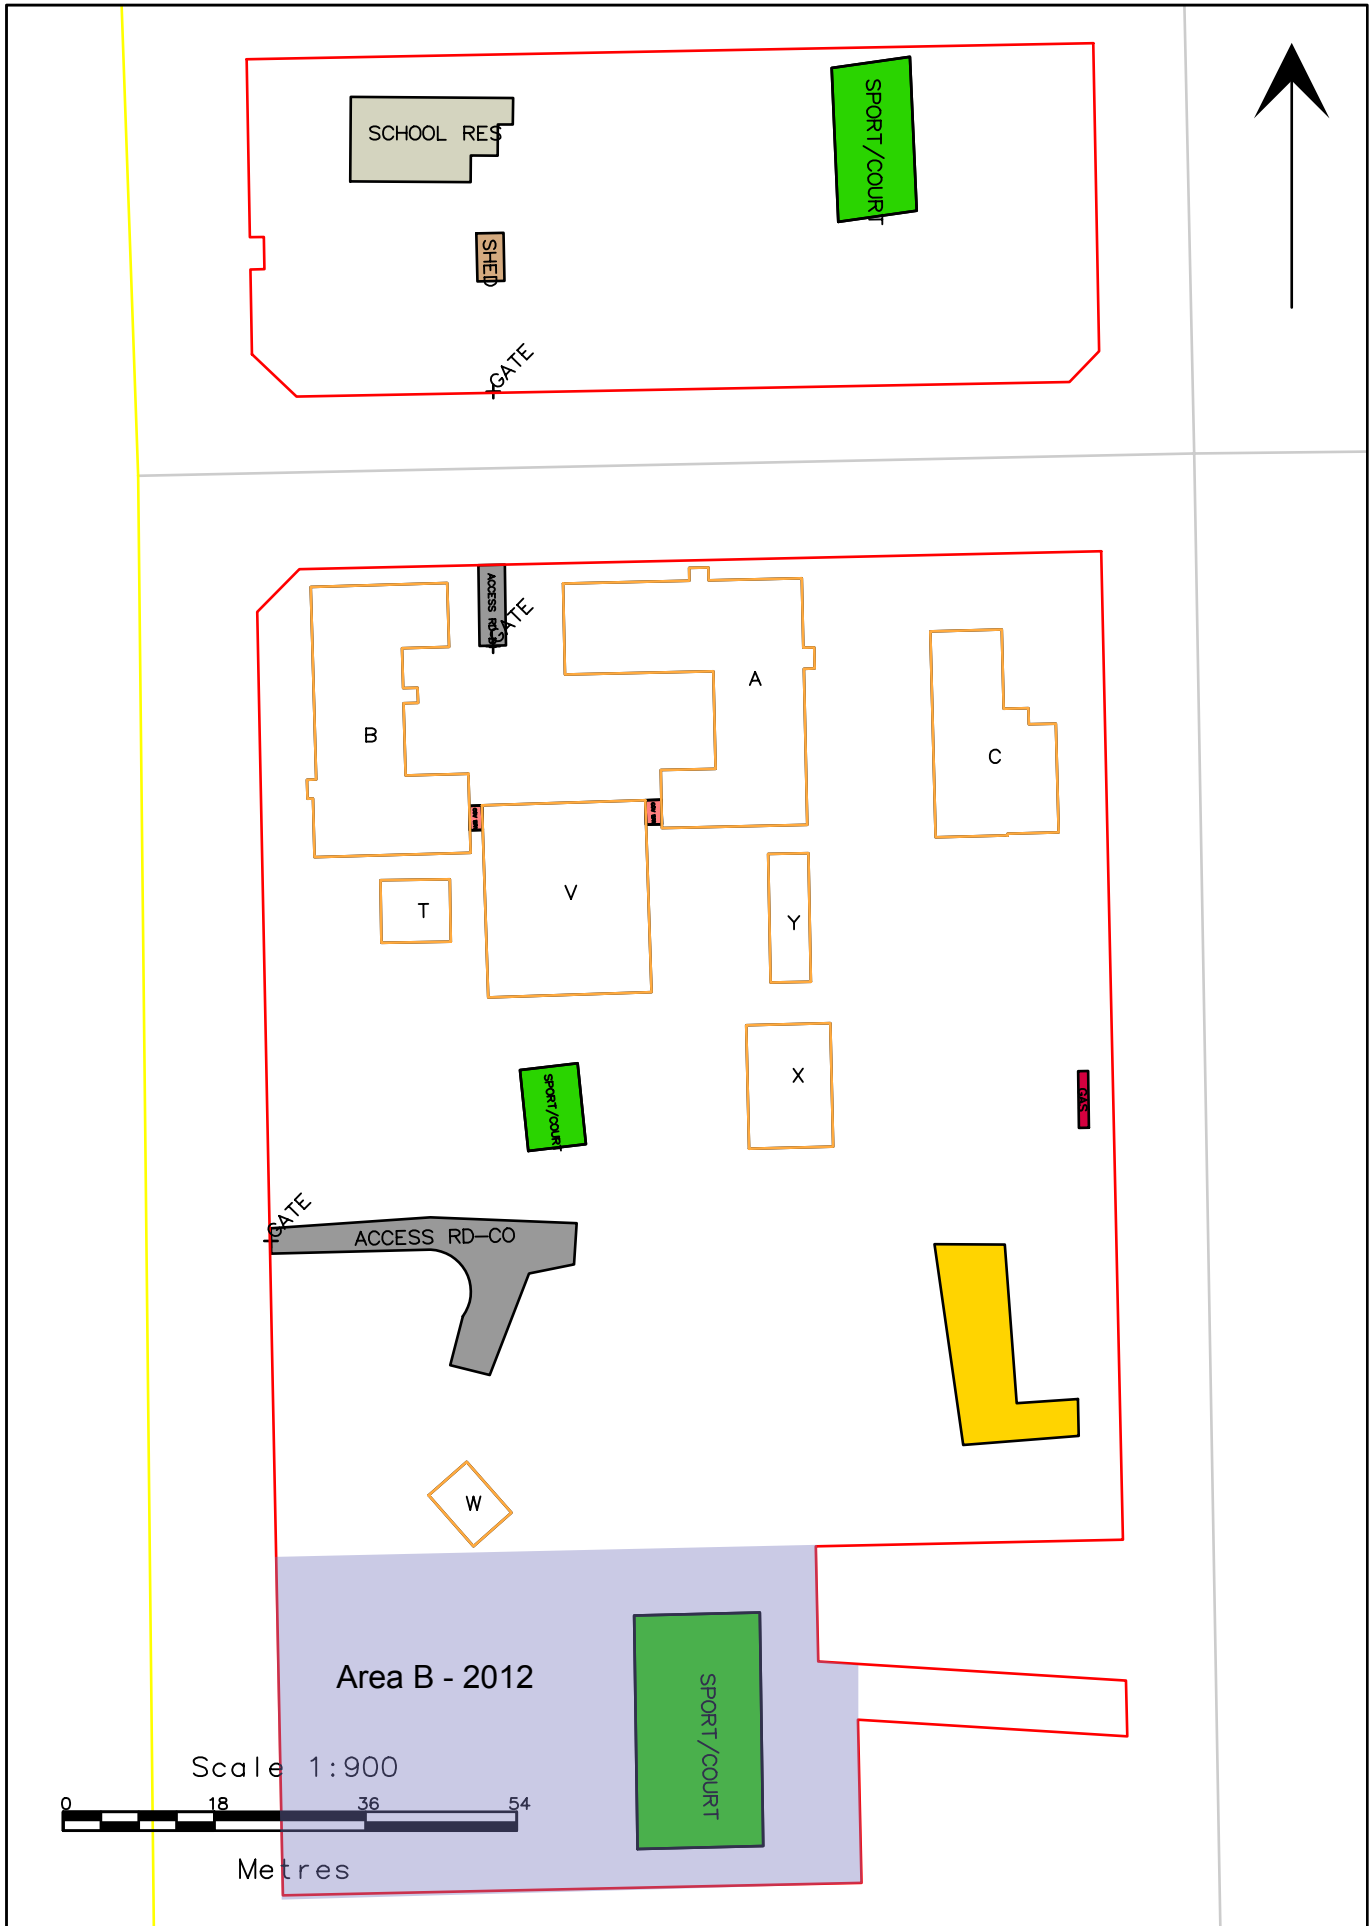
1246 – Blackheath Public School Site Plan (Allsites)

Asbestos cement fragments may be present as a component of buried fill within the asbestos zone areas. Refer to Figure 1 site plan.

*Refer to Figure 1 for detail of area locations

The remediated areas are shown in Figures 1 & 2.

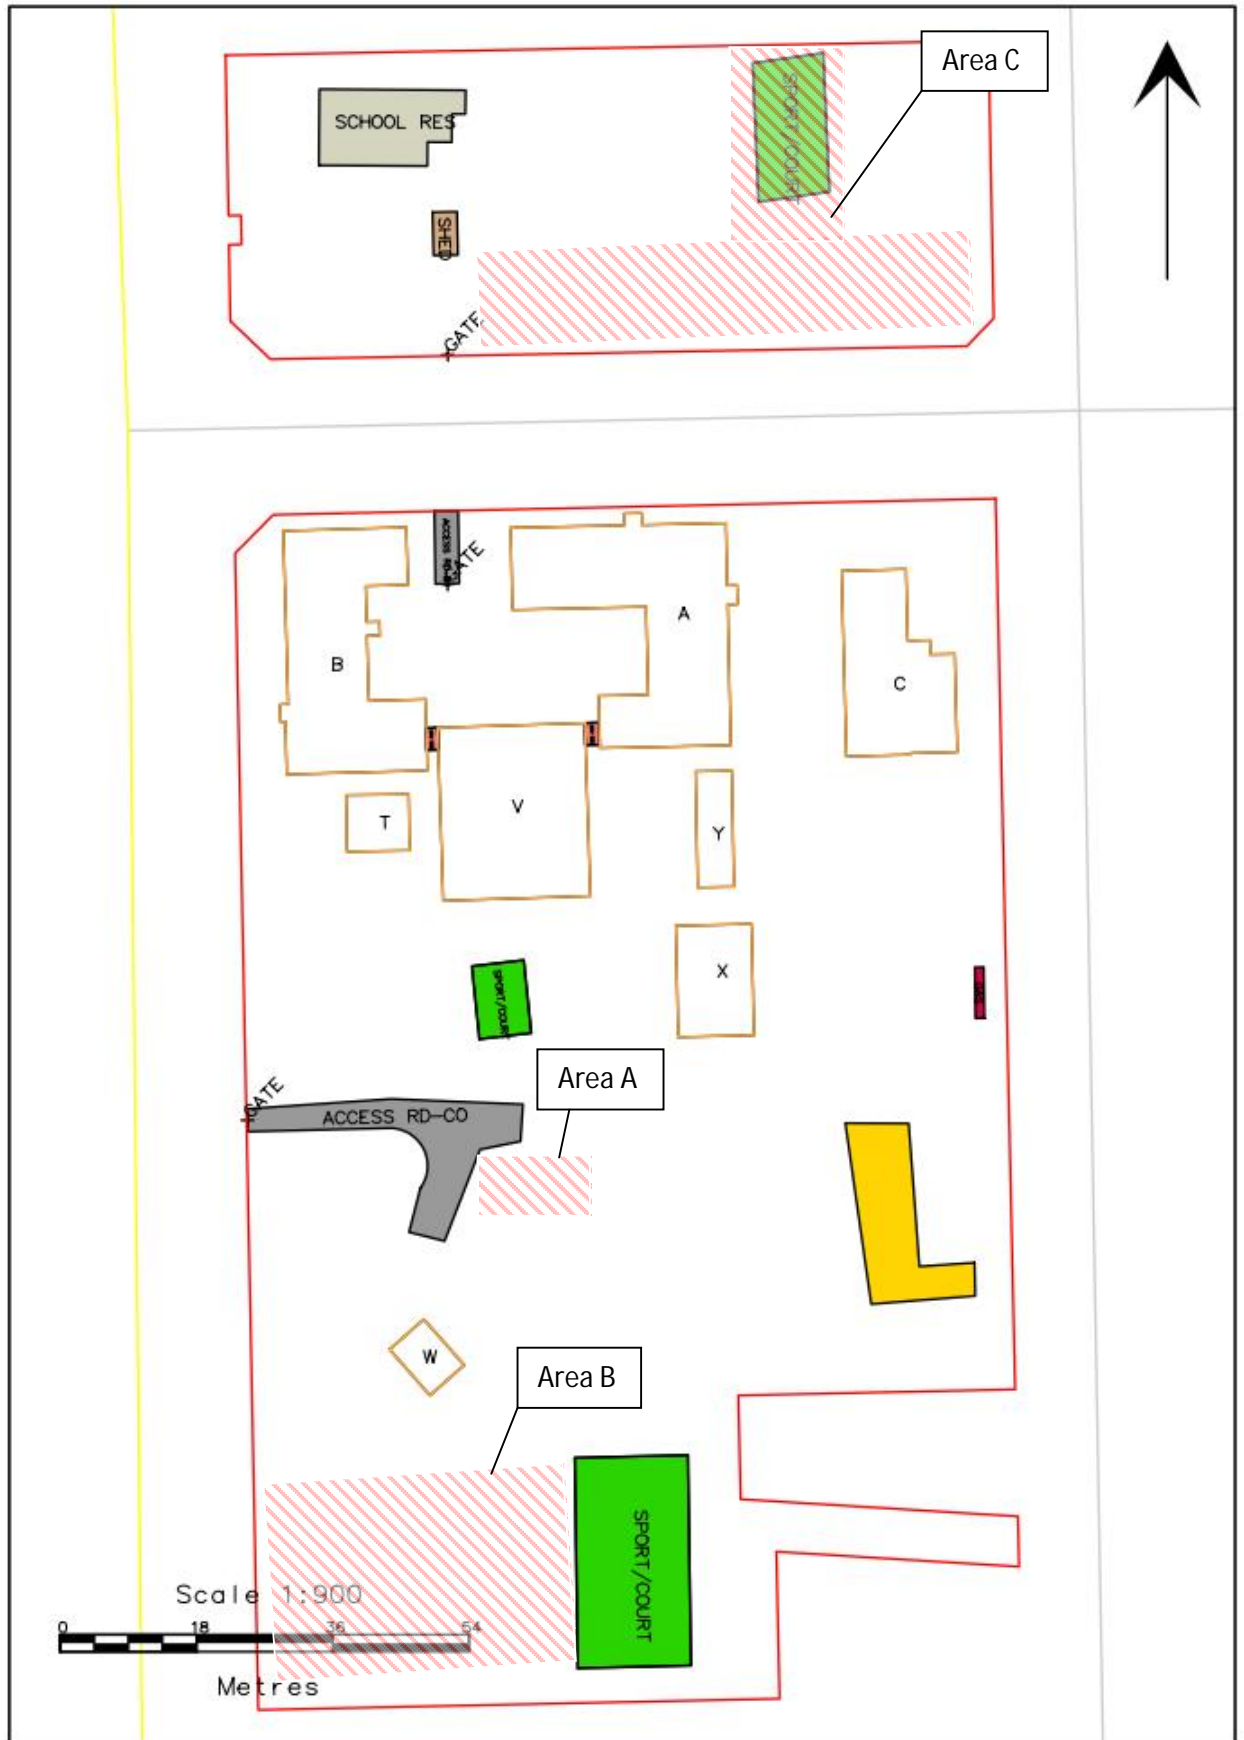
1246 – Blackheath Public School Site Plan (Allsites)

Asbestos zones
