Asbestos in Grounds, Asbestos Management Plan, Padstow Park Public School, Padstow NSW

November 2012

NSW Public Works

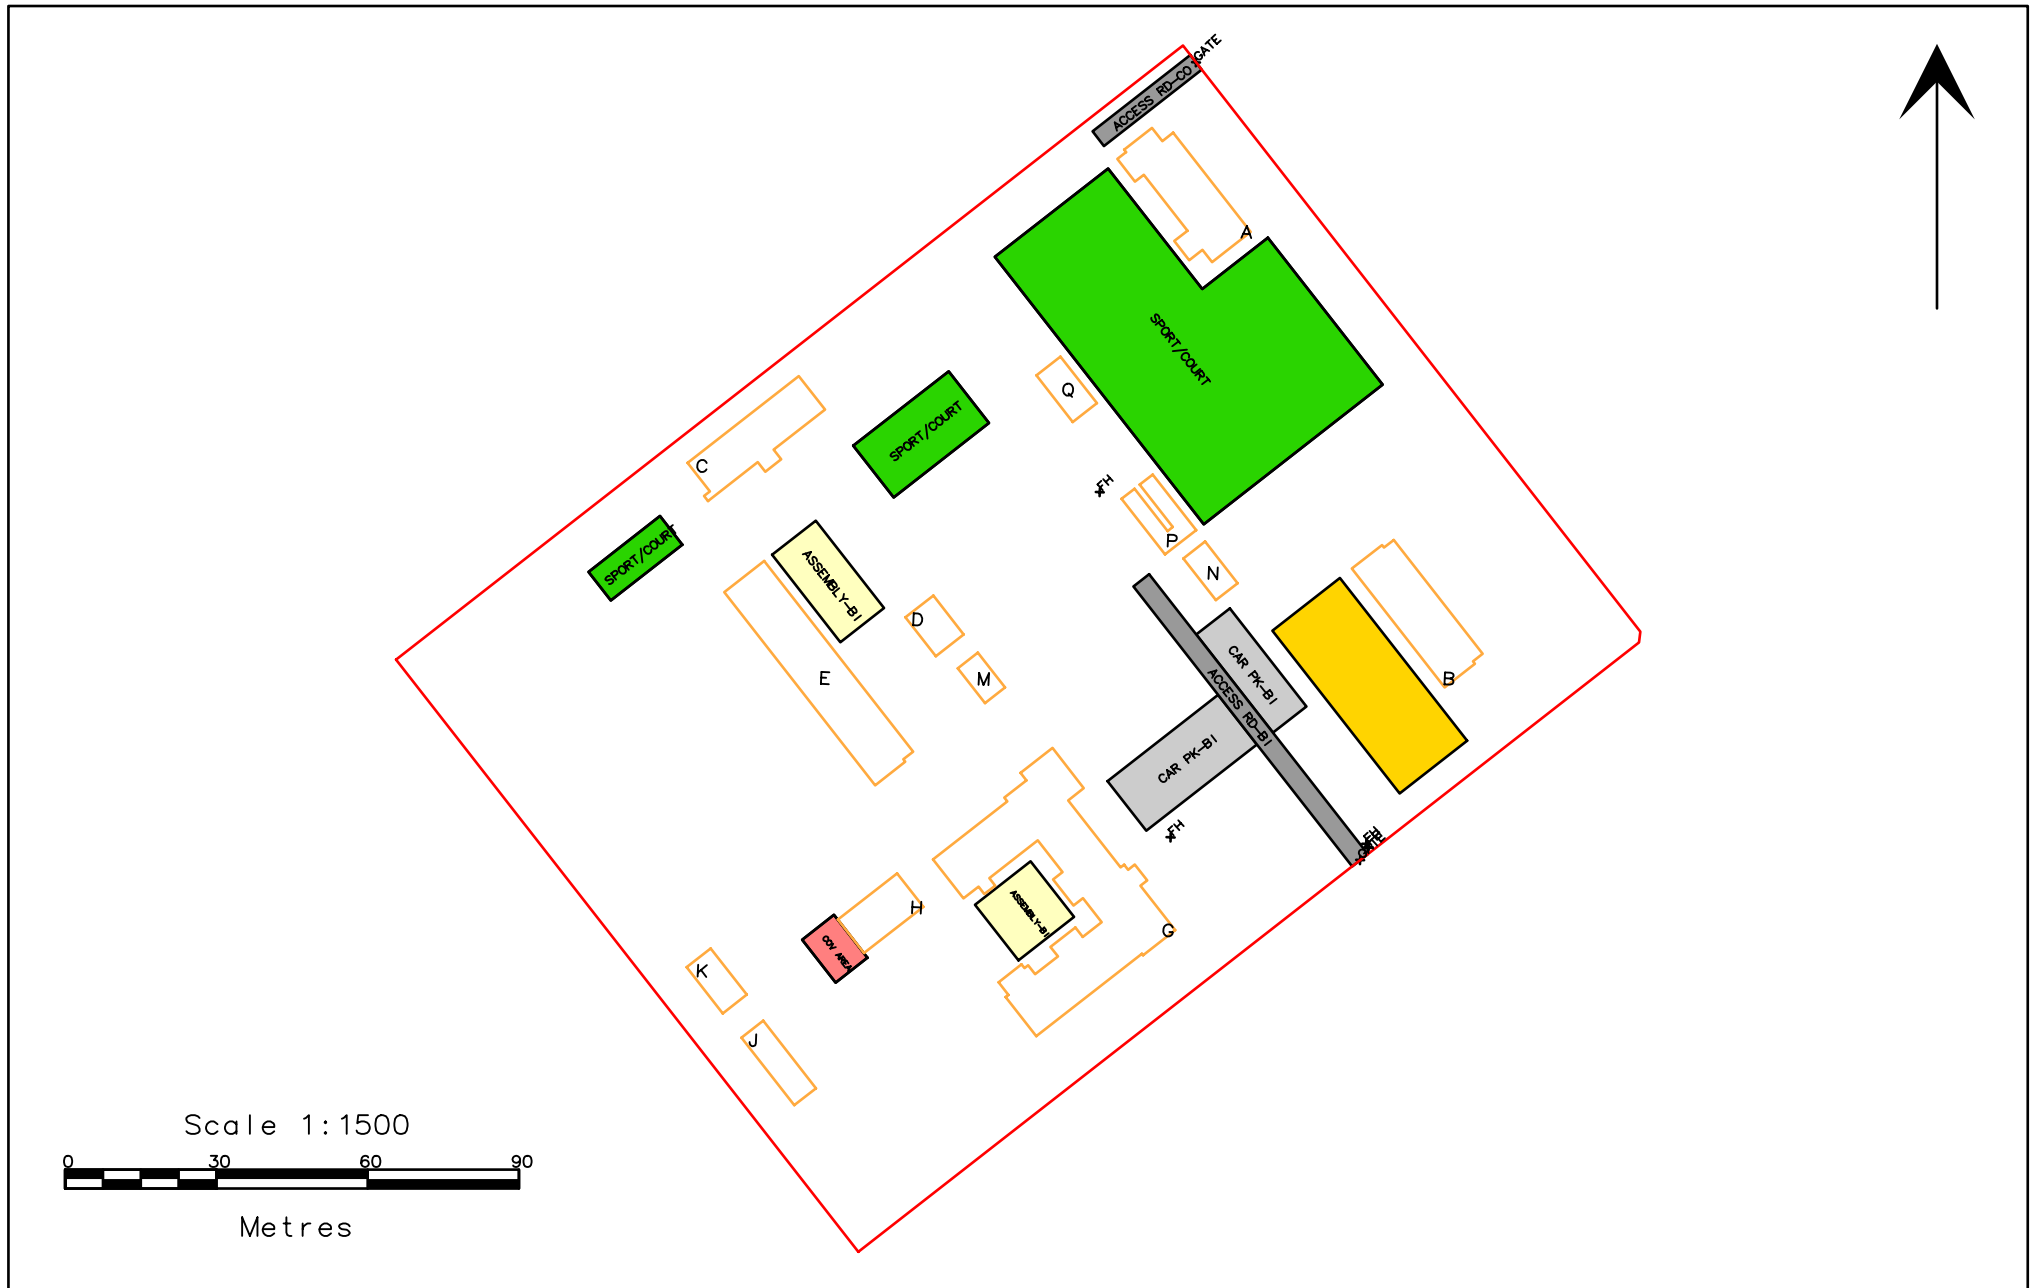
2826 – Padstow Park Public School Site Plan (11350)

The school site plan is shown in Figure 1. However the exact location of the asbestos impacted areas are not known by PB at this time.

Asbestos cement fragments may be present as a component of buried fill within the asbestos zone areas. Refer to Figure 1 site plan. A hygienist should be engaged to determine whether the asbestos within the Asbestos Zones is considered *non friable* or *friable* in accordance with the NSW WorkCover Authority 'Working with Asbestos, 2008'. This contains safety guidelines and requirements for work involving asbestos.

Site layout plan
